Carina Iron Ore Project

Ministerial Statement 852 - 957 Compliance Assessment Report

30 April 2021

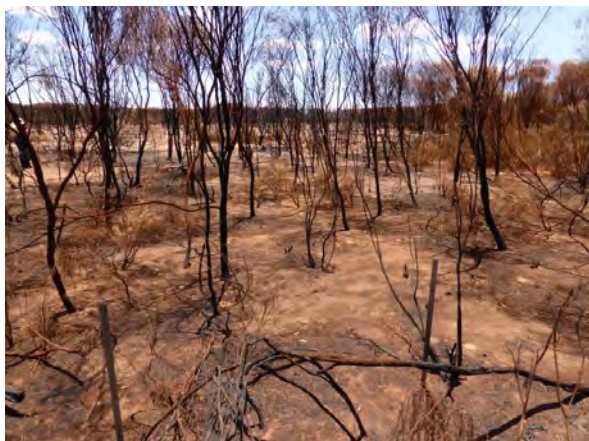
Plate 1: Transect RS-14-B in 2017 showing fire damage (Astron Environmental Services 2017).

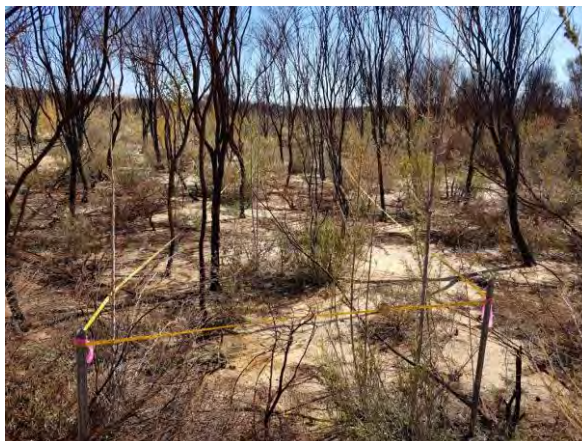
Plate 2: Transect RS-14-B in 2020 showing signs of regrowth from the fire in 2017.
