Hudson River Hydrilla Survey

2015 Hydrilla Monitoring in the Croton River (NY) and Nearby Waters (Hudson River)

New England Interstate Water Pollution Control
Commission and the New York State
Department of Environmental Conservation

Project Code: 2015-020

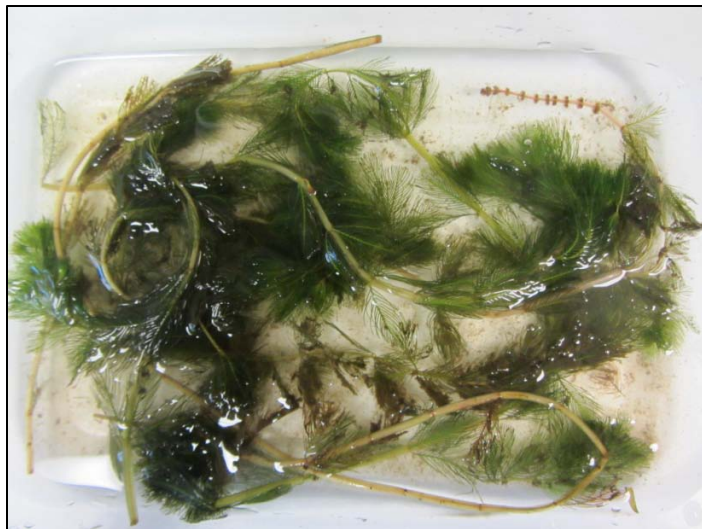
Eurasian water milfoil has long (2 meters or more) spaghetti-like stems that grow from submerged rhizomes. The stems often branch repeatedly at the water's surface creating a canopy that can crowd out other vegetation, and obstruct recreation and navigation. The leaves are arranged in whorls of 4 to 5, and spread out along the stem. The leaves are

divided like a feather, resembling the bones on a fish spine. Eurasian water milfoil is an exotic originating in Europe and Asia, but its range now includes most of the United States. It's ability to grow in cool water and at low light conditions gives it an early season advantage over most other native submersed plants. Although it can reproduce via fruit production, it typically also reproduces via fragmentation.

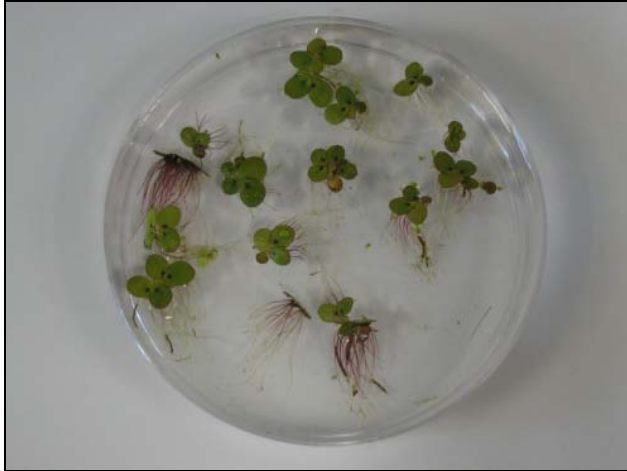
Small Duckweed (*Lemna minor*. Common Names: Small duckweed, water lentil, lesser duckweed. **Native.**). Small duckweed is a free floating plant, with round to oval-shaped leaf bodies typically referred to as fronds. The fronds are small (typically less than 0.5 cm in diameter), and it can occur in large densities that can create a dense mat on the water's surface. Each frond contains three faint nerves, a single root (a characteristic used to distinguish it from other duckweeds), and no stem. Although it can produce flowers, it usually reproduces via budding at a tremendous rate. Its population can double in three to five days. Since it is free floating, it drifts with the wind or water current, and is often found intermixed with other duckweeds. Since it's not attached to the sediment, it derives nutrients directly from the water, and is often associated with eutrophic conditions. It over winters by producing turions late in the season. Small duckweed is extremely nutritious and can provide up to 90% of the dietary needs for

waterfowl. It's also consumed by muskrat, beaver and fish, and dense mats of duckweed can actually inhibit mosquito breeding.

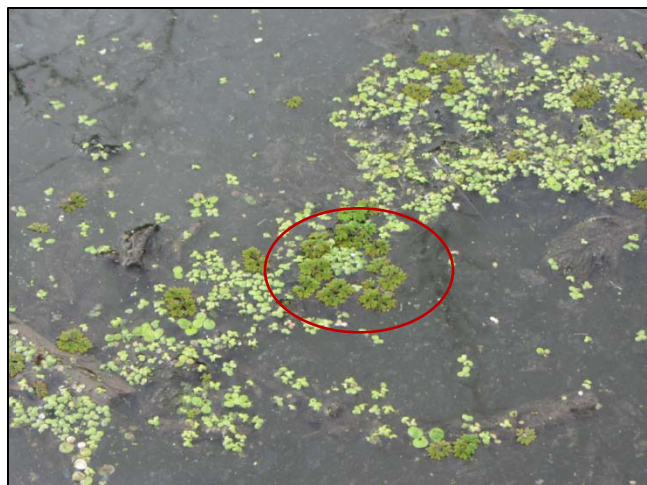
Water Fern (*Azollo caroliniana*. Common Names: mosquito fern, duckweed fern, fairy moss, water velvet. **Native**.). Water fern is a reduced fern that floats on the surface of the water, similar (and often found intermixed with) duckweeds. It is native to eastern North America. It has scale-like fronds that are green with a reddish tint at the edges. It displays more of a reddish color late in the season or in the winter. The fronds are coated with fine hairs, giving it a velvety appearance and texture.

Water fern can fix nitrogen from the air via symbiotic cyanobacteria. Water fern is a very efficient reproducer (both sexual, and asexual, via division) and can double its biomass in a few days to a week. It often develops dense surface mats under ideal growing conditions, which

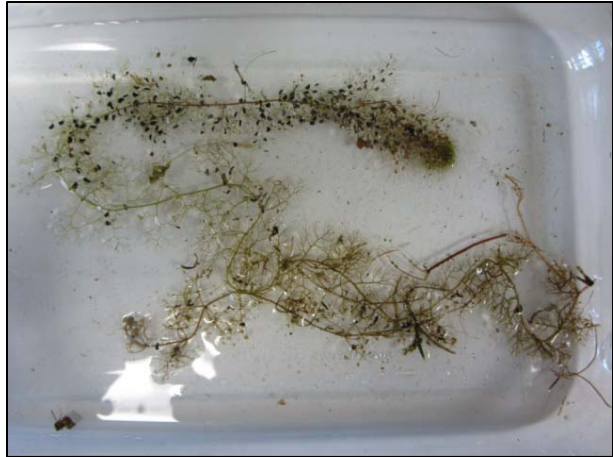
Small Bladderwort (*Utricularia minor*. Common Names: Small bladderwort, lesser bladderwort.

Native.) Small bladderwort is a free floating aquatic perennial herb. The delicate stems can be both floating and creeping usually, no more than 75 cm long. The leaves are linear, flat, and bristle-tipped, generally three parted at the base and forked three to seven times. The stem is densely lined with leaves bearing the bladders. The bladders are used to capture prey, such as protozoa, zooplankton, and even small insect larvae. Small yellow snap dragon-like flowers are produced. Since

it is free floating, and it derives nutrients from captured prey, it can inhabit low nutrient waters. It is not limited to substrate type, water clarity, or water depth, due to its lack of roots, but it is at the mercy of wind or water currents. Thus it prefers the shallow quiet waters of lakes, ponds and sluggish stream margins, or among stands of lilies at the surface.

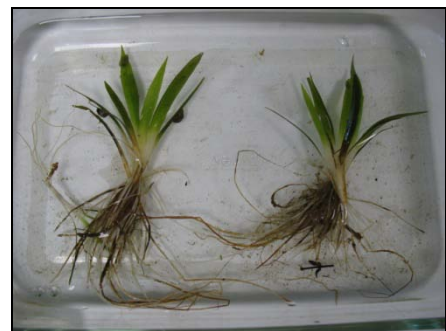
Arrowhead (Submersed Rosette) (*Sagittaria* sp. Common Name: Arrowhead. **Native.**): This plant is the submersed rosette of a species of arrowhead. The submersed rosette lacks both flowers and seeds, so further identification is not possible. Arrowhead has emergent leaves, and usually inhabits shallow waters at pond or lake edges, or along

sluggish streams. It can tolerate a wide variety of sediment types and pH ranges. Arrowhead is very suitable for constructed wetland development due to its tolerance of habitats, and ability to act as a nutrient sink for phosphorous. Typical arrowhead reproduction is via rhizomes and tubers although seed production is possible if conditions are ideal. Arrowhead has high wildlife value, providing high-energy food sources for waterfowl, muskrats and beavers. Arrowhead beds provide suitable shelter and forage opportunities for juvenile fish as well.

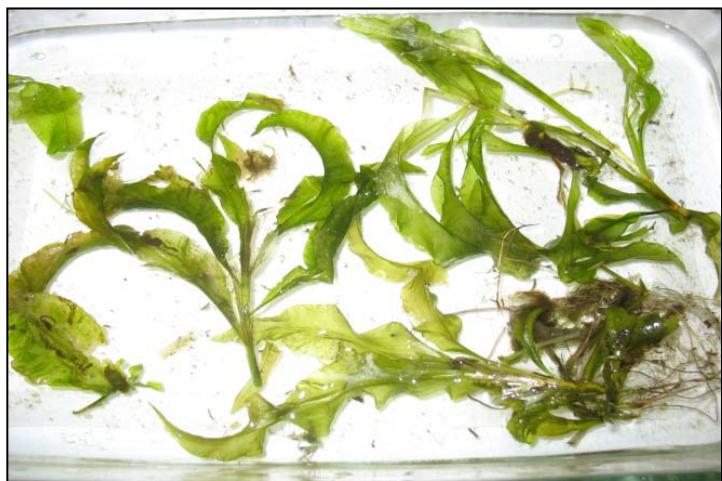
Bass Weed (*Potamogeton amplifolius*. Common Names: Large-leaf Pondweed, Bass Weed, Musky Weed. **Native.**): Bass weed has robust stems that originate from black-scaled rhizomes. The submersed leaves of bass weed are among the broadest in the region. The submersed leaves are arched and slightly folded, attached to stems via stalks, and possess many (25-37 veins). Floating leaves are produced

on long stalks (8-30 cm). Stipules are large, free and taper to a sharp point. Flowers, and later in the season fruit are densely packed onto a spike. Bass weed prefers soft sediments in water one to 4 meters deep. This plant is sensitive to increased turbidity and also has difficulty recovering from top-cutting, from such devices as boat propellers and aquatic plant harvesters. As its name implies the broad leaves of this submersed plant provides abundant shade, shelter
