# Ludwigia Control Project Final Report

**Laguna de Santa Rosa, Sonoma County, California**

**Final Report: Ludwigia Control Project**  
**Laguna de Santa Rosa, Sonoma County, CA**  
Date of Report: February 2008

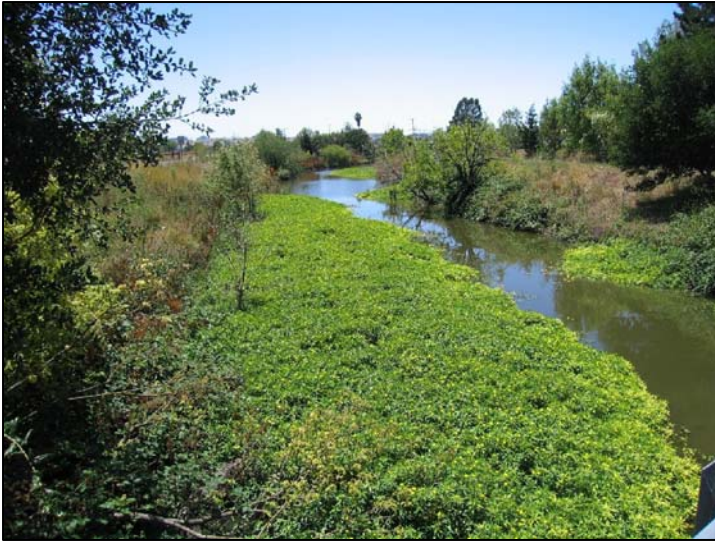
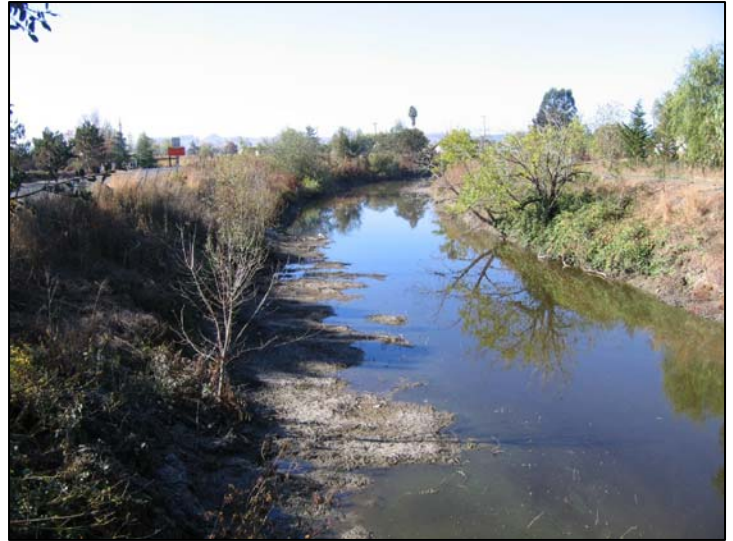
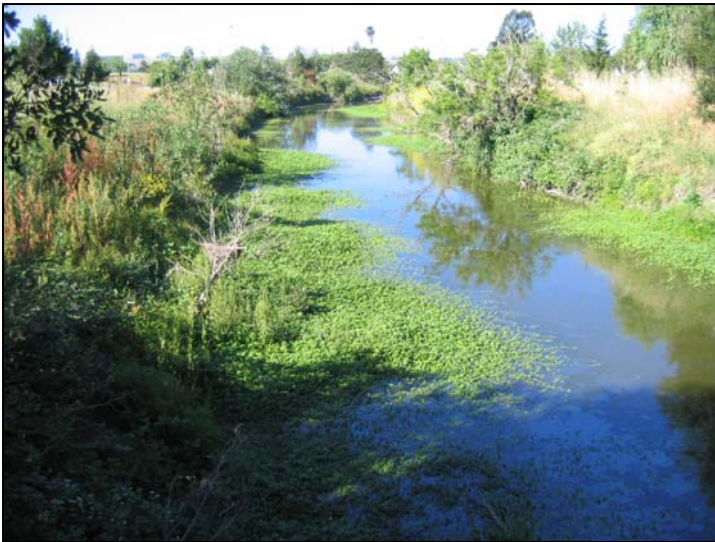
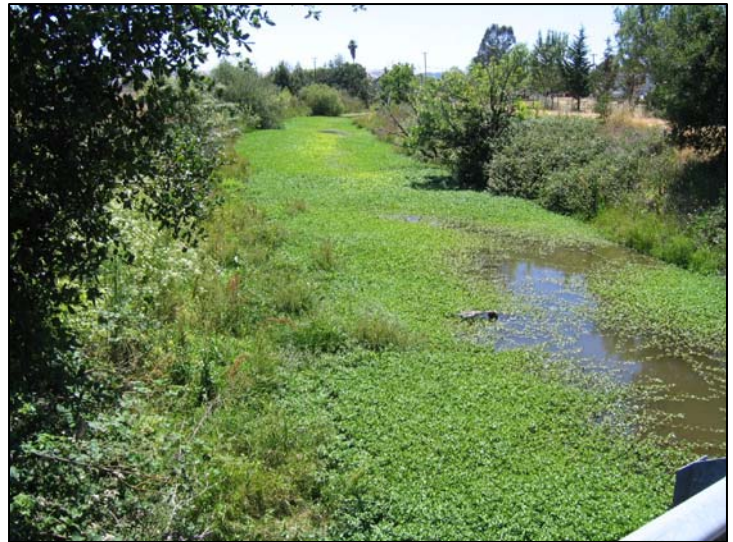
**Bellevue Wilfred Channel, SCWA Field Site: Photo Point A-01**

Bellevue Wilfred channel looking southwest off the Millbrae Road Bridge. Prior to project activities *Ludwigia* covered roughly 75% of the channel. Following 2005 spray/removal activities the channel was clear. In spring 2006 regrowth was moderate. Following another season of spray/removal, regrowth was strong in 2007 and *Ludwigia* reoccupied at least 75% of the channel though the density was reduced from pre-project levels. Note that much of the growth is occurring from the east (left) side of the channel where a mudflat provides ideal medium for germination, growth from fragments, and sprouting from existing roots. Removal of this sediment during the creation of a low flow channel could stem the regrowth in this section.

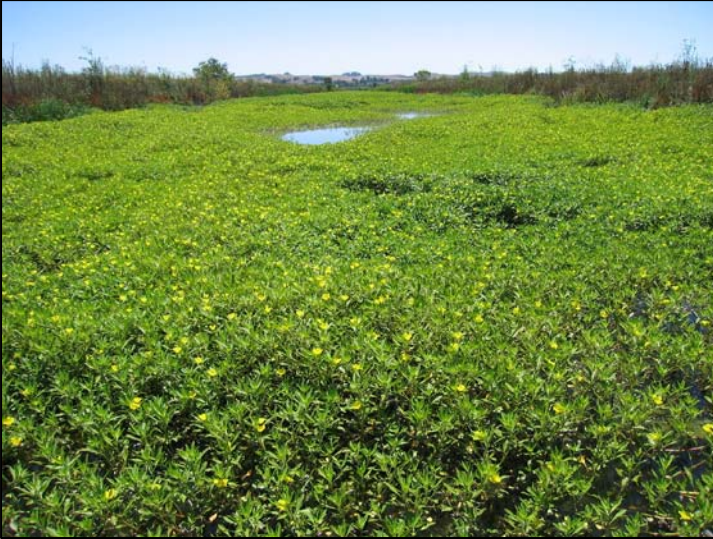
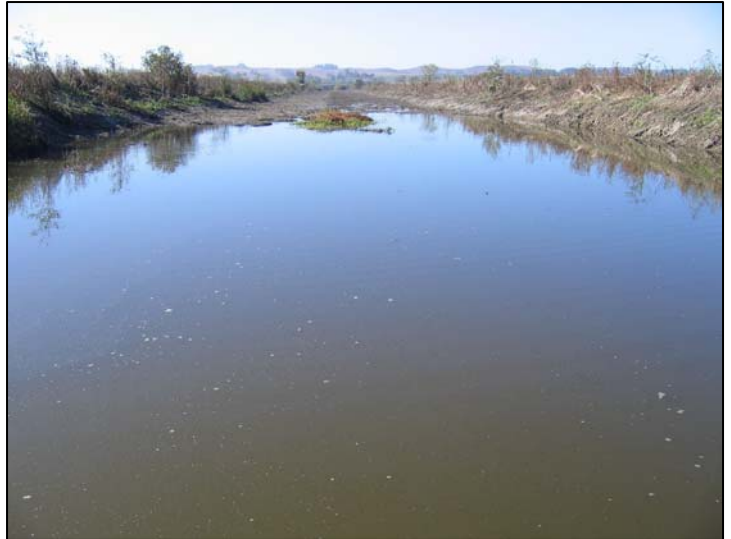
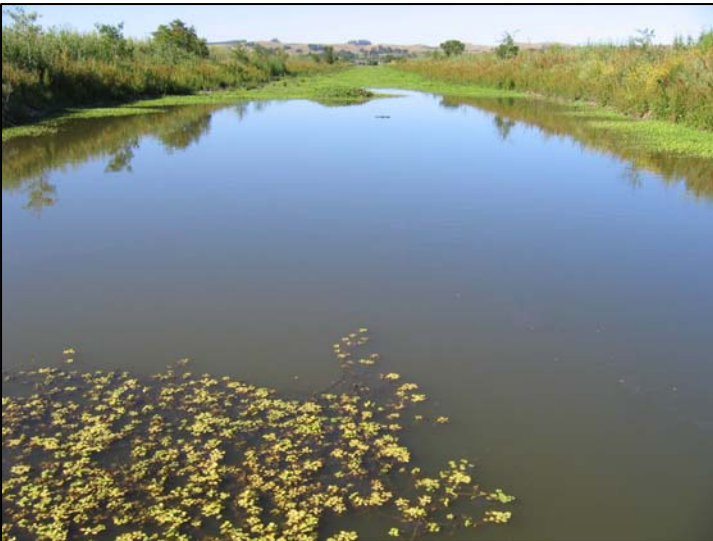
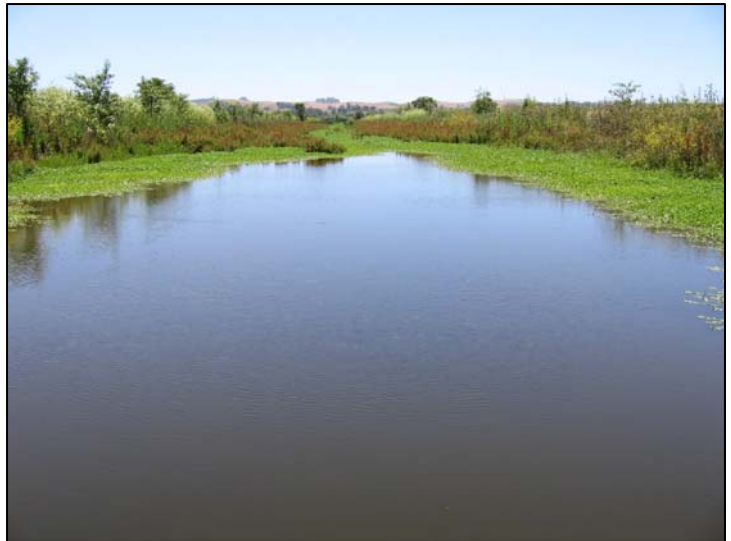
**Bellevue Wilfred Channel, SCWA Field Site: Photo Point D-07**

Bellevue Wilfred channel looking north toward the Wilfred Bridge. Photo taken from cross bridge within channel. Note the open water in the foreground following the first year. Although *Ludwigia* can easily creep across this deeper water (~36 inches), the time required to reoccupy it is greater than in uniformly shallow areas. The important point is that deeper water will limit *Ludwigia* growth for a period of time but not indefinitely as is obvious from the pre-spray July 2005 photo. Following the 2007 spray/removal activities, this section was once again clear.

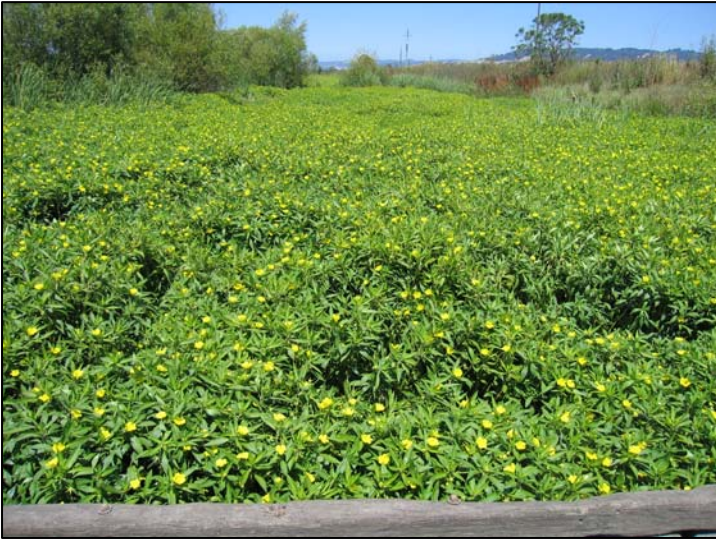
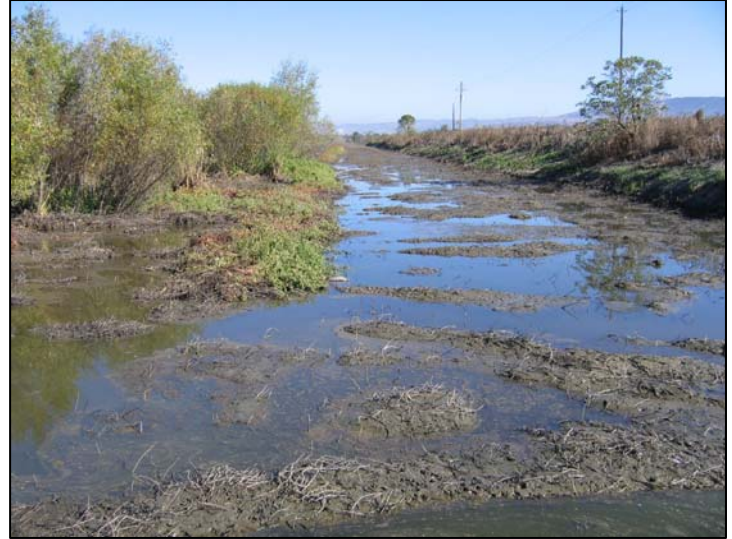
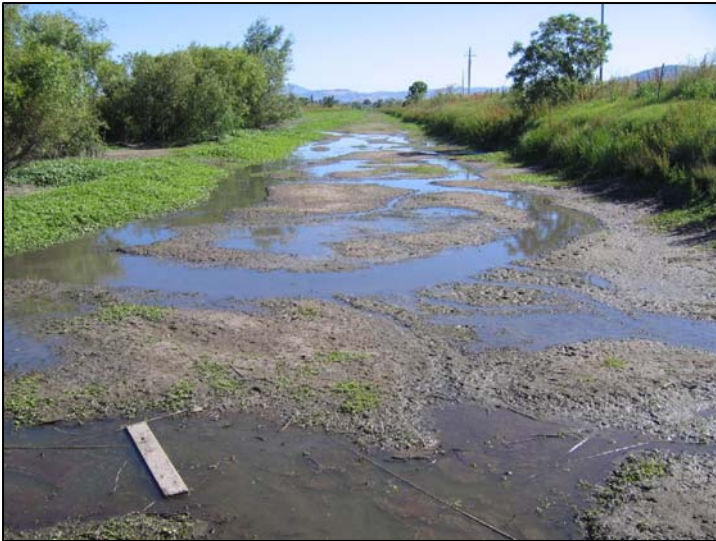
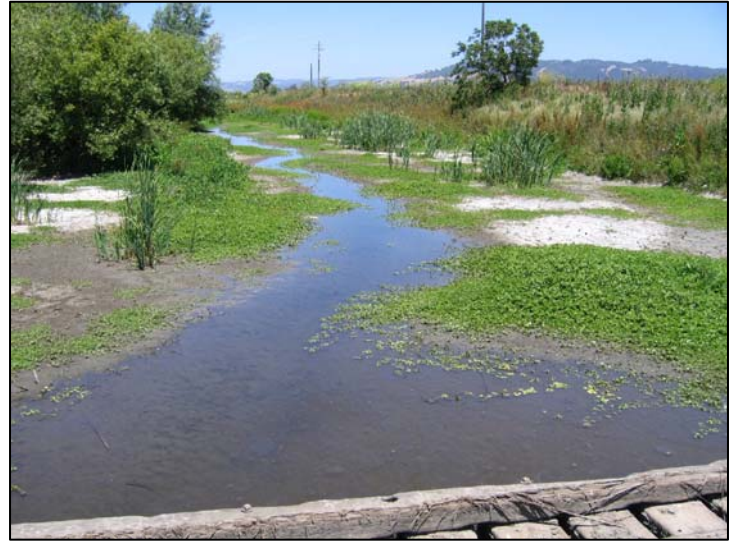
**Bellevue Wilfred Channel, SCWA Field Site: Photo Point E-08**

Bellevue Wilfred channel looking north from cross bridge within channel (just north of Rohnert Park Expressway). Dense infestation in July 2005 was growing on shallowly inundated mudflat. Regrowth in June 2006 was limited partly from cool wet spring. By mid-summer regrowth was more pronounced. Regrowth in June 2007 was stronger following a warm spring and drought winter. Note the natural low-flow channel in June 2007. If this were made deeper it is possible the soil on the adjacent mudflats would not be saturated and would be less conducive to *Ludwigia* growth.

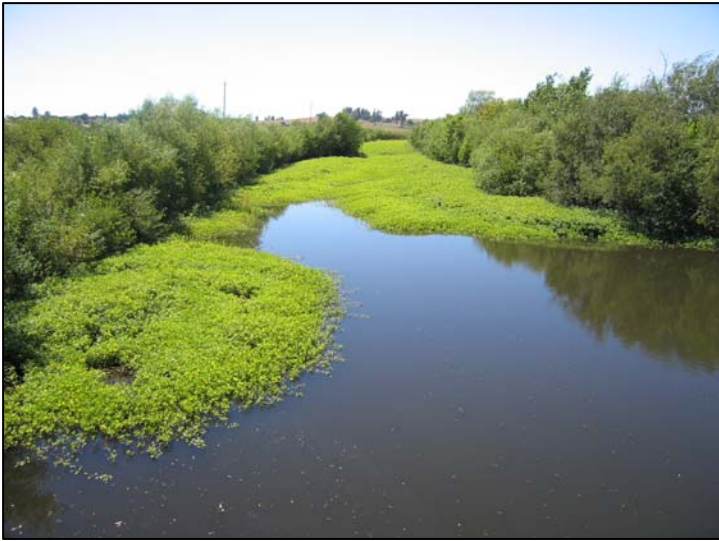
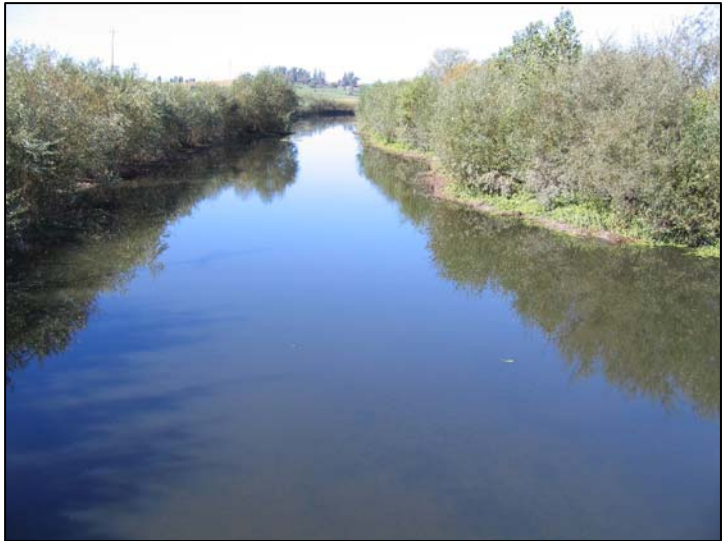
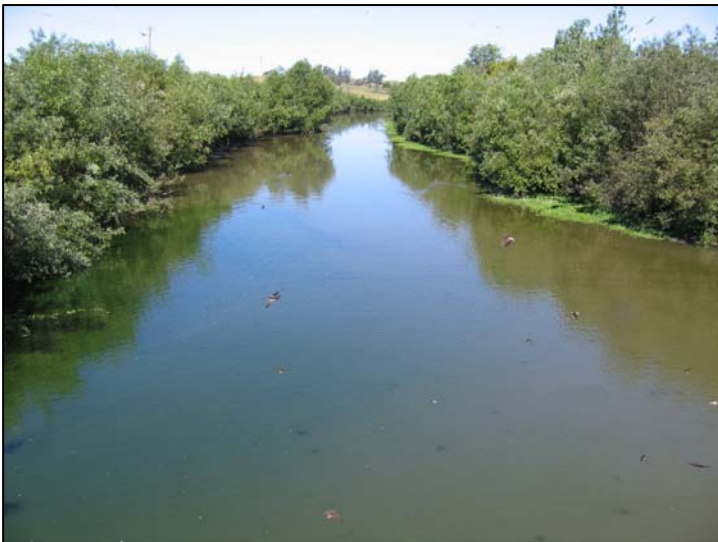
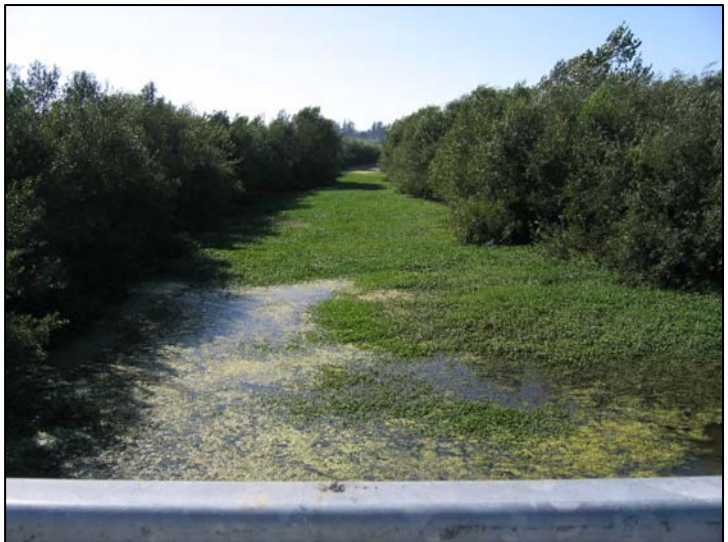
**Laguna Main Channel, SCWA Field Site: Photo Point I-13**

Main Laguna channel looking west from the Stony Point Road Bridge. Prior to project activities this relatively deep section was heavily infested. Following the first year of spray/removal the channel was largely clear and remained so in June 2006. No removal occurred in 2006. The drought of 2006/2007 resulted in shallow conditions in spring/summer 2007 allowing *Ludwigia* to root mid-channel. Despite two herbicide applications, the channel experienced significant regrowth in 2007 as well as large algal blooms. A low flow channel to contain summer flow would limit the area of the channel available for colonization.

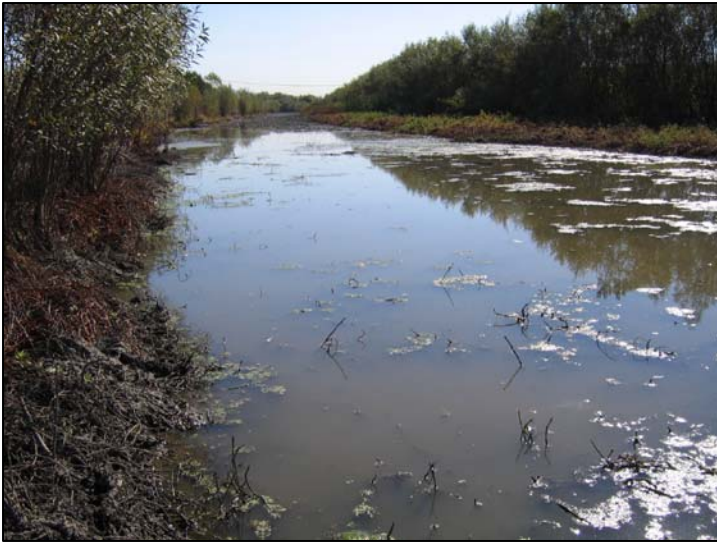
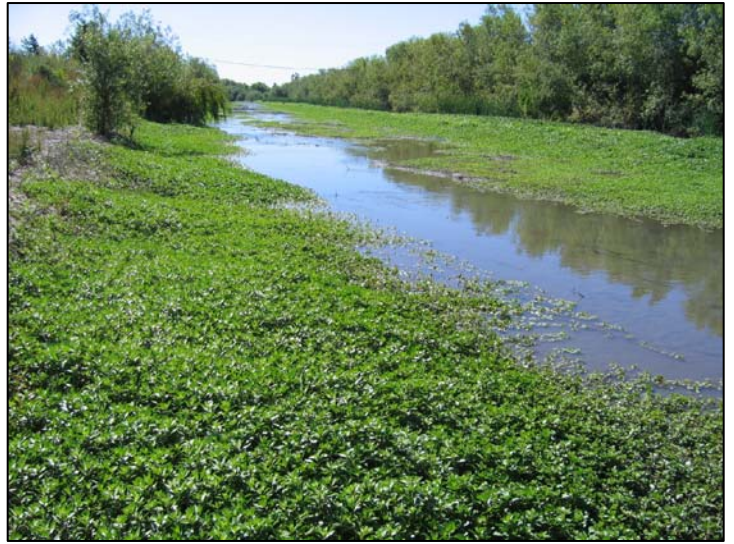
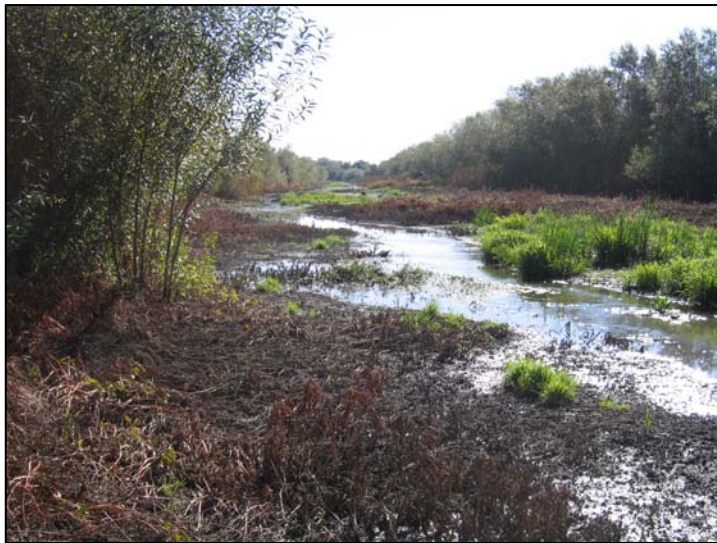
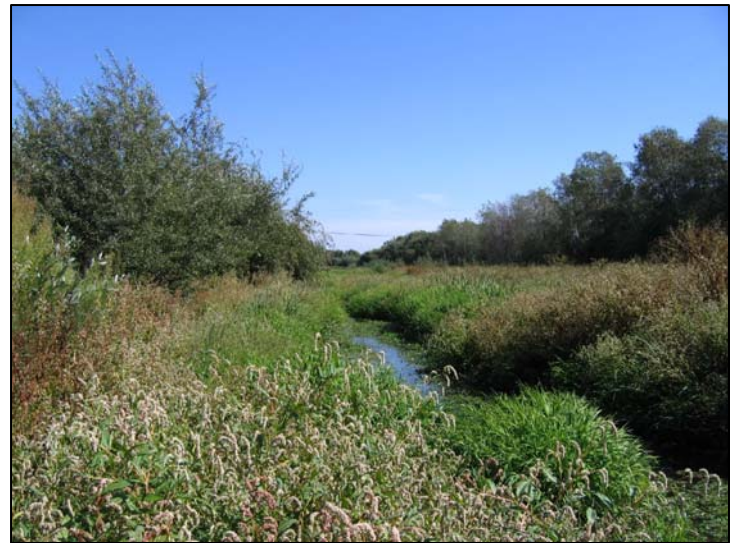
## Laguna Main Channel, SCWA Field Site: Photo Point O-22

Main Laguna channel looking east of confluence with Bellevue Wilfred Channel. No photo available for June 2005. This section was treated with herbicide each year. Mechanical removal occurred only in 2005. Note that in September 2007 *Ludwigia* only occurs in the wetted channel and even here it is low density. The vegetation on the sides is not *Ludwigia* and the soil underneath is largely dry. This is the goal of a low flow channel, to contain water to a small area where *Ludwigia* can easily be contained and to keep the remainder of the channel dry during summer. Although water levels would be higher outside of a drought year, a constructed low flow channel would be deeper and the net result would likely be the same.

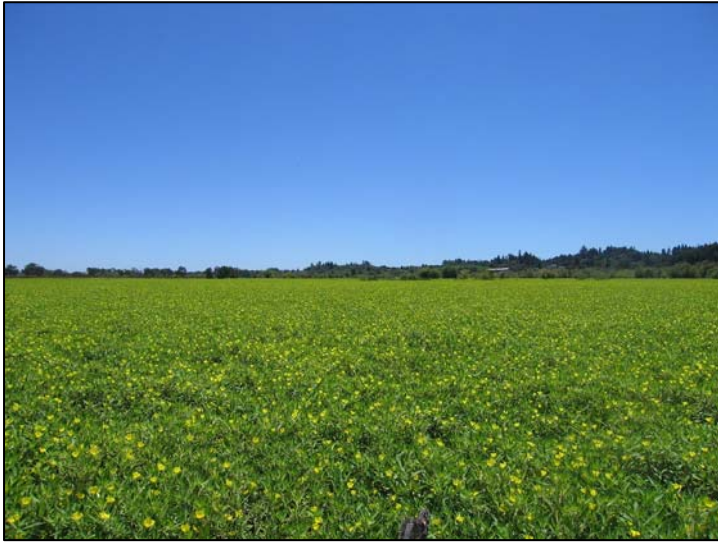
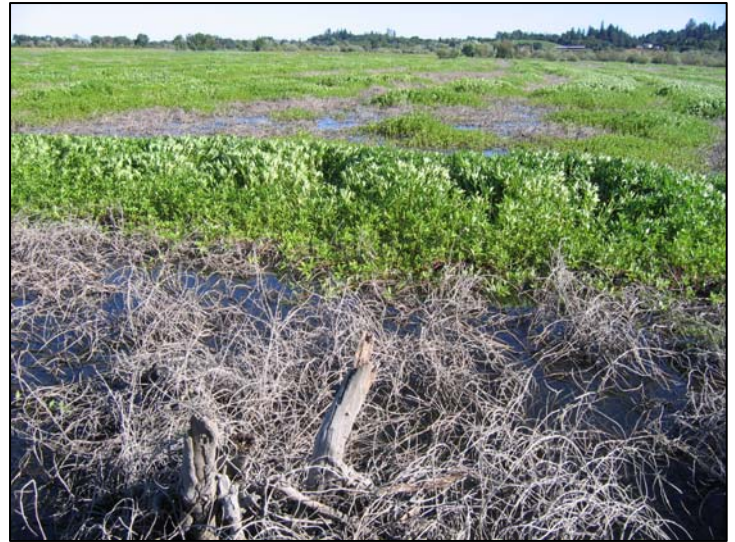
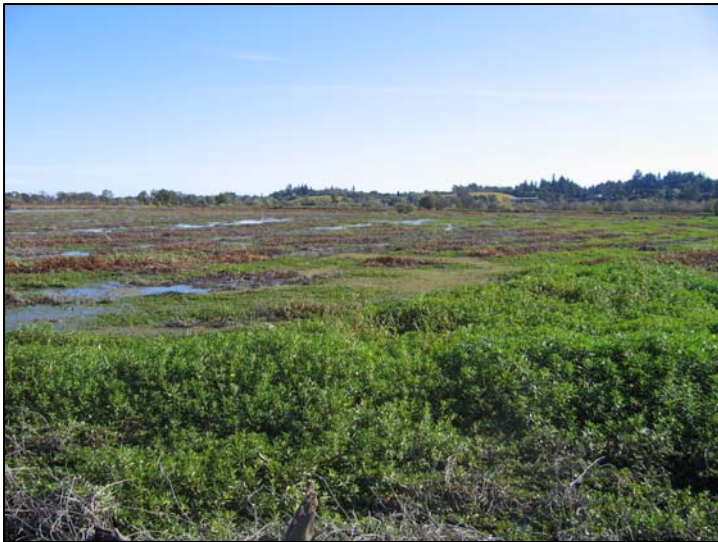
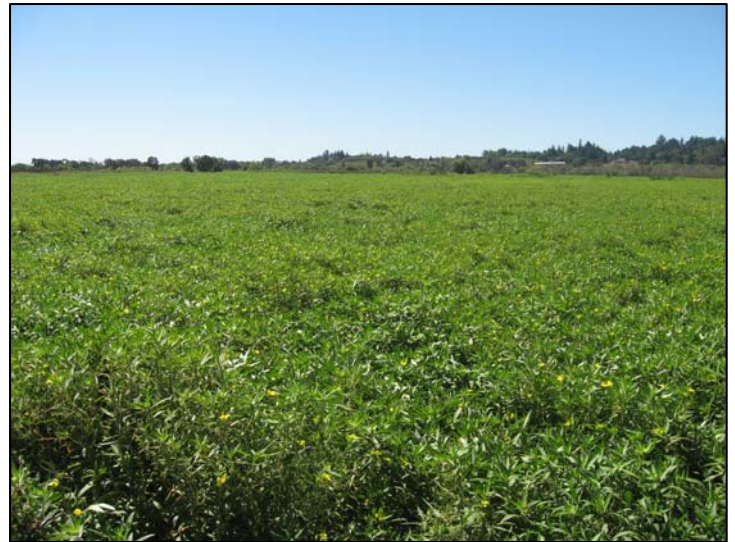
**Floodplain, CDFG Laguna Wildlife Area: Photo Point C-11**

Looking south over the northern floodplain of the CDFG Laguna Wildlife Area. Because mechanical removal was not feasible in the floodplain, herbicide was the only management method used. Despite a promising appearance following spraying in 2005 and 2006, regrowth was strong by the following spring of each year. Although this portion of the floodplain was sprayed again in 2007, much of the floodplain was not sprayed in 2007 due to the limited efficacy of previous efforts. Decaying biomass left in place following spraying also degrades water quality by consuming dissolved oxygen and releasing stored nutrients.

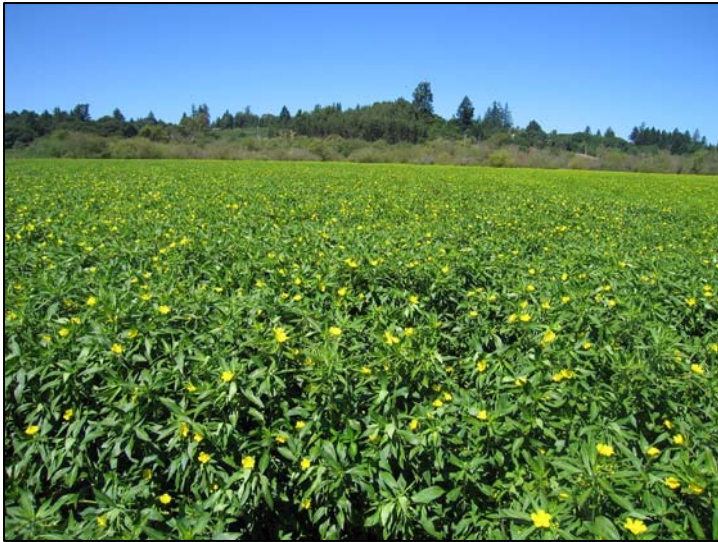
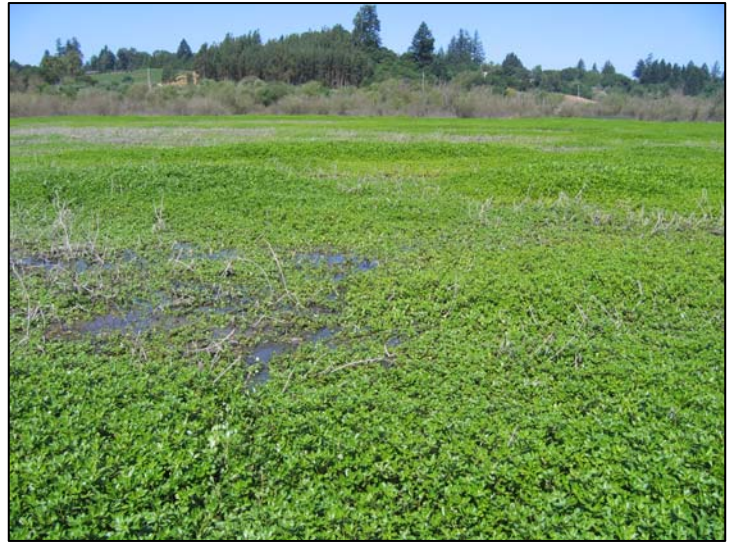
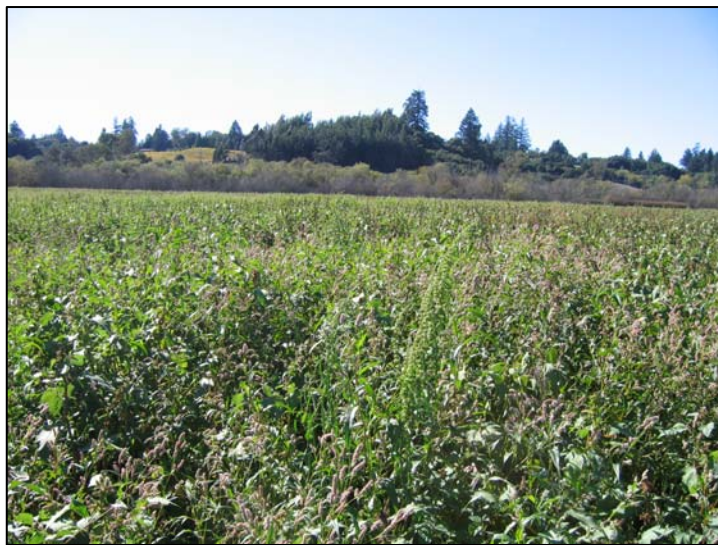
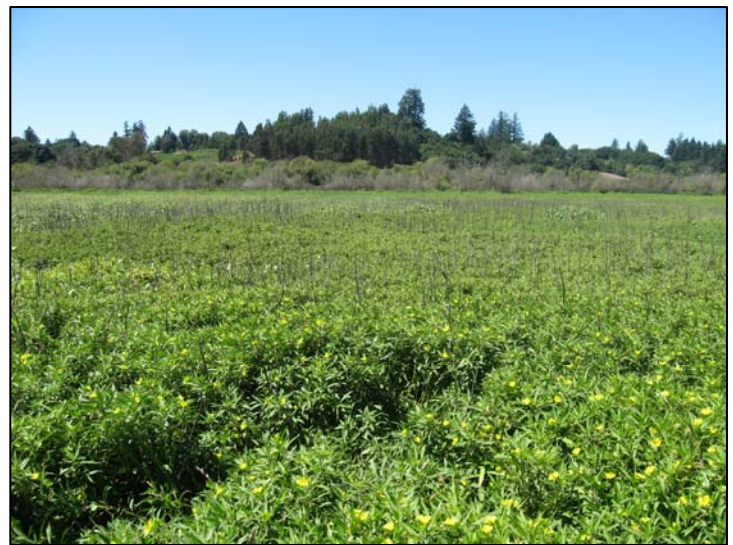
**Floodplain, CDFG Laguna Wildlife Area: Photo Point Q-46**

Looking west over the southern section of the Laguna Wildlife Area floodplain. As in the previous photo series, limited efficacy was achieved through spraying. Although the October 2006 photograph shows a strong component of non-*Ludwigia* species including *Polygonum* sp. and *Xanthium strumarium*, *Ludwigia* quickly regained a competitive edge by the following spring. This area was not sprayed in 2007.

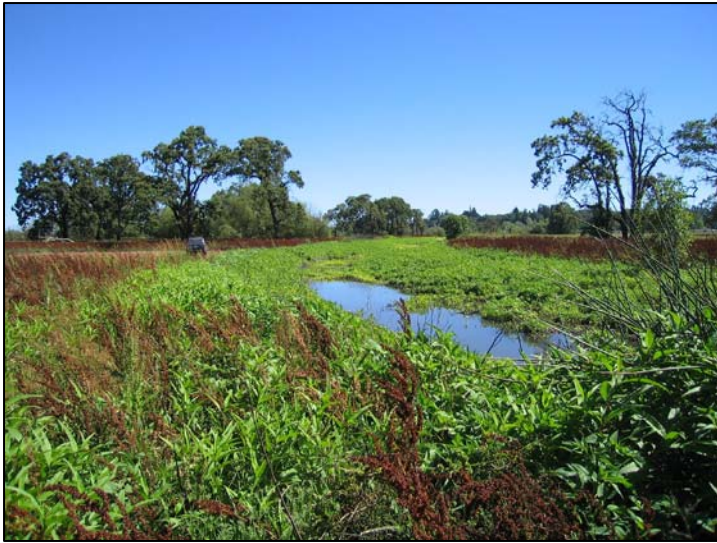
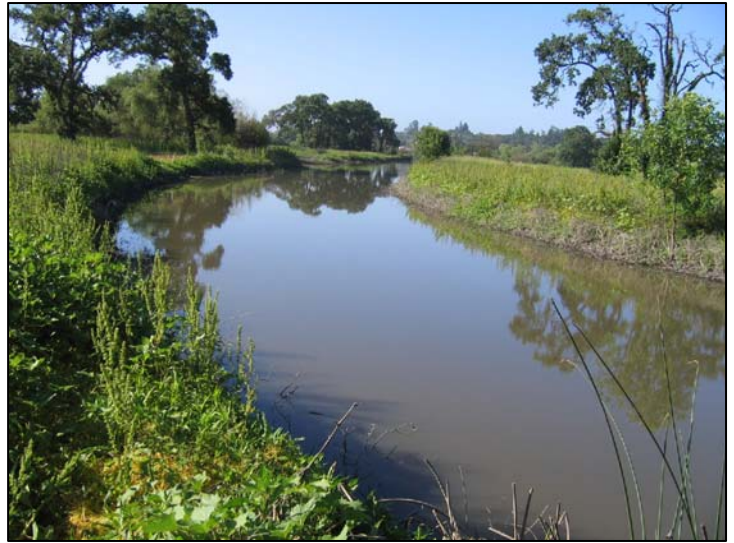
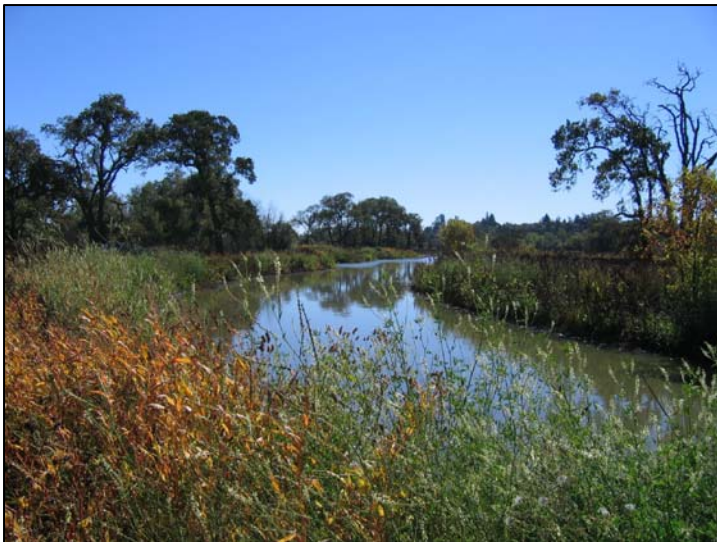
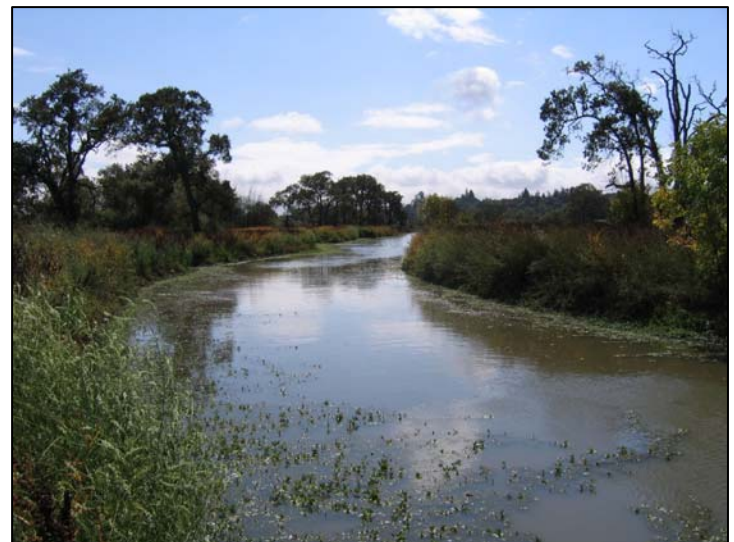
### Channel, CDFG Laguna Wildlife Area: Photo Point L-38

Channel through CDFG Laguna Wildlife Area. Spraying occurred each year. Mechanical removal occurred only in 2005. The channel remained quite clear until late 2007 when shallow water conditions prevailed following a low rainfall winter. Ongoing maintenance will be required to keep the channel clear. Mechanical removal is the preferred method and will need to occur every 2-5 years depending on the rate of regrowth. Maintenance will continue until the underlying issues that encourage rapid growth of *Ludwigia* are addressed. Planning efforts to restore the site will begin in spring 2008.

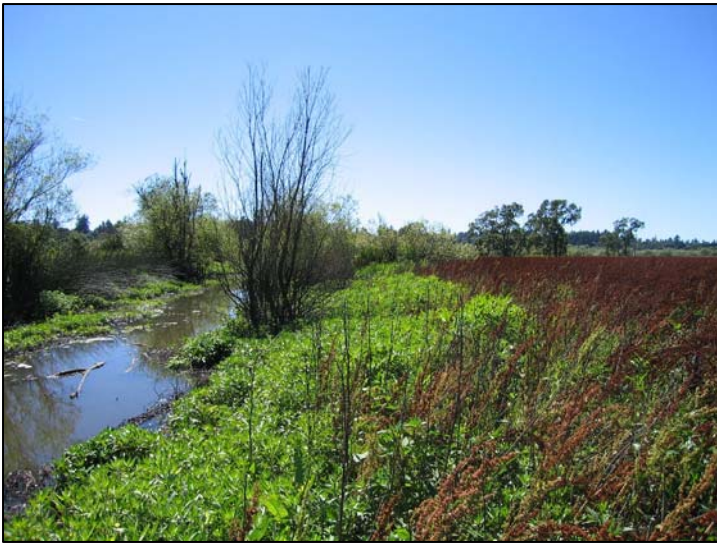
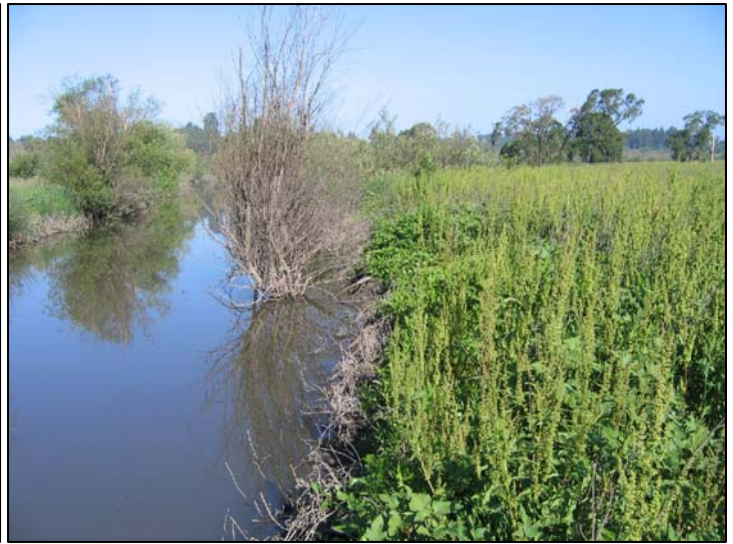
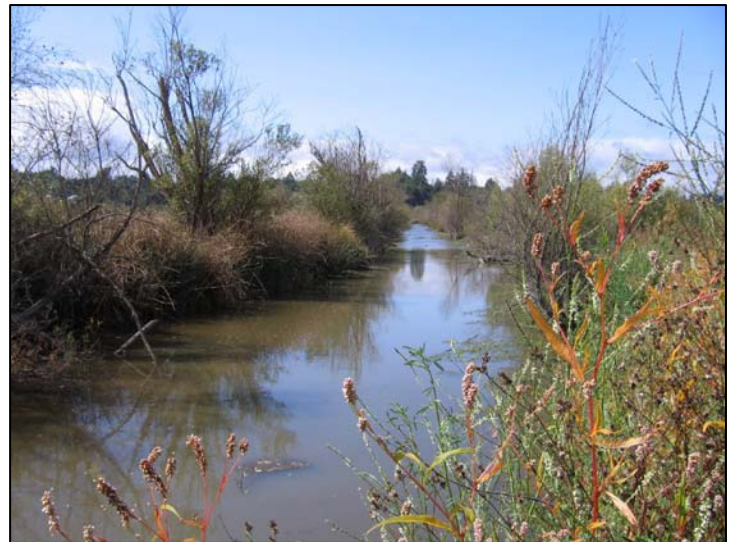
**Channel, CDFG Laguna Wildlife Area: Photo Point K-35**

Channel through Laguna Wildlife Area. Spraying occurred each year. Mechanical removal occurred only in 2005. This deeper section of channel retained excellent control throughout the project period.
