# PRELIMINARY ECOLOGICAL HABITAT ASSESSMENT FOR THE NKANDLA-UMLALAZI SMART GROWTH VILLAGE KWAZULU-NATAL

DRAFT REPORT SUBMITTED: 18<sup>th</sup> JUNE 2012

The assignment is interpreted as follows: **Determine the current ecological status of the vegetation and fauna and the potential ecological impacts of the Nkandla-Umlalazi Smart Growth Centre on the immediate environment.** In order to compile the report the following had to be done:

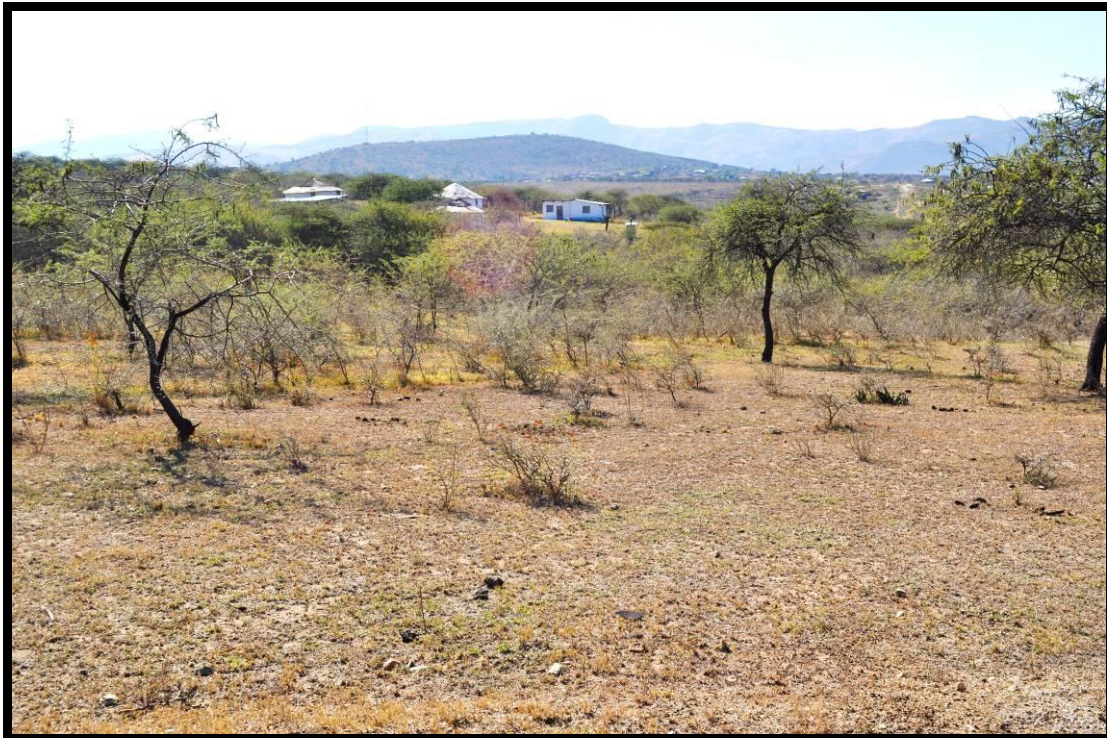
**Figure 5. A conglomerate of photographs displaying the current impacts on the vegetation within the Nkandla-Umlalazi Smart Growth Village. A:** Extensive vegetation clearance including wood harvesting, sand harvesting, collection of traditional medicinal plants as well as loosely embedded rock material. **B:** Extensive overgrazing by cattle and goats has resulted in an extremely poor herb and grasses grazed down to the ground. The majority of grass species remaining are mainly unpalatable species. **C & D:** Severe bush encroachment occurs in certain areas especially towards the non-perennial drainage lines as well as Mamba River.

The transformed and degraded Eastern Valley Bushveld comprises the largest component of the vegetation within the Nkandla-Umlalazi Smart Growth Village project area. The area consists of existing residential houses, small-scale agricultural fields (old and current) that are mostly located on the mid-slopes as well as crest grassland plateaus. As a result the natural vegetation has become degraded and is mostly transformed. A few scattered large trees occur around the homesteads as well as around the old agricultural lands. Tree density as well as diversity increases towards the Mamba River. The grassland areas are heavily used for grazing purposes and the grasses grazed down to the ground. Dominant species include *Aristida congesta*, *Cynodon dactylon*, *Digitaria spp.*, *Chloris virgata*, *Sporobolus africanus*, *Panicum maximum*, *Cymbopogon sp.*, *Eragrostis curvula*, *Imperata cylindrica*, *Hyparrhenia hirta* and *Melinis repens*. The grasses cover varies from bare patches to approximately 70-80% of the site and the forbs and herbs layer is poorly

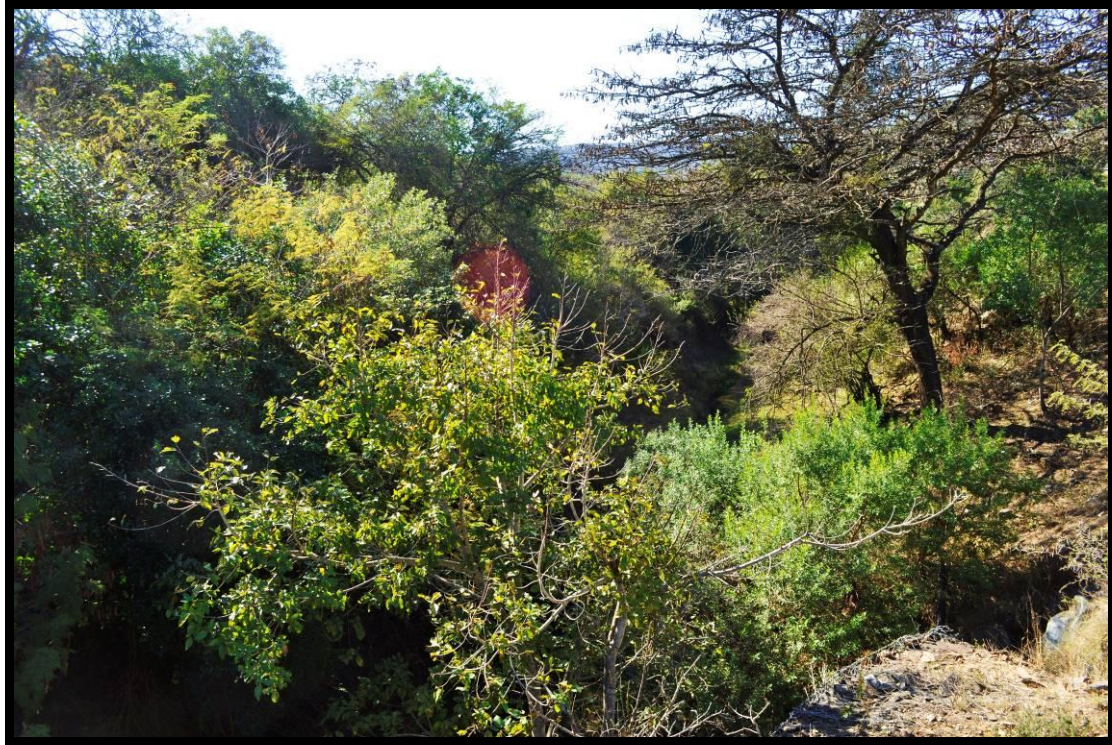
<b>Vegetation Type</b>	Eastern Valley Bushveld (SVs 6)	<b>Tree cover</b>	0-80%
<b>Soil</b>	Light-Brown Sandy Soils and darker clays within Mamba River	<b>Shrub cover</b>	0-20 %
<b>Topography</b>	Undulating Hillslopes	<b>Herb cover</b>	<5%
<b>Land use</b>	Homesteads and small-scale agricultural and livestock (cattle and goats) grazing activities. Wood harvesting along Mamba River and non-perennial drainage lines	<b>Grass cover</b>	0-40%
<b>Dominant Grass spp.</b>	<i>Aristida congesta</i> , <i>Hyparrhenia hirta</i> , <i>Panicum maximum</i> , <i>Melinis repens</i> , <i>Sporobolus africanus</i> , <i>Imperata cylindrica</i> , <i>Eragrostis curvula</i> , <i>Eragrostis curvula</i> , <i>Cynodon dactylon</i> ;

Remnant patches of indigenous open and closed woodland riparian vegetation occurs along the northern non-perennial drainage line as well as the upper sections of the Mamba River. Dominant riparian species included *Acacia nilotica* subsp. *kraussiana*, *Acacia natalitia*, *Acacia robusta*, *Acacia tortilis* subsp. *heteracantha*, *Acacia ataxacatha*, *Dicrostachys cinerea*, *Sclerocarya birrea* subsp. *caffra*, *Combretum molle*, *Cussonia spicata*, *Olea europaea*, *Dombeya rotundifolia*, *Schotia brachypetala*, *Spirostachys africana*, *Gymnosporia senegalensis*, sp., *Grewia occidentalis*, *Syzigium cordatum*, *Ficus sur*, *Celtis africana*, *Trema orientalis*, *Erythrina caffra*, *Aloe matlothii*, *Euphorbia ingens* *Lantana camara*\*, *Solanum mauritianum*\*, *Ziziphus mucronata*.

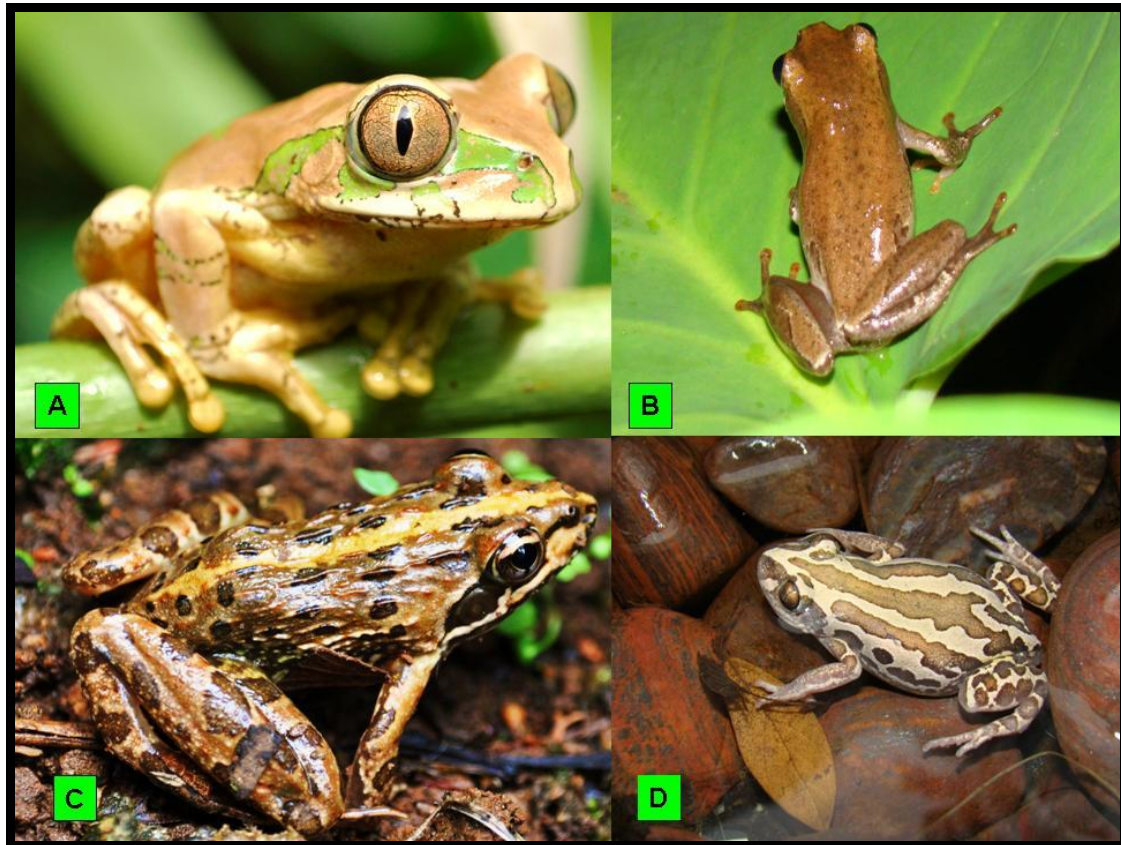
**Figure 8.** Frog species recorded (\*) or likely to occur within the Nkandla-Umlalazi Smart Growth Centre included: **A:** Natal Tree Frog (*Leptopelis natalensis*); **B:** Painted Reed Frog (*Hyperolius marmoratus marmoratus*); **C:** \*Common River Frog (*Amietia angolensis*) and **D:** Bubbling Kassina (*Kassina senegalensis*).

As the survey was undertaken for only 1 day during daylight hours of the winter months only a small proportion of species are present (winter breeders). Only one frog species was recorded during brief site inspection namely a Common River Frog (*Amietia angolensis*) which was flushed from the riparian zone of the Mamba River. Ideally, a herpetological survey should be undertaken throughout the duration of the wet season (November-March) including several nocturnal surveys. It is only during this period that accurate frog species lists can be compiled. During this survey; fieldwork was augmented with species lists compiled from personal records; data from the South African Frog Atlas Project (SAFAP)(1999-2003) and published data, and the list provided below is therefore regarded as likely to be fairly comprehensive.

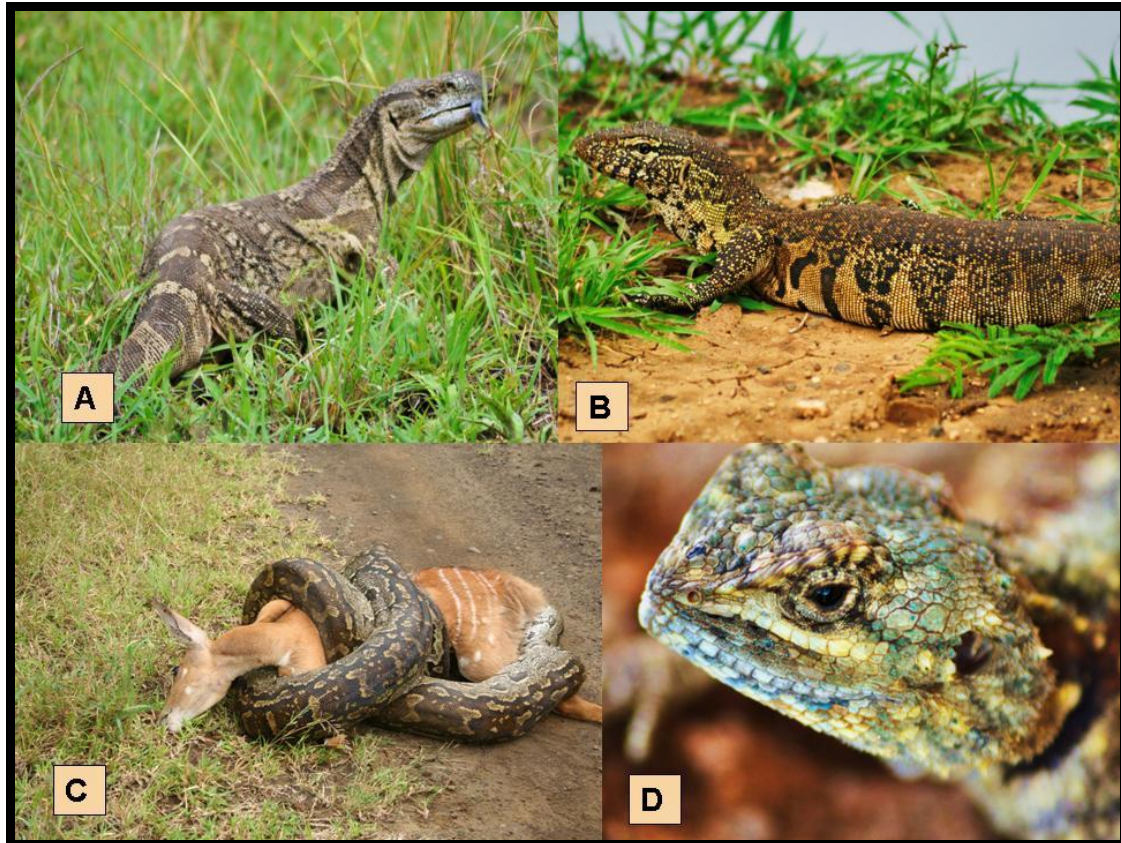
**Figure 9. Reptile species recorded (\*) or likely to occur on the site. A:** Rock Monitors (*Varanus albigularis*) and **B:** Nile Monitors\* (*Varanus niloticus*) may still occur around the site. Both species are hunted and killed due to raiding chicken runs as well as for food. **C:** South African Python (*Python natalensis*); especially dispersing juveniles could remain in the closed woodland riparian vegetation along the Mamba River. **D:** A female Southern Tree Agama\* (*Acanthocercus atricollis*) was observed on the trunk of an *Acacia robusta*. Due to extensive habitat transformation and degradation as well as high levels of human activities alteration to the original reptile species composition (especially snakes) has already occurred. Remaining reptile species are restricted to the scattered large trees as well as remnant bushveld along the Mamba River and non-perennial drainage lines.

hibernating species, which are extremely sluggish. Fires during the early summer months destroy the emerging reptiles as well as refuge areas increasing predation risks. Three reptile species were recorded during the survey all within the wooded riparian zone of the Mamba River, namely a juvenile Nile Monitor (*Varanus niloticus*) a female Southern Tree Agama (*Acanthocercus atricollis*) and a Variable Skink *Trachylepis (Mabuya) varia*. A probable species list is provided in Table 2 below.

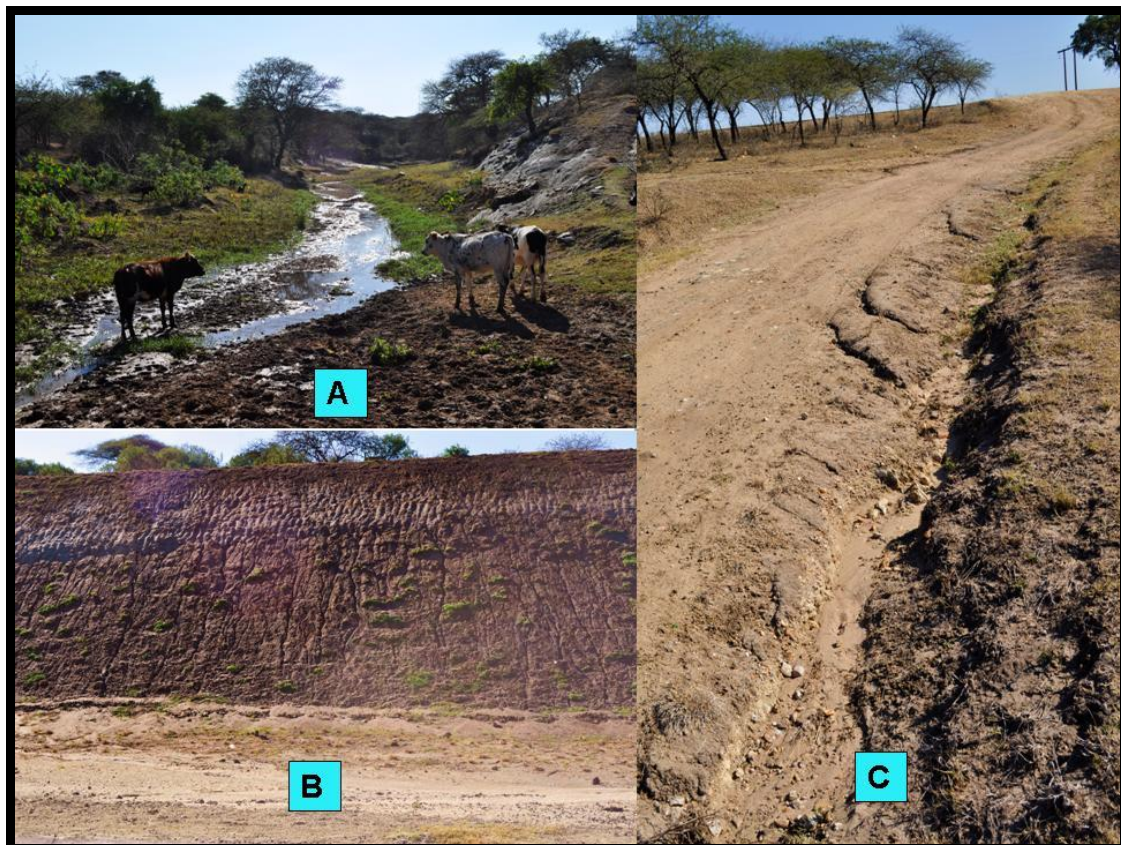
**Figure11. Poor soil conservation was observed around the entire site. A:** Extensive bank erosion along the Mamba River due to uncontrolled livestock drinking as well as removal of riparian vegetation. **B:** Several erosion rills were observed on the poorly re-vegetated embankments of the recently upgraded P15-2. **C:** No stormwater management measures occur on the site and runoff enters through eroded channels into the heavily eroded (incised) non-perennial drainage lines.

Urban and commercial development is characterised by large areas of sealed surfaces such as roads, houses etc. Impermeable surface cover ranges from 15% to 60% of suburban areas to almost 100% in central business districts. Infiltration is considerably reduced with an increase in surface run-off. Run-off is generally discharged to surface water systems and often contains pollutants. Pollutants range from organic matter, including sediments, plant materials and sewage, to toxic substances such as heavy metals, oils and hydrocarbons. Construction activities associated with urban development can lead to massive short term erosion unless adequate measures are implemented to control surface run-off. Sheet erosion occurs when run-off surface water carries away successive thin layers of soil over large patches of bare earth. This type of erosion is most severe on sloping soils, which are weakly structured with low infiltration, which promotes rapid run-off. It occurs on the site where vegetation has been destroyed. Continual erosion in sheet-eroded slopes is a common cause of gully erosion. Gully erosion results from increased flow along a drainage line, especially where protective vegetation has been removed and soils are readily transported. A gully has steep, bare sides and is often narrow and deep. Once formed, a gully usually spreads upstream through continual slumping of soil at the gully head. Gully erosion can be associated with salting as the saline sub-soils are readily eroded.

Vegetation plays a critical role in the hydrological cycle by influencing both the quantity and quality of surface run-off. It influences the quantity of run-off by intercepting rainfall, promoting infiltration and thus decreasing run-off. Vegetation can influence water quality in two ways: by binding soils thus protecting the surface layer, and by intercepting surface run-off thus buffering the Mamba River and non-perennial drainage lines against suspended and dissolved substances. When the speed of the run-off is reduced, suspended particles can settle out and dissolve substances, such as nutrients, can be assimilated by plants. The vegetation has a filtering effect. Storm-water and runoff should be channelled through natural grassland buffer areas or into shallow seasonal retention/attenuation ponds reducing the erosional force and the potential risk of contamination and erosion of the Mamba River. The eroded areas adjacent to the Mamba River as well as non-perennial drainage lines should be appropriately rehabilitated and re-vegetated (especially below stormwater discharge pipes and culverts) in order to prevent further erosion and siltation of downstream habitats.
