A restoration strategy for the Ruppia Community of the southern Coorong

Michelle Waycott and Ryan Lewis

Goyder Institute for Water Research
Technical Report Series No. 22/19

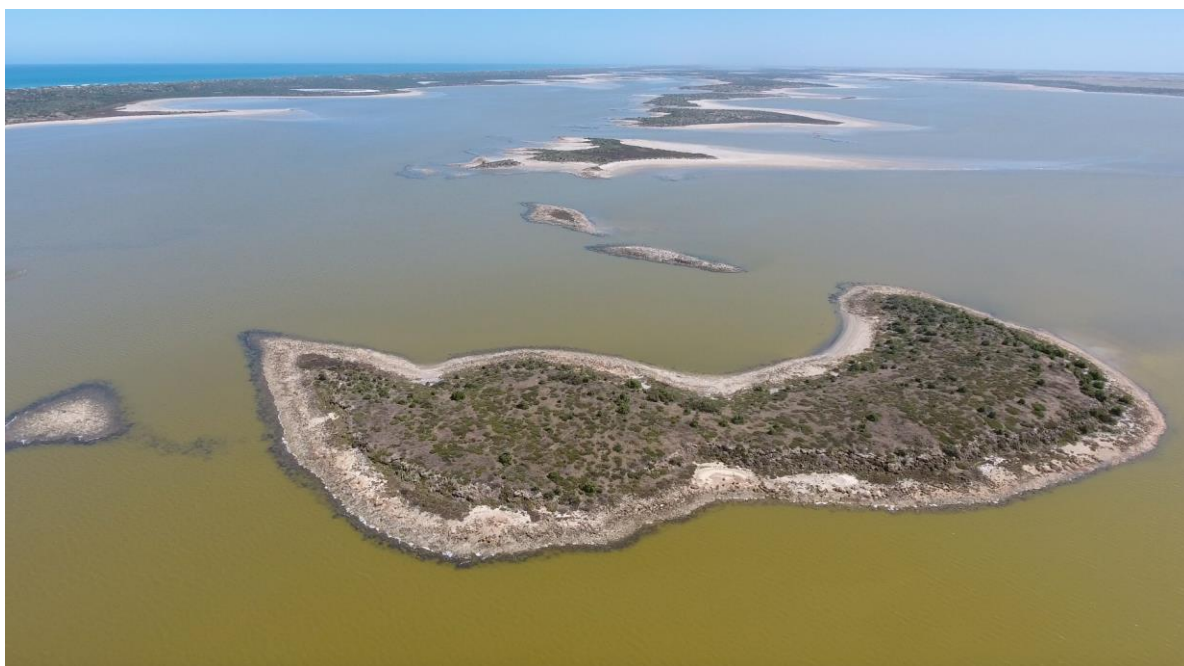
Figure 1. View of the central section of the Coorong, South Australia, during January 2021. The photo looks northward from Swan Island at the southern end in the foreground towards the very narrow flow constriction at Parnka Point at the centre of the region, shown by the visible string of small Islands ~8 km away (top of photo). The ocean is visible to the left separated from the Coorong by the Youngusband Peninsula. Note the opaque, yellow coloured water, caused by water column phytoplankton blooms. Image provided by Geoff Gallasch, used with permission. Refer to Figure 2 for additional details on locations.

The Coorong is a long, narrow lagoon (Figure 1) at the end of the River Murray stretching for more than 100 kilometres parallel to the coast south of the Murray Mouth (Figure 2). The main body of the lagoon is separated from the ocean by a narrow sand dune system, the Youngusband Peninsula. The Murray Mouth has a history of being ephemerally closed and today ocean connectivity is maintained through a dredging program during periods of low flow (Mosley et al. 2018). The Coorong is a culturally, environmentally and economically important wetland at local, national and international scales. Notably the Coorong and Lakes Alexandrina and Albert Wetland was recognised in 1985 as a wetland of international importance under the Ramsar Convention. Long-term declines in the flow of water from the River Murray have led to reduced system connectivity, lower water levels, and reduced flushing of nutrients and salt out of the Coorong (Brookes et al. 2018). These impacts were exacerbated during the Millennium Drought (2001 to 2010), the worst drought and one of the driest periods ever recorded across south-eastern Australia (Ferguson et al. 2013, Van Dijk et al. 2013). During the Millennium Drought the combination of low flows and high evaporation led to low water levels and extreme high salinity in the southern Coorong (Figure 3A); defined here as the section of the Coorong from Long Point in the North Lagoon to south of Salt Creek at Tea Tree Crossing (Figure 1).

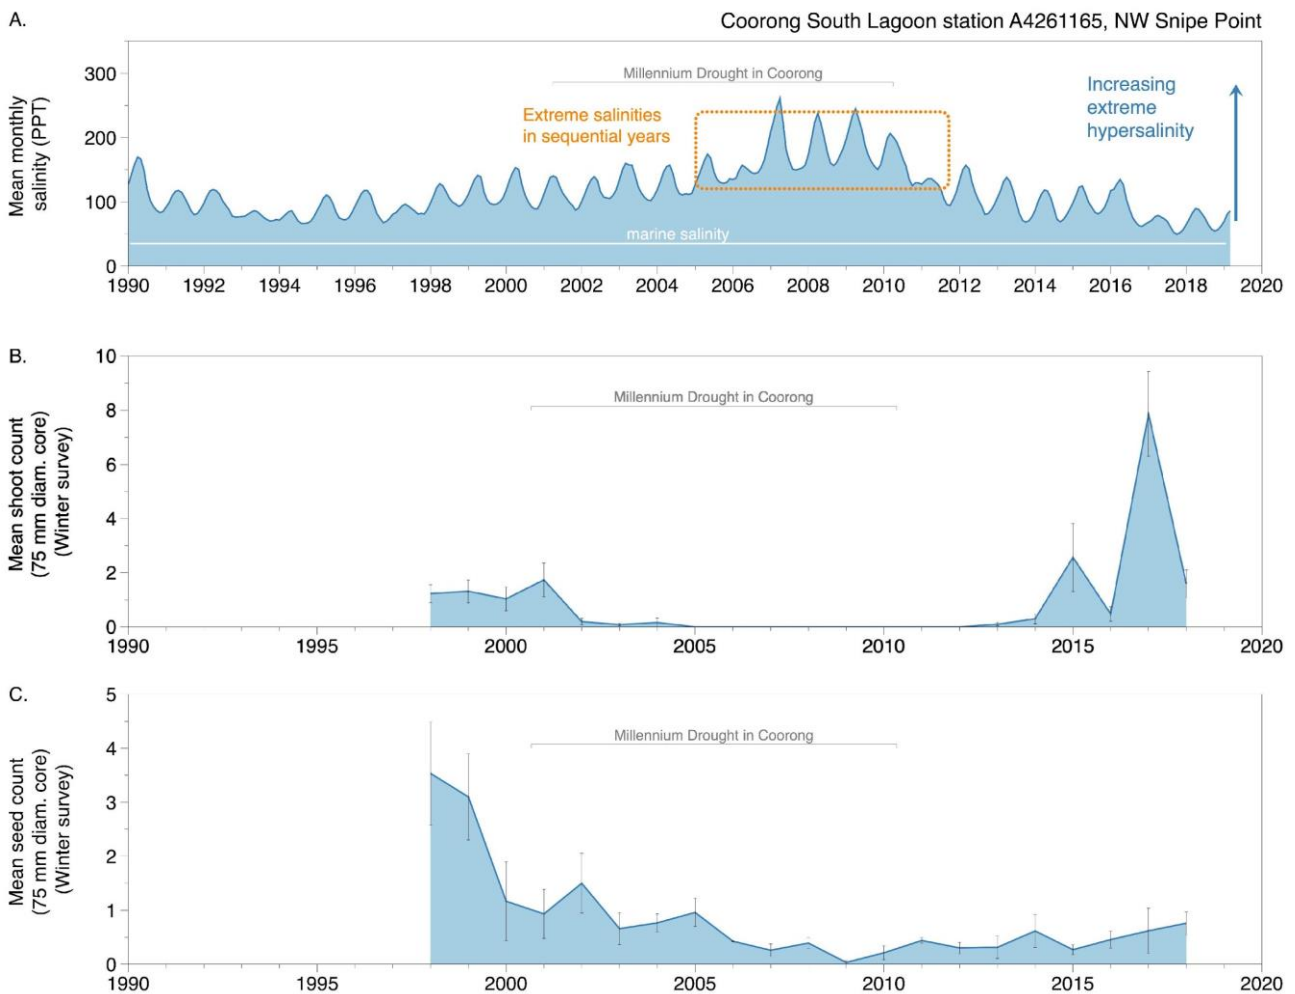
Figure 3. A. Mean monthly salinity (g L^{-1}) based on data collected by the Healthy Coorong, Healthy Basin program's water quality monitoring project (Healthy Coorong Healthy Basin 2022b). B. Mean (\pm s.e.) shoot counts of *Ruppia tuberosa* (the Ruppia Community) per 75 mm diameter core in winter at Coorong South Lagoon sites south of Hack Point during The Living Murray program (Healthy Coorong Healthy Basin 2022c). C. As for B., but for abundance of seeds per core.

of the Coorong have become modified since the 1950s, as River Murray water has been restricted through managed barrage water releases that have led to changes in the timing and magnitude of water availability (Krull et al. 2008). As a consequence, the aquatic macrophyte community has had to adapt to lower water levels and higher salinities, and seasonal variation in both water level and salinity. The additional pressures of long-term climate cycles, particularly drought, have led to a community of aquatic macrophytes becoming highly resilient to the unique suite of prevailing conditions present in the system (Department of Environment Water and Natural Resources 2014b, Asanopoulos and Waycott 2020). Despite the presence of this highly resilient community of aquatic plants, they continue to exhibit slow recovery trajectories and poor resilience (Figure 3).

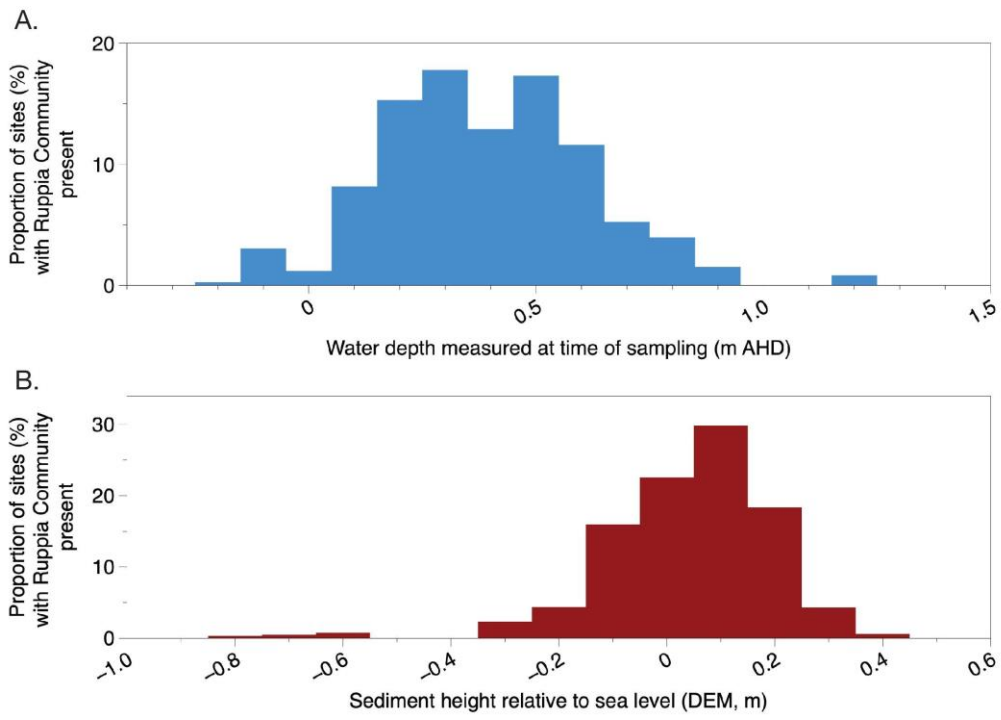
Figure 4. The proportion of sites (n=90) across the central and southern Coorong that had a Ruppia Community present (i.e. living plants present) during the reproductive surveys in 2020 and 2021 (Lewis et al. 2022); A. grouped by the in-field water height measured above the sediment at time of sampling calibrated to Australian Height Datum (AHD) and B. grouped by Hobbs et al. (2019) digital elevation model (DEM) sediment height above sea level (m AHD). Results for both measures of depth binned into 0.1 m intervals.

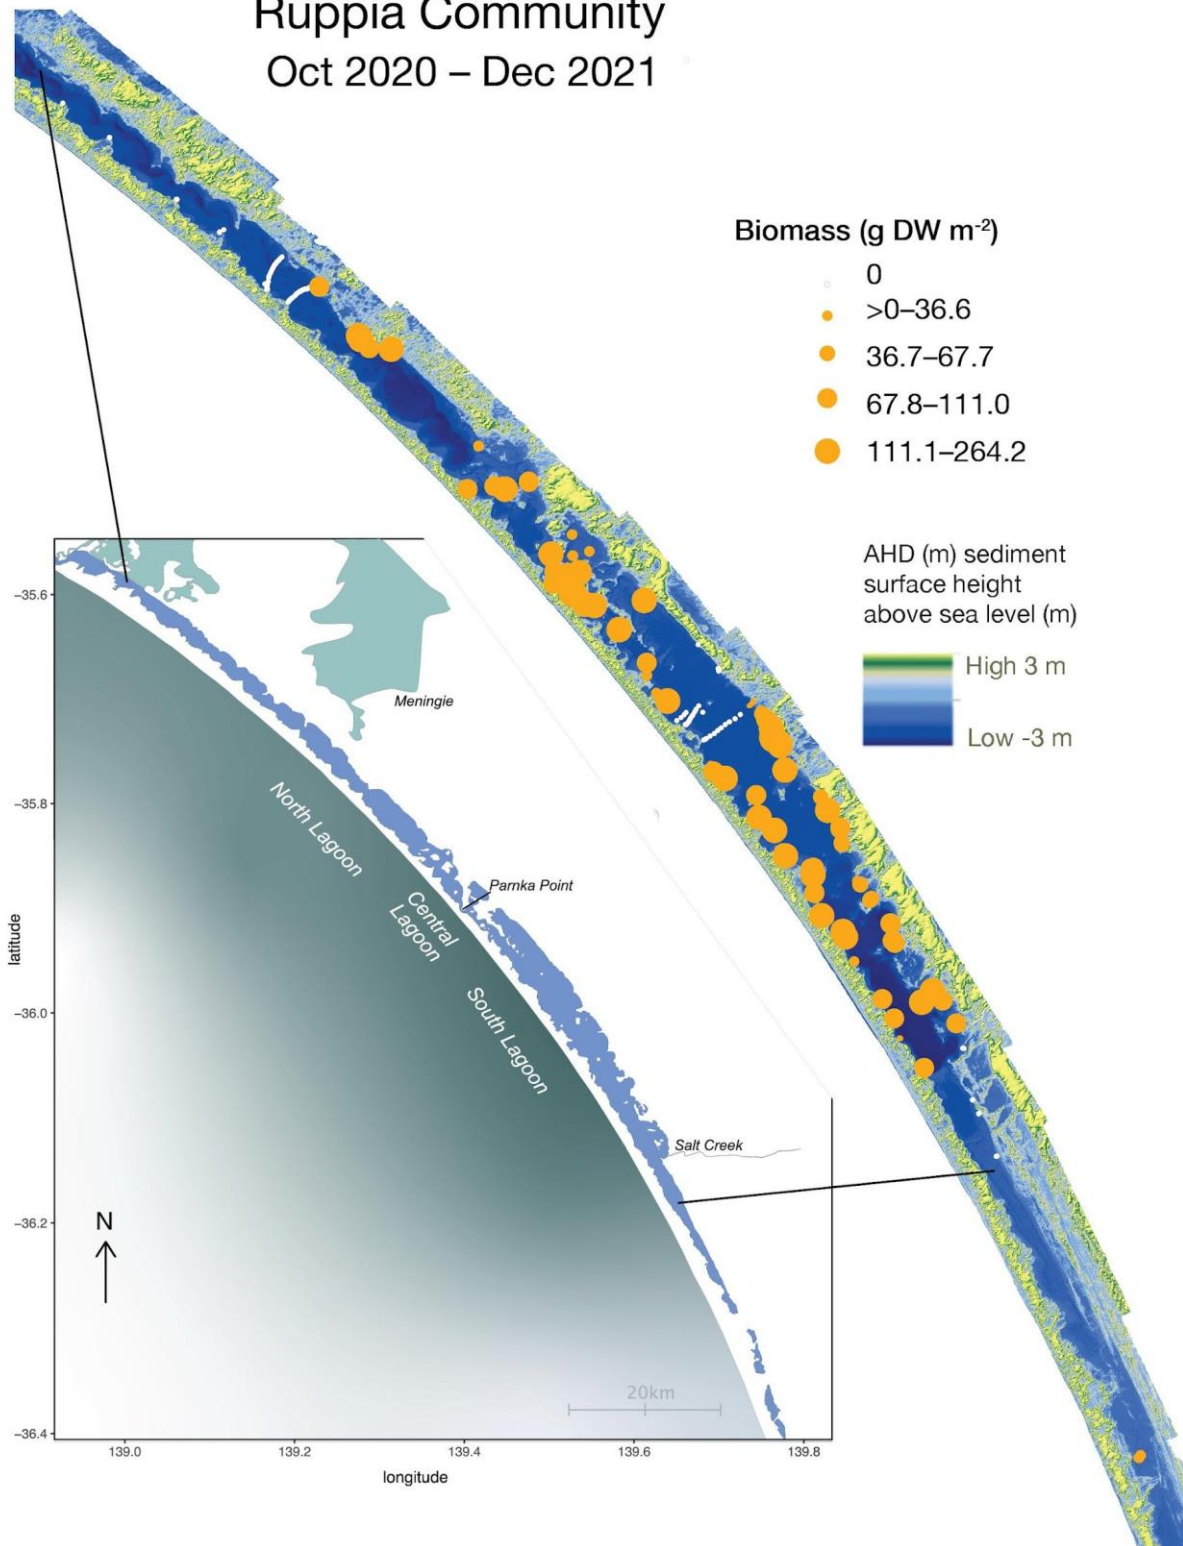
Figure 7. *Ruppia* Community biomass (g dry weight (DW) m⁻² for cores) across the central and southern Coorong; surveyed in December 2021 (Lewis et al. 2022), points overlaid on the sediment height above sea level (AHD, m) (Hobbs et al. 2019), data only shown for survey locations, including those that had an absence of a *Ruppia* Community; white dots. Refer to Figure 2 for additional details on locations.

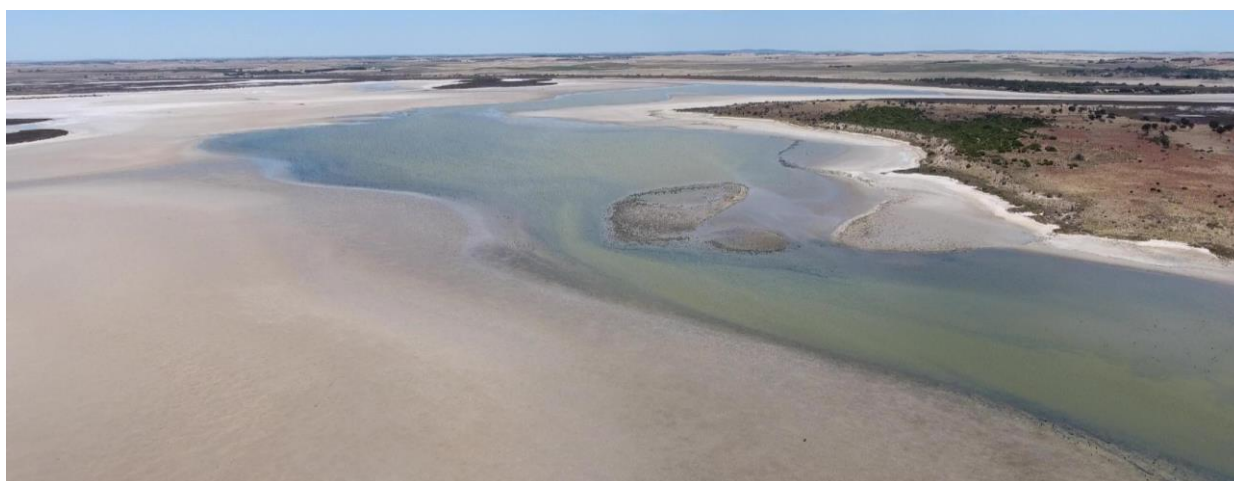
Figure 8. View of the central section of the Coorong, opposite Rabbit Island ($-35.854223^{\circ} 139.384918^{\circ}$) looking south in January 2021 when water levels were low. Note the darker areas in the water are algal covered remnants of the annual *Ruppia* Community, water column salinity was $> 100 \text{ g L}^{-1}$. Photograph provided by Geoff Gallasch, used with permission. Refer to Figure 2 for additional details on locations.

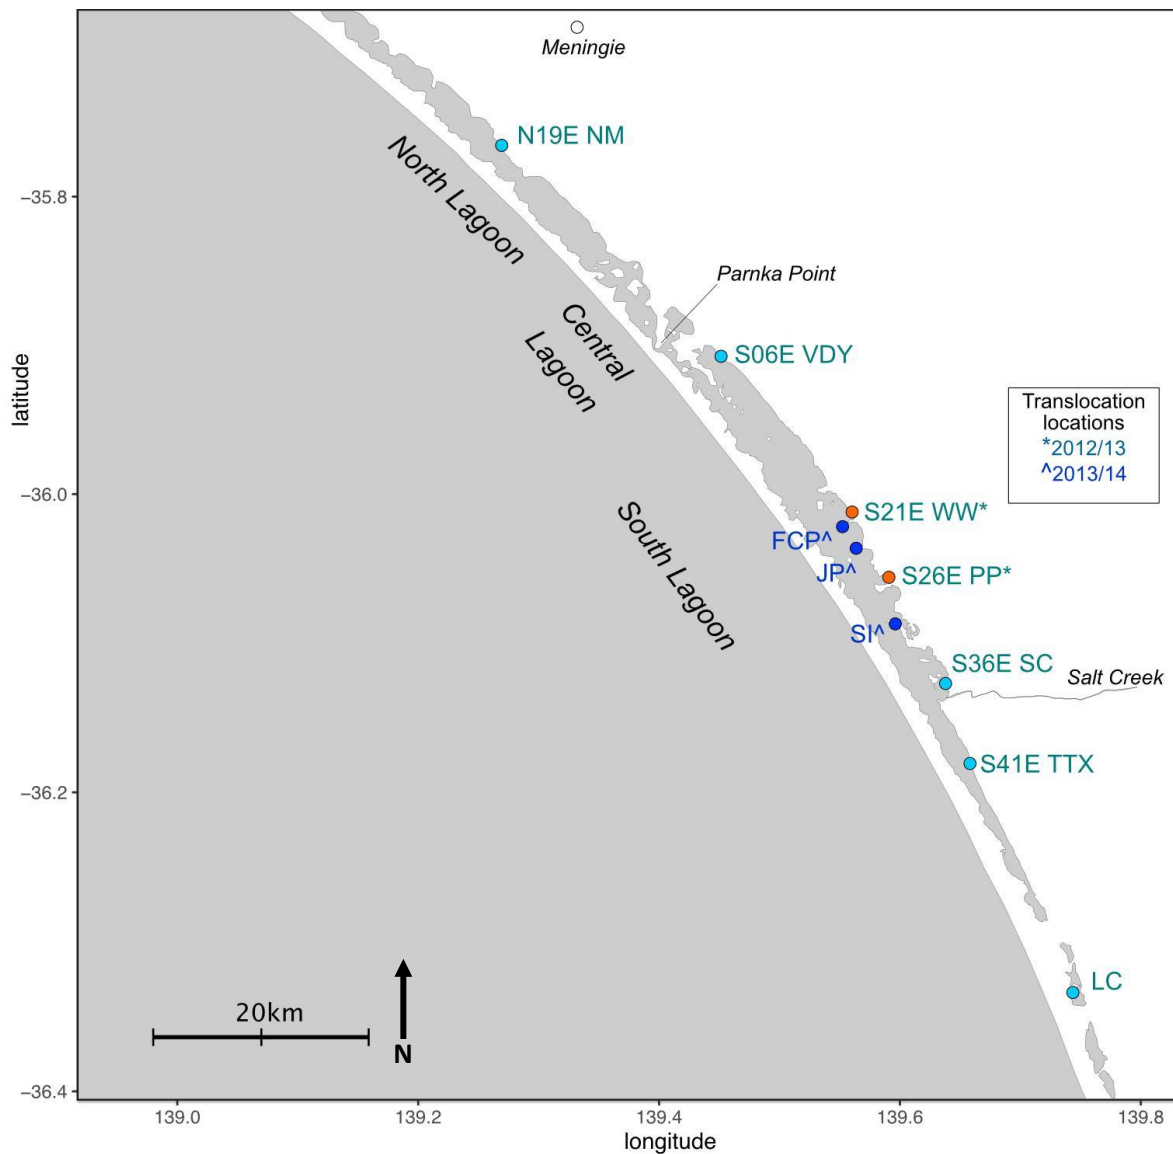
Figure 9. Locations of Coorong sites and regions, codes refer to long-term monitoring sites for The Living Murray (TLM) condition monitoring program (Paton et al. 2020). The locations where restoration sites were established are also indicated (2012-13 translocation locations orange circles: WW = Woods Well and PP = Pelican Point; 2013-14 dark blue circles: FCP = Fat Cattle Point, JP = Jack Point and SI = Seagull Island). Seed donor site LC = Lake Cantara).

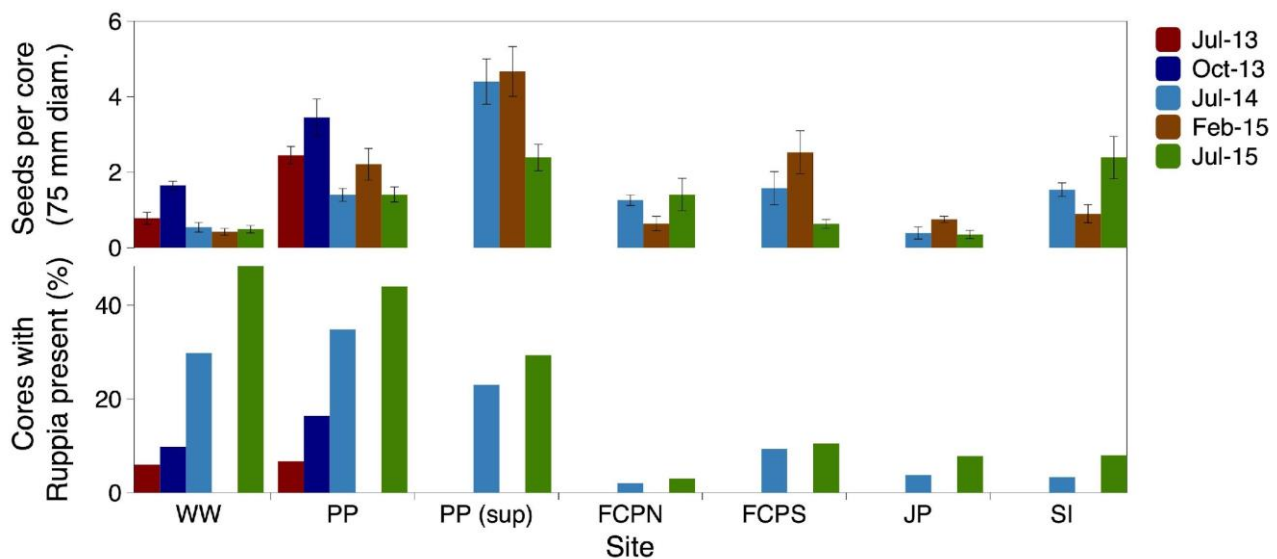
Figure 11. Reported outcomes of post seed translocation monitoring (Paton et al. 2015b). Sites WW and PP received translocated sediments in 2012-13, the remainder in 2013-14 (Department of Environment Water and Natural Resources 2014a, Ryan 2015). Data source notes: Mean \pm s.e. *R. tuberosa* seeds per core (75 mm diameter and 40 mm deep) at sites following translocation of surface sediment containing seeds from Lake Cantara in Autumn 2013 (WW, PP) in both Autumn 2013 and 2014 (PPsup; which received second translocation) and in Autumn 2014 (FCPN, FCPS, JP, SI). Missing data points are due to no sampling in that period as described in Paton et al. (2015b). Percent of cores (75 mm diameter and 40 mm deep) with *R. tuberosa* shoots present following translocation of surface sediment containing seeds from Lake Cantara in Autumn 2013 (WW, PP) in both Autumn 2013 and 2014 (PPsup) and in Autumn 2014 (FCPN, FCPS, JP, SGI).

The recovery of these areas followed a positive but erratic trajectory observed with the two years of monitoring data collected (Figure 11). Observations of nearby sites that were not in the direct seeded zones and included in long-term monitoring efforts exhibited a general positive trend over this period (Paton et al. 2018a). For example, at one long-term monitoring site, Policeman Point, there were zero shoots in sampling cores in annual monitoring of the site prior to translocation in 2011 and by 2015, 37.5% of cores had shoots (Paton et al. 2018a). Water levels experienced over the monitored period (2011-2015) were adequate for successful reproduction (Figure 12).

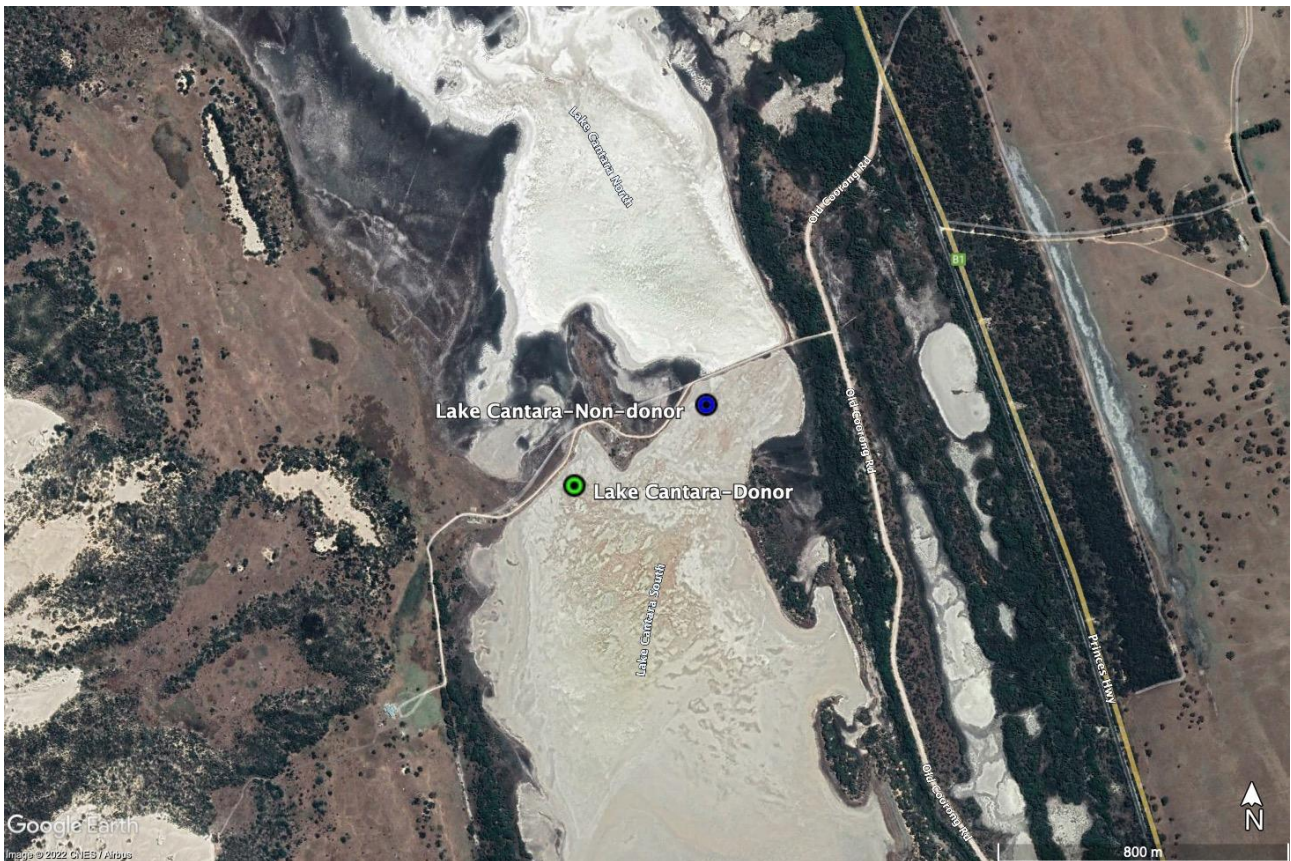
Figure 14. Location of the Lake Cantara seed bank donor site from 2012 and the non-donor site used for the 2021 seed bank donor site evaluation surveys.

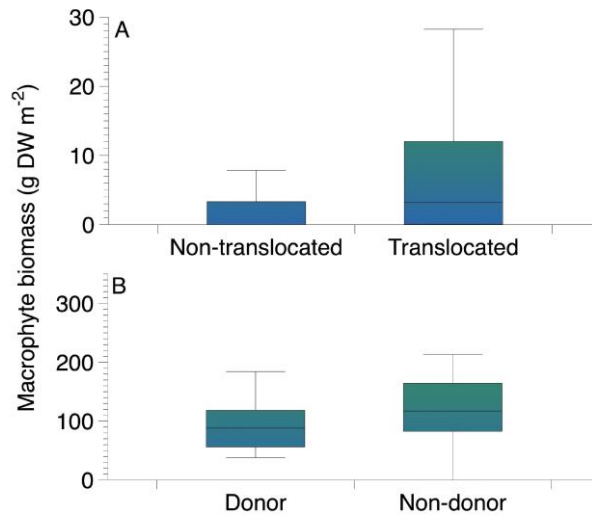
Figure 15. Aquatic macrophyte biomass m⁻² box and whisker plots representing the Inner-Quartile-Range (IQR; lower value 25%, upper value 75%), mean, and 95% confidence interval (error bars). A. non-translocated (control) and translocated sites. B. Lake Cantara seed bank donor and non-donor (control) sites. Note different y-axes. Survey dates 15-16 June 2021.

SITE	TYPE OF SITE	MEAN BIOMASS (G DW/M ²)	SD	N
Woods Well	translocated	4.80	6.80	45
	non-translocated (control)	1.10	5.13	45
Fat Point	Cattle translocated	7.64	12.10	45
	non-translocated (control)	11.84	20.68	39
Jack Point	translocated	23.43	37.90	45
	non-translocated (control)	0.36	0.17	45
Policeman Point	translocated	8.80	10.16	45
	non-translocated (control)	8.98	19.66	45
Total	translocated	11.17	21.85	180
	non-translocated (control)	5.27	14.97	174
Lake Cantara	seed donor	91.10	37.23	45
	non-donor (control)	117.80	75.88	45

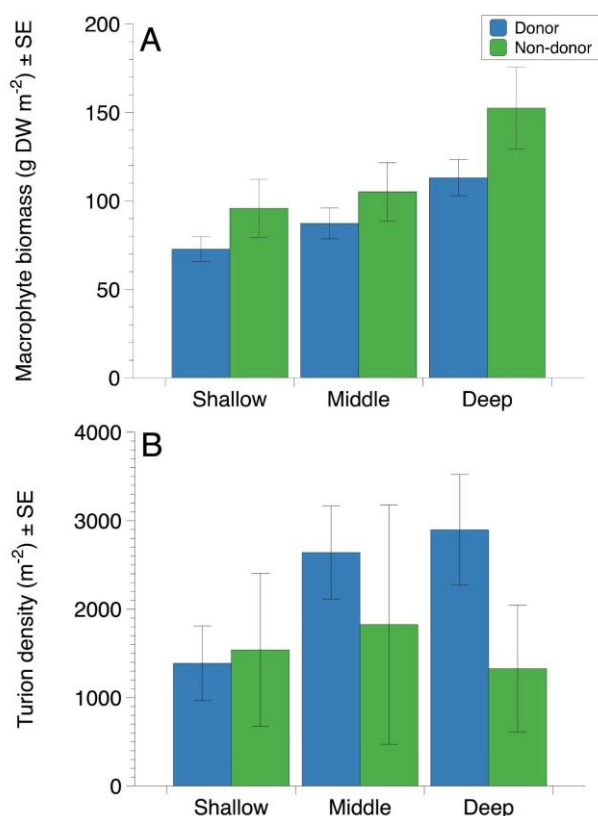
Figure 17. Results per depth range for the condition surveys (Table 3) at seed bank donor and non-donor (control) sites for; A. Mean aquatic macrophyte biomass (g DW m⁻²) ± s.e. B. Mean Ruppia turion counts m⁻² ± s.e. (note turions are in the forming stage at this time of year and were not completely formed). No Ruppia seeds were found in cores during this survey so are not reported. Depths surveyed; shallow, +0.2 – 0 m AHD; middle, -0.1 – -0.25 m AHD; and deep, -0.25 – -0.4 m AHD. Survey date 12 October 2021.

There was no significant difference in turion counts between donor and non-donor sites ($F=1.267$, $p=0.264$) or at different depths ($F=0.522$, $p=0.595$) (Figure 17B). No seeds were present in samples collected during the seed bank donor site condition survey.

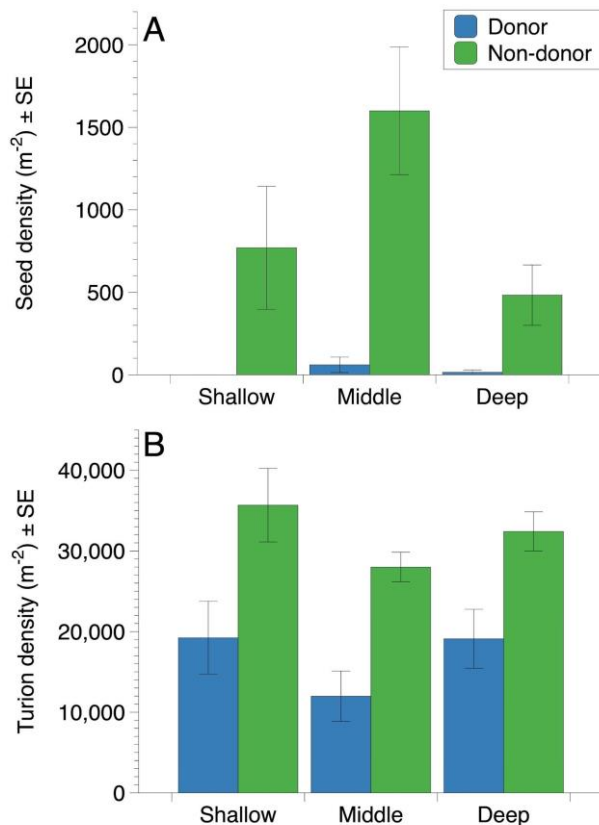
Figure 19. Results per depth range for the seed bank donor site resilience surveys at donor and non-donor (control) sites, 24 March 2022 for A. Mean Biomass $m^{-2} \pm s.e.$ and B. Mean turion counts $m^{-2} \pm s.e.$ Depths surveyed; Shallow, +0.2 – 0 m AHD; middle, -0.1 – -0.25 m AHD; and deep, -0.25 – -0.4 m AHD. Survey date 24 March 2021.

There was significantly lower seed density found at the seed bank donor site, than at the non-donor site ($F=23.756, p<0.001$) with overall means of 25.20 m⁻² found within the donor site and 950.7 m⁻² at the non-donor site. This trend was also seen in turion counts with 16,770 and 32,026 m⁻² found at the donor and non-donor sites respectively ($F=28.360, p<0.001$). Seeds density also differed significantly across water depths ($F=3.415, p=0.038$) with Tukey's HSD indicating that there was significantly less seeds in the deep transects ($p<0.05$) (Figure 19A). Turion counts m⁻² did not differ significantly across water depths ($F=0.123, p=0.884$) (Figure 19).

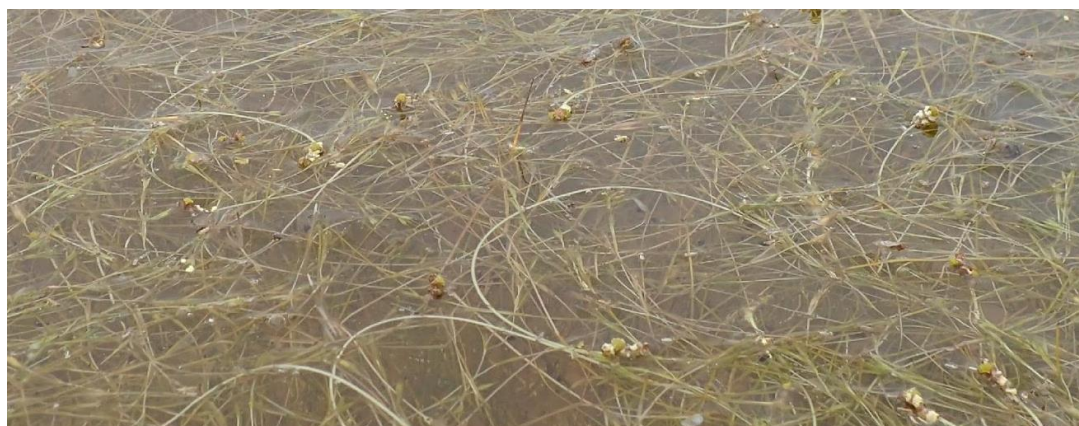
Figure 20. Dense Ruppia Community (*Ruppia tuberosa*, *Ruppia megacarpa* and *Althenia cylindrocarpa* growing inter-mixed) flowering in a small lagoon adjacent to the main Coorong waterway (near Parnka Point, Central Coorong). Scale: the width of the image is ~1 m across and water was approximately 30 cm deep, photograph taken in November 2016 by M. Waycott.

Key elements of monitoring the progress of any restoration actions, should be to provide evidence of the trajectory towards the desired state, including attributes associated with the biota itself. Thus, a focus on the Ruppia Community, physical environment, hydrological conditions, physical disturbances (such as sediment disruption) and the chemical environment (including inorganic and organic nutrients) is essential. To achieve effective monitoring, establishing the ‘reference condition’ followed by the evaluation of monitored attributes will provide evidence of the trajectory of the system and a clear vision of an outcome, (e.g. production of a dense, higher biomass Ruppia Community to provide a food source and habitat, as well as slow nutrient cycling and reduce availability within the Coorong system, Figure 20).

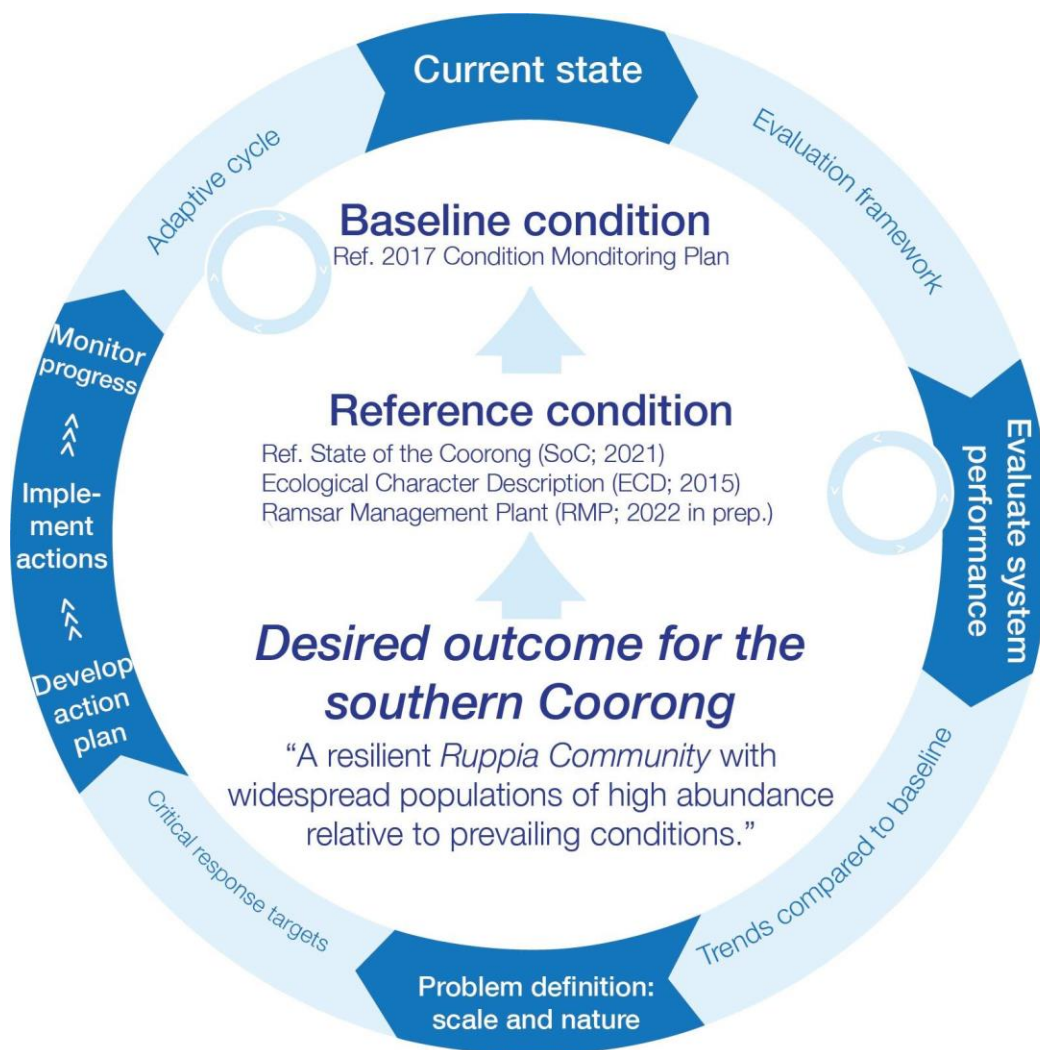
Figure 21. Model for a southern Coorong *Ruppia* Community restoration cycle where iterations are based on an evaluation of the progress the current state of the system has made towards long-term targets. The stages of actions (dark blue) are linked by the objectives to be implemented to achieve outcomes (light blue).

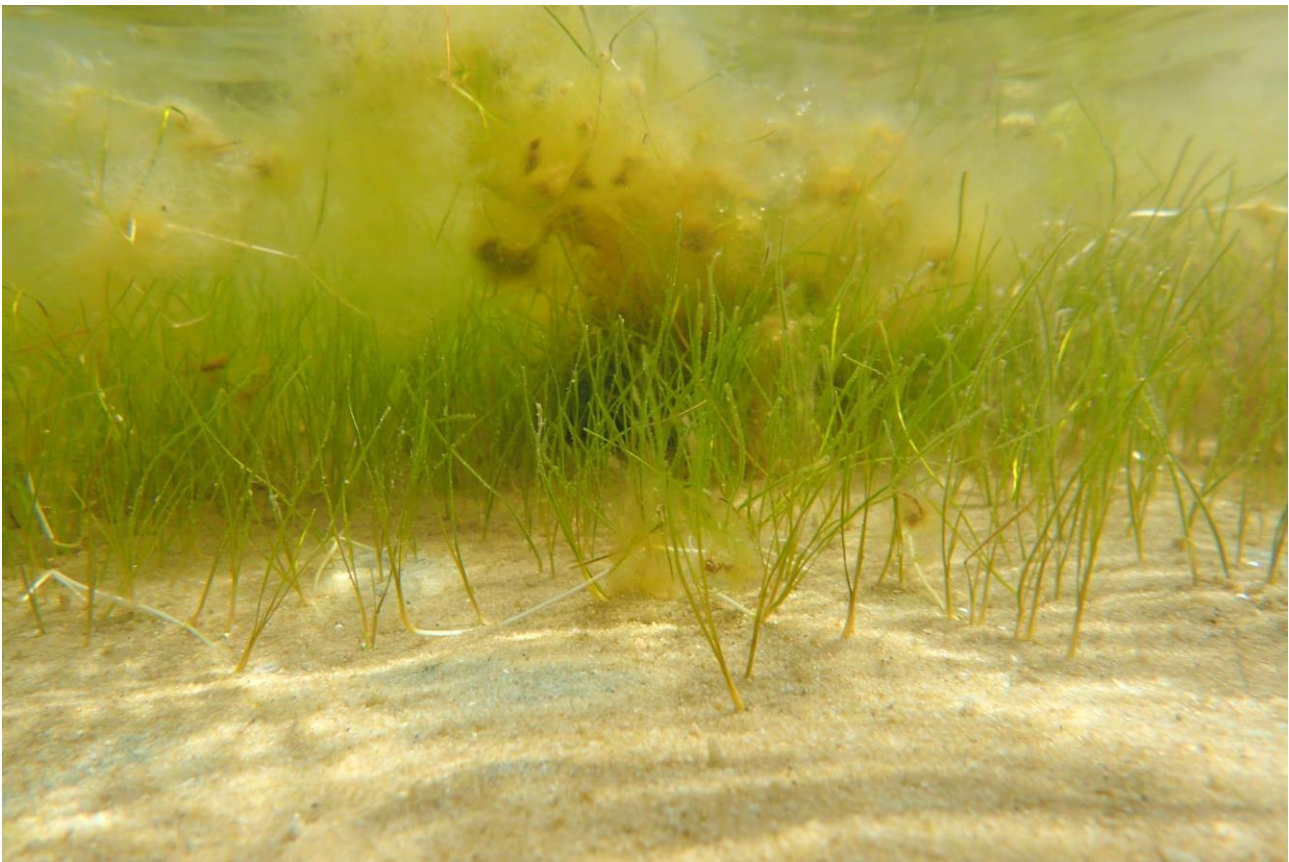
Figure 22. Mixed species Ruppia Community in the Coorong south of the Nooameena National Parks offices, 2 November 2021. Leaf length of plants ~1—15 cm. Note colonising growth form with rhizomes (white horizontal stems) visible at the edge of the meadow, filamentous algal tufts already attaching to new plant structures and a larger clump of algae with plants caught above the main canopy. Underwater photograph by Ryan Lewis.

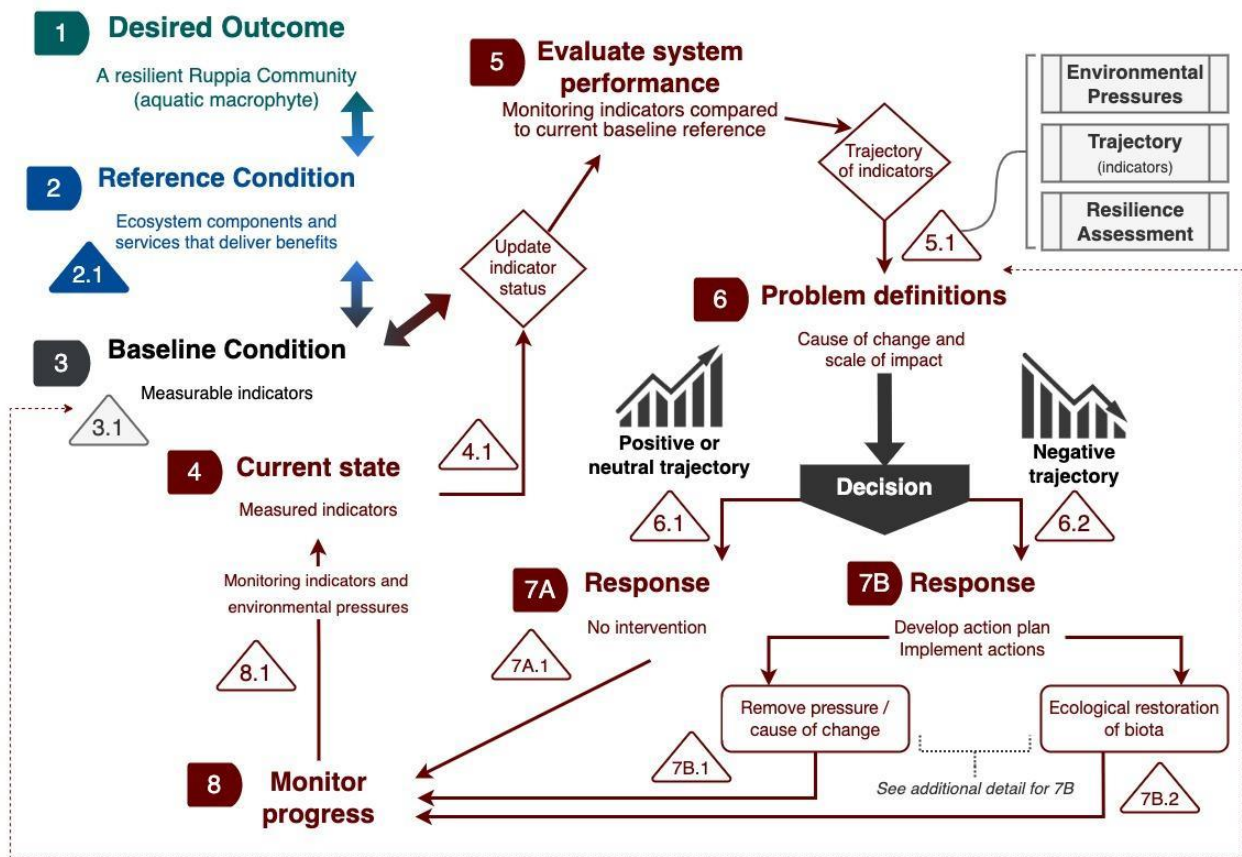
Figure 26. Restoration strategy workflow for the Ruppia Community in the Coorong. Numbers placed to provide reference to discussion points in the text or associated figures and tables. Additional detail is available for 7B in Figure 28.

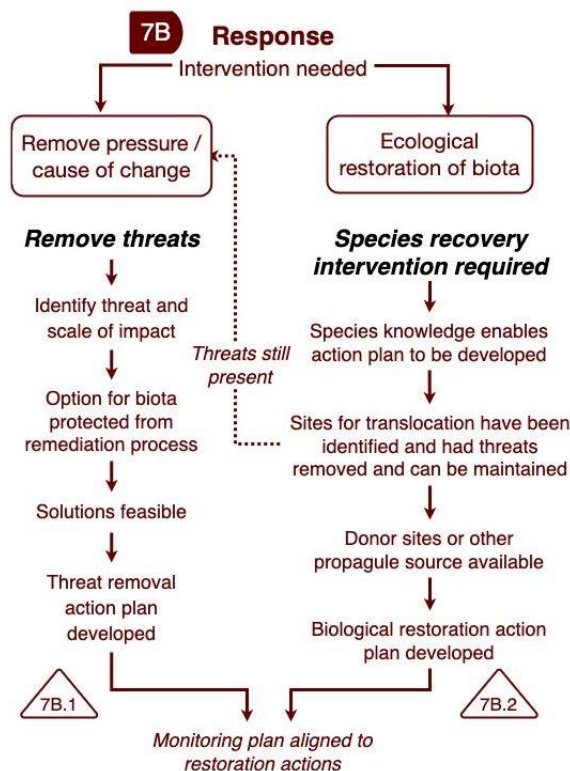
Figure 28. Restoration strategy workflow details for 7B (refer to Figure 26 for other workflow components). This section provides critical elements to decision making for moving to develop a restoration plan for different strategies and scales of restoration intervention.

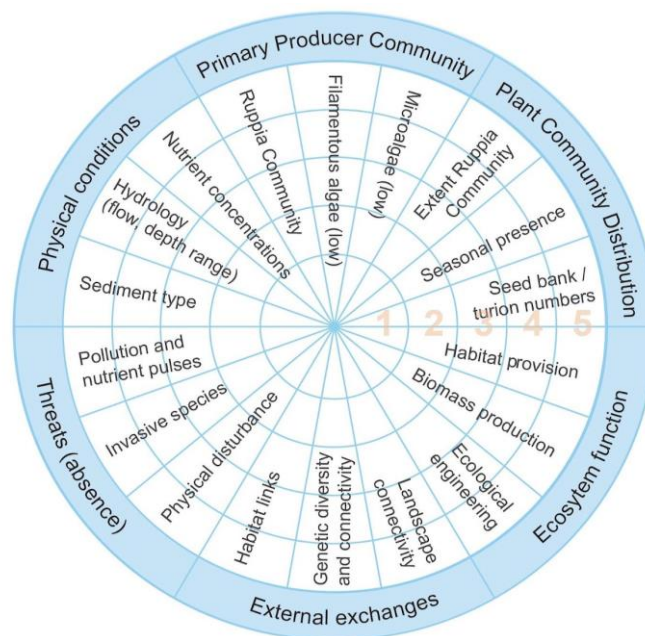
Figure 29. Progress assessment template adapted for assessing the state of the Coorong Ruppia Community with goals supported by monitoring activities and restoration actions informing the progress towards targets (SERA 2021b). The scale should correspond to progress towards recovery outcomes that have been established for the program of work.

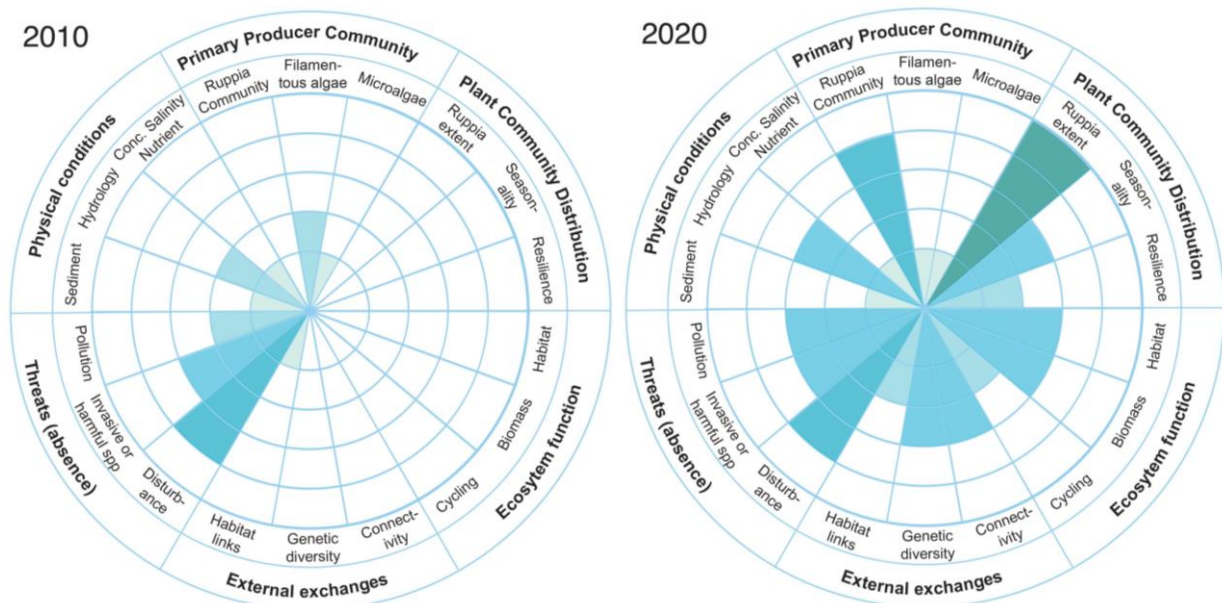
Figure 30. Progress assessment evaluation for the two examples of restoration actions, 2021 and 2020, to support restoration of the Ruppia Community in the Coorong (Table 7).
