Botanical Statement

Proposed Dana Bay emergency access road, Mossel Bay

November 2022

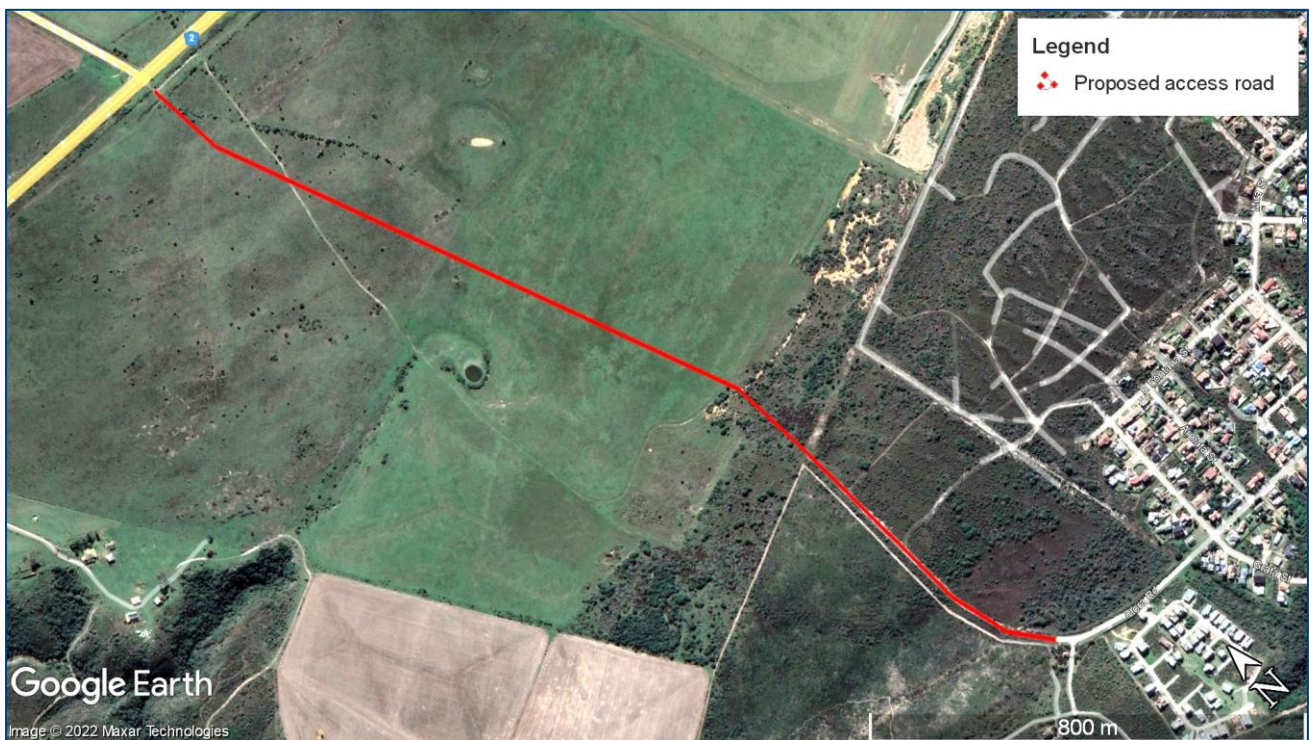
Figure 1-2: Aerial photograph of proposed new access road.

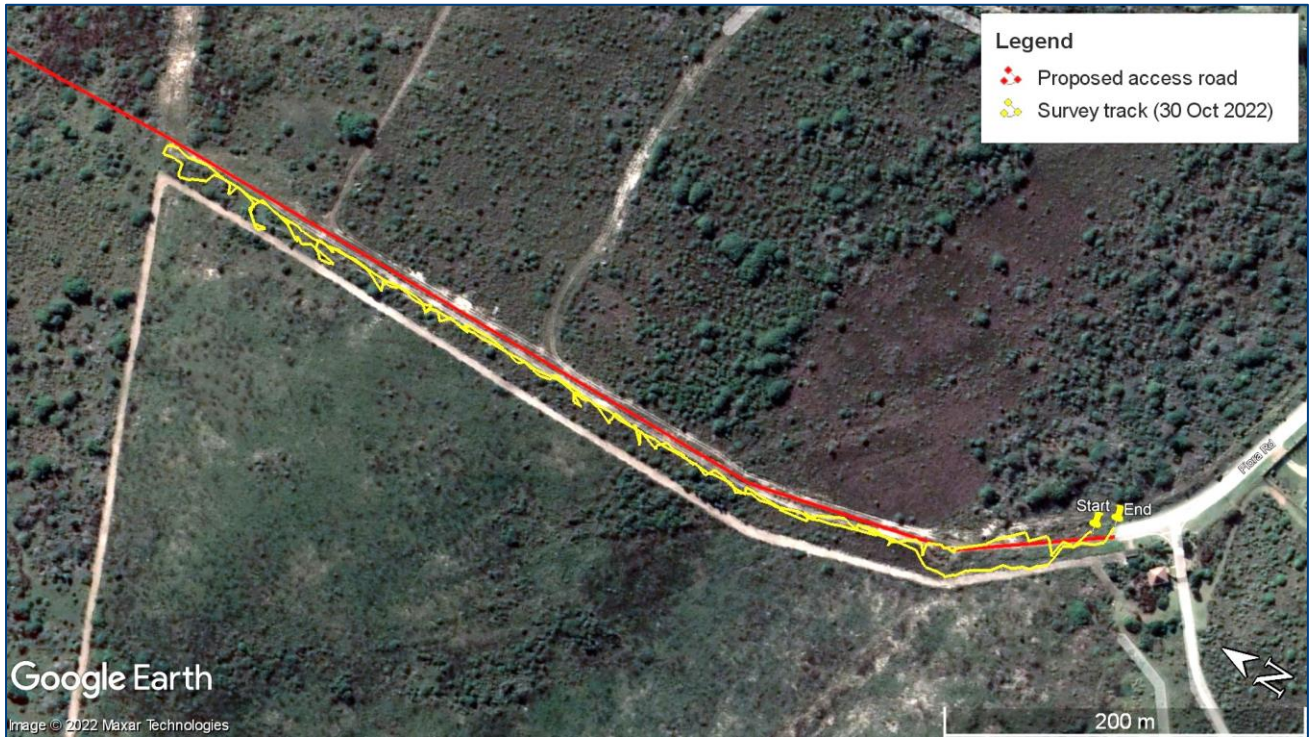
Figure 3-1: Satellite photo showing the survey track.

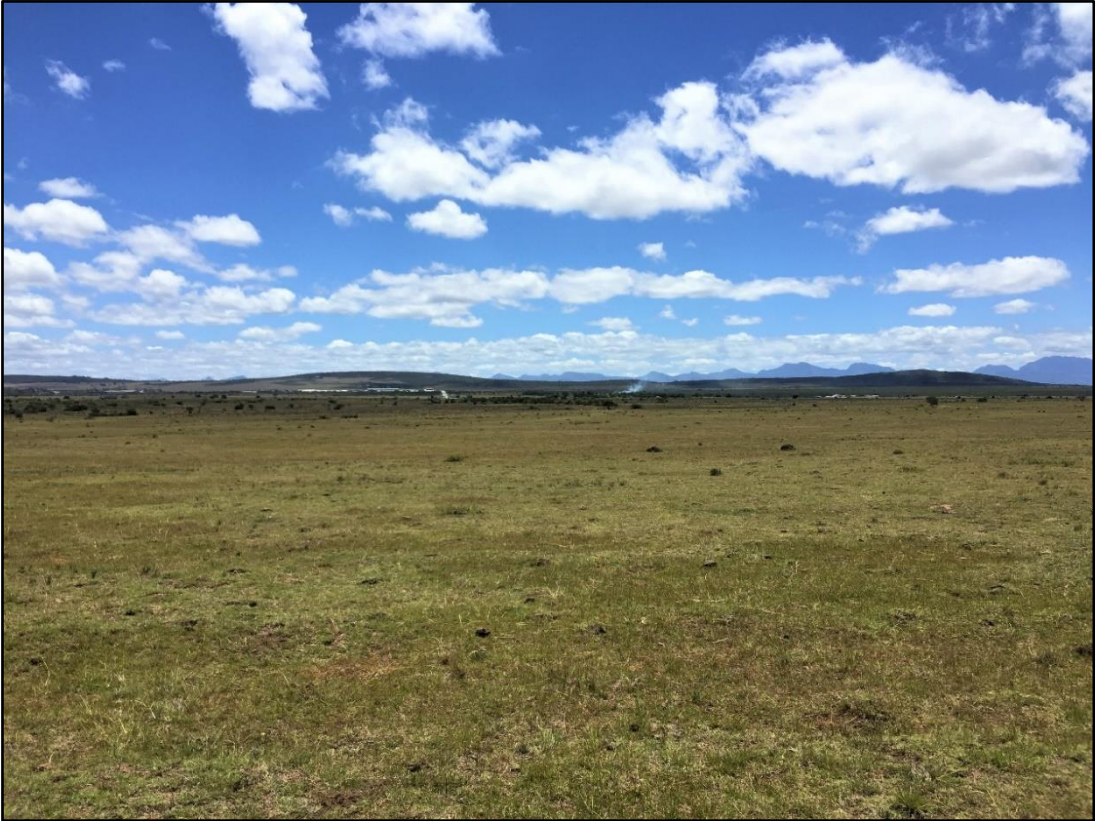
Figure 4-2: Pasture, looking north towards the proposed junction with the N2.

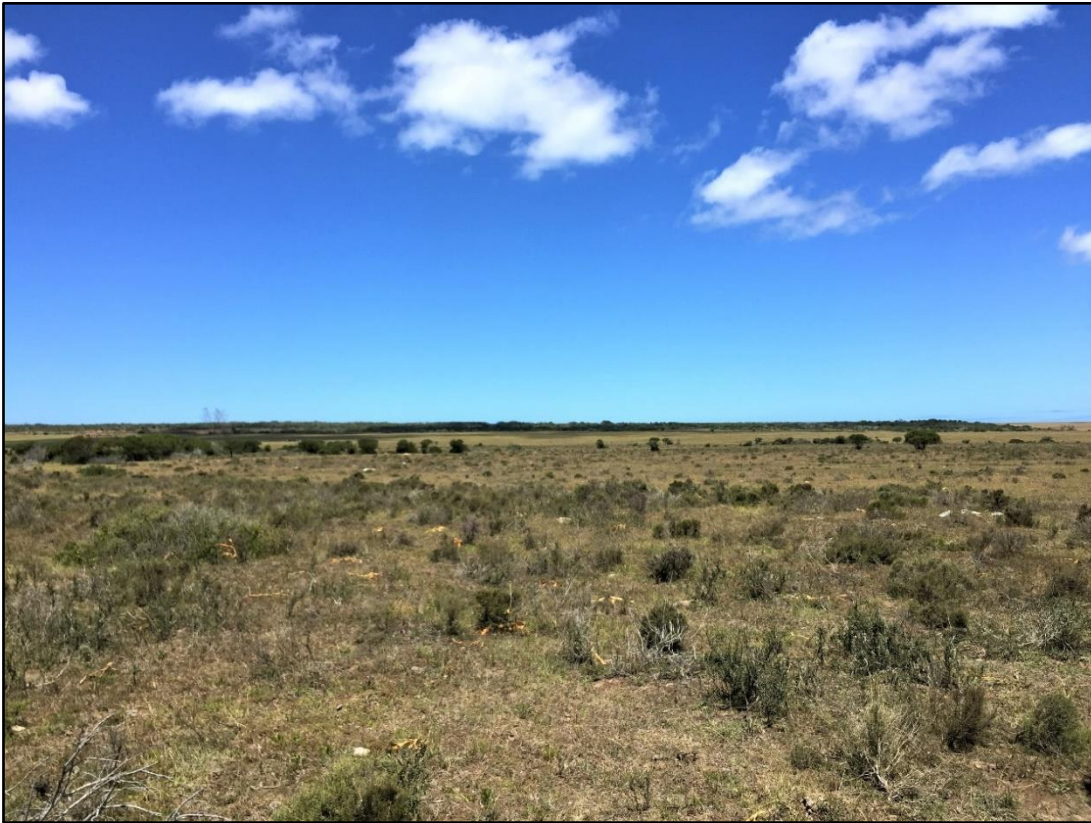
Figure 4-3: Looking south across the fallow land portion of the site.

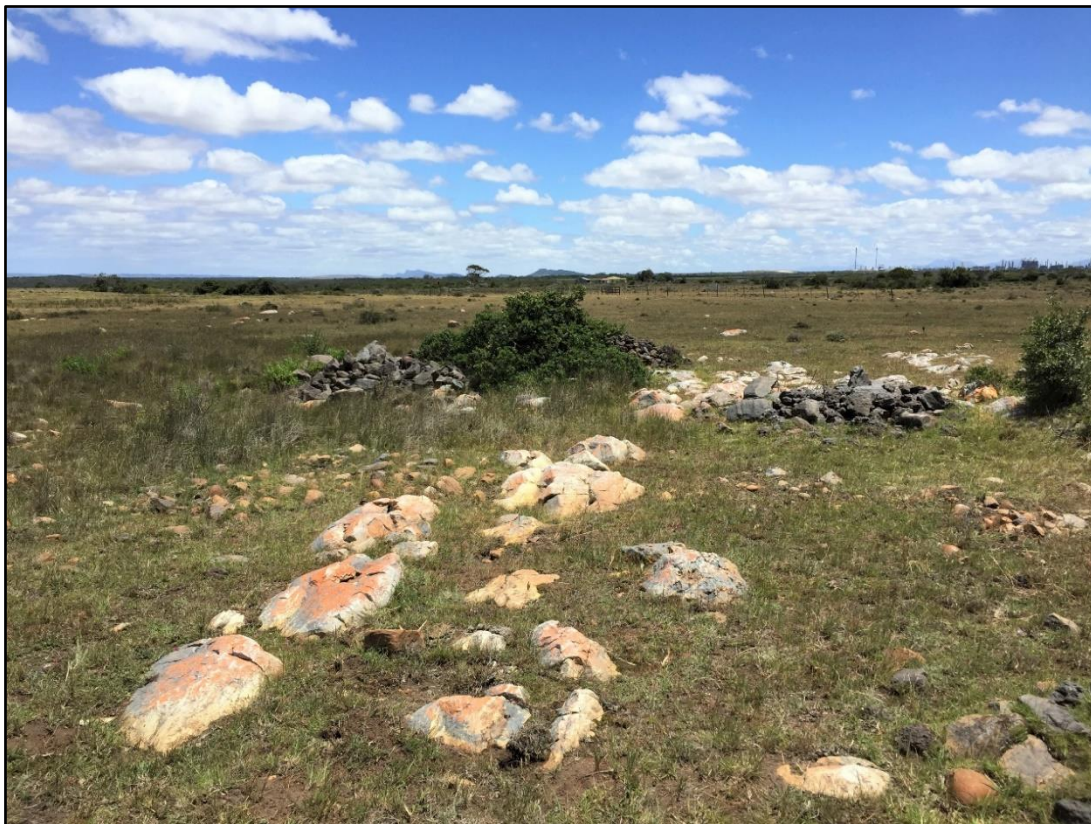
According to the 3422 AA Mossel Bay 1:50 000 geological map, the southern part of the site is underlain by non-shelly sand (a target for sand mining activities), which changes into loam and sandy loam soil in the northern part. The base rock comprises Table Mountain Group sandstone, presumably Skurweberg Formation (**Figure 4-4**). These sediments typically support fynbos types.

Figure 4-4: Exposed Table Mountain Group sandstone (Skurweberg Formation) in the fallow land.

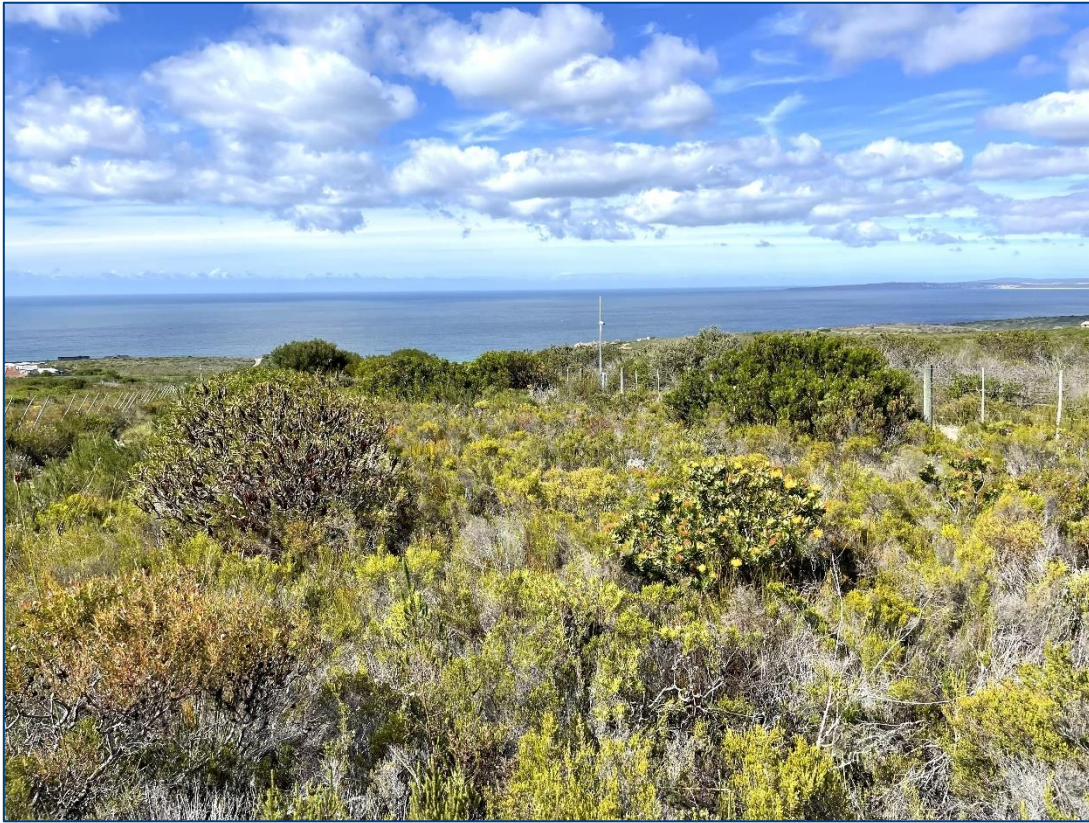
The vegetation at the southern end of proposed route, especially along the road reserve, comprises a fynbos type that shows a strong affinity with Albertinia Sand Fynbos. There is also a bit of influence from Groot Brak Dune Strandveld and Canca Limestone Fynbos. Structurally, it can be described as a low to mid-high (0.5-2 m) closed shrubland following Campbell's classification (Campbell, 1981). It is low (<1 m) along the road reserve and somewhat taller (1-2 m) in the strip between the road reserve and pasture. Dominant species include *Helichrysum patulum*, *Osteospermum moniliferum*, *Searsia lucida* and *Passerina corymbosa*. The fynbos along the road reserve is generally of a good quality

(**Figure 5-1**). The presence of a two-track dirt road, some *Acacia cyclops* (rooikrans) and a few disturbed patches do not detract from its value or quality.

Figure 5-1: Good quality fynbos in the road reserve.

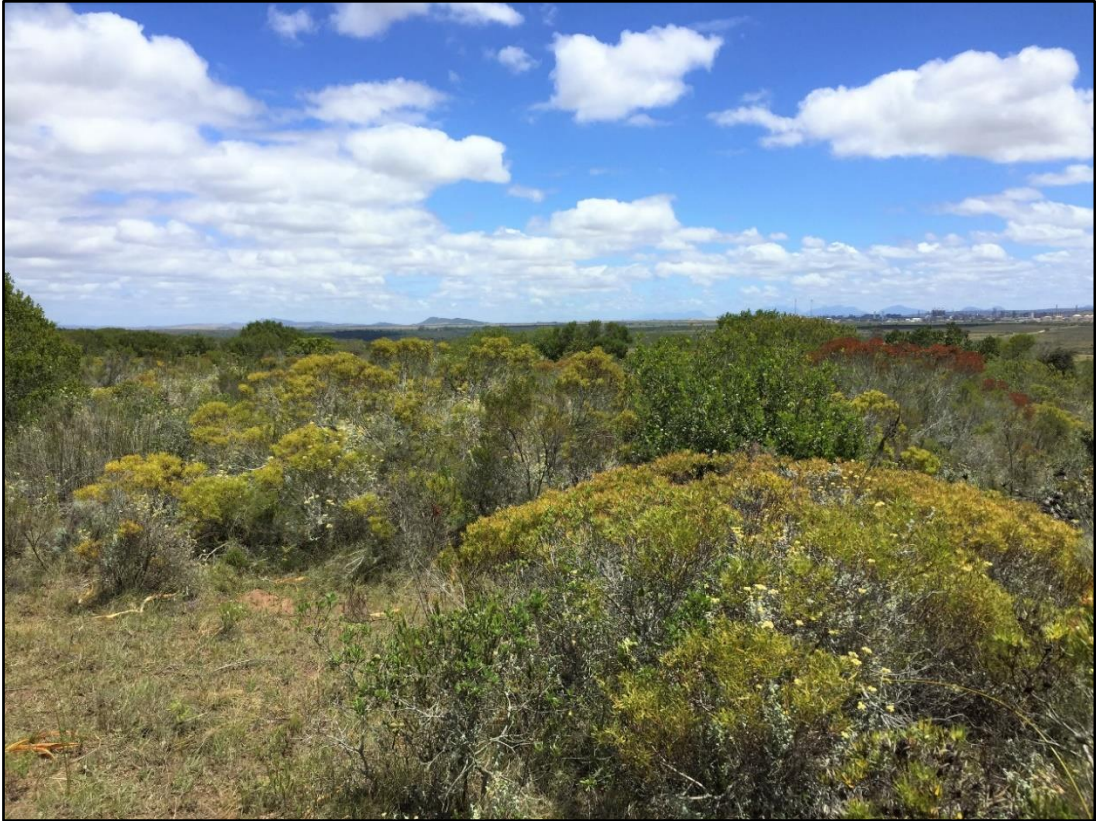
The strip of vegetation between the road reserve and pasture shows clear signs of disturbance by cattle grazing and alien infestation, notably *A. cyclops* and some *Opuntia ficus-indica* (prickly pear) (**Figure 5-2**). It was also noted to be senescent (very woody) and in need of a fire. Fire is an important trigger for germination in fynbos and it can also be used in an integrated manner to control invasive aliens.

Figure 5-2: Strip of senescent fynbos between the road reserve and pasture.

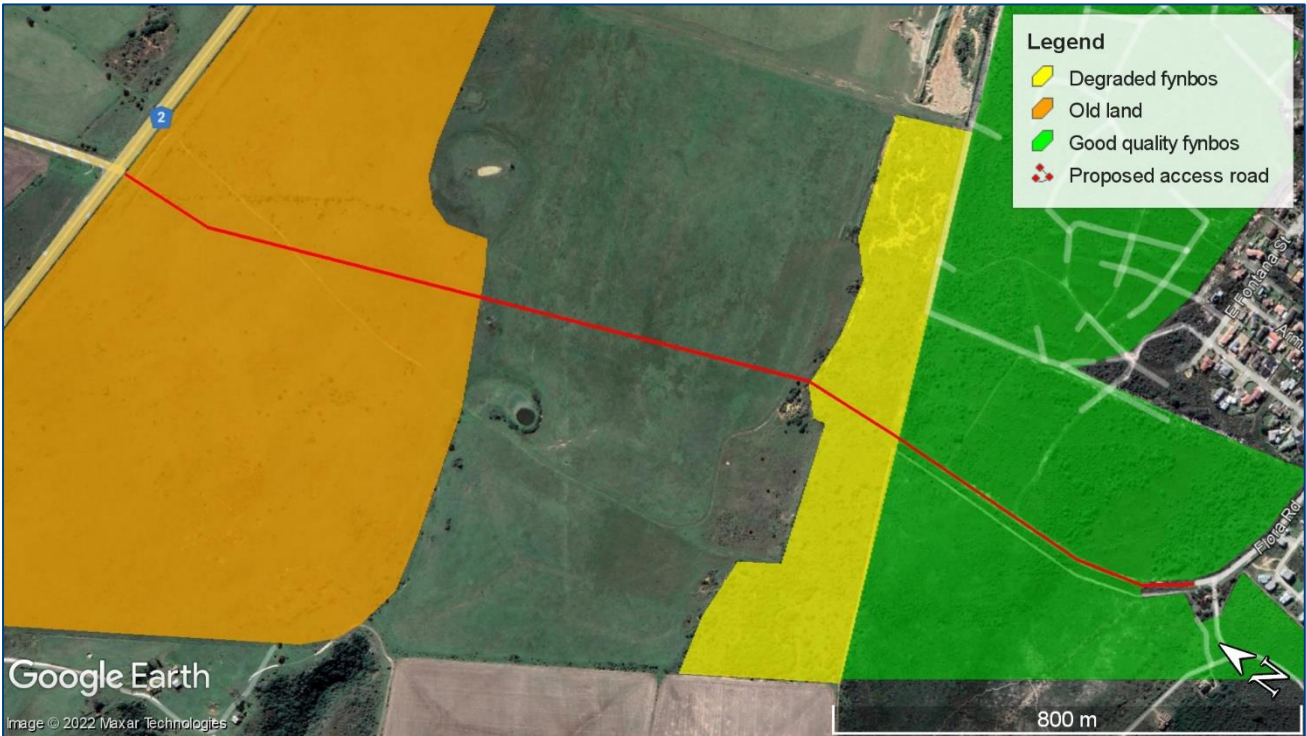
The history of the old (fallow) land is not clear, but a fair bulb population was noted here, notably *Albuca cf. acuminata*, *Ornithogalum dubium*, *Drimia capensis*, *Haemanthus coccineus*, *Crossyne guttata* and *Boophone disticha*. The shrub component (<0.4 m high) comprises a few scattered *Elytropappus rhinocerotis* (renosterbos), *Metalasia acuta*, *Athanasia quinqueidentata*, *Delosperma neethlingiae*, *Lampranthus elegans*, *Muraltia ericoides* and *Crassula nudicaulis*. It shows some potential to revert back to the original vegetation (presumably North Langeberg Sandstone Fynbos), but only if further farming activities in the area are ceased. The pasture is significantly degraded or devoid of indigenous vegetation. It is currently used for grazing purposes. **Figure 5-3** shows the vegetation attributes of the site.

Figure 5-3: Vegetation attributes of the site. The untuned area(s) are devoid of significant vegetation.

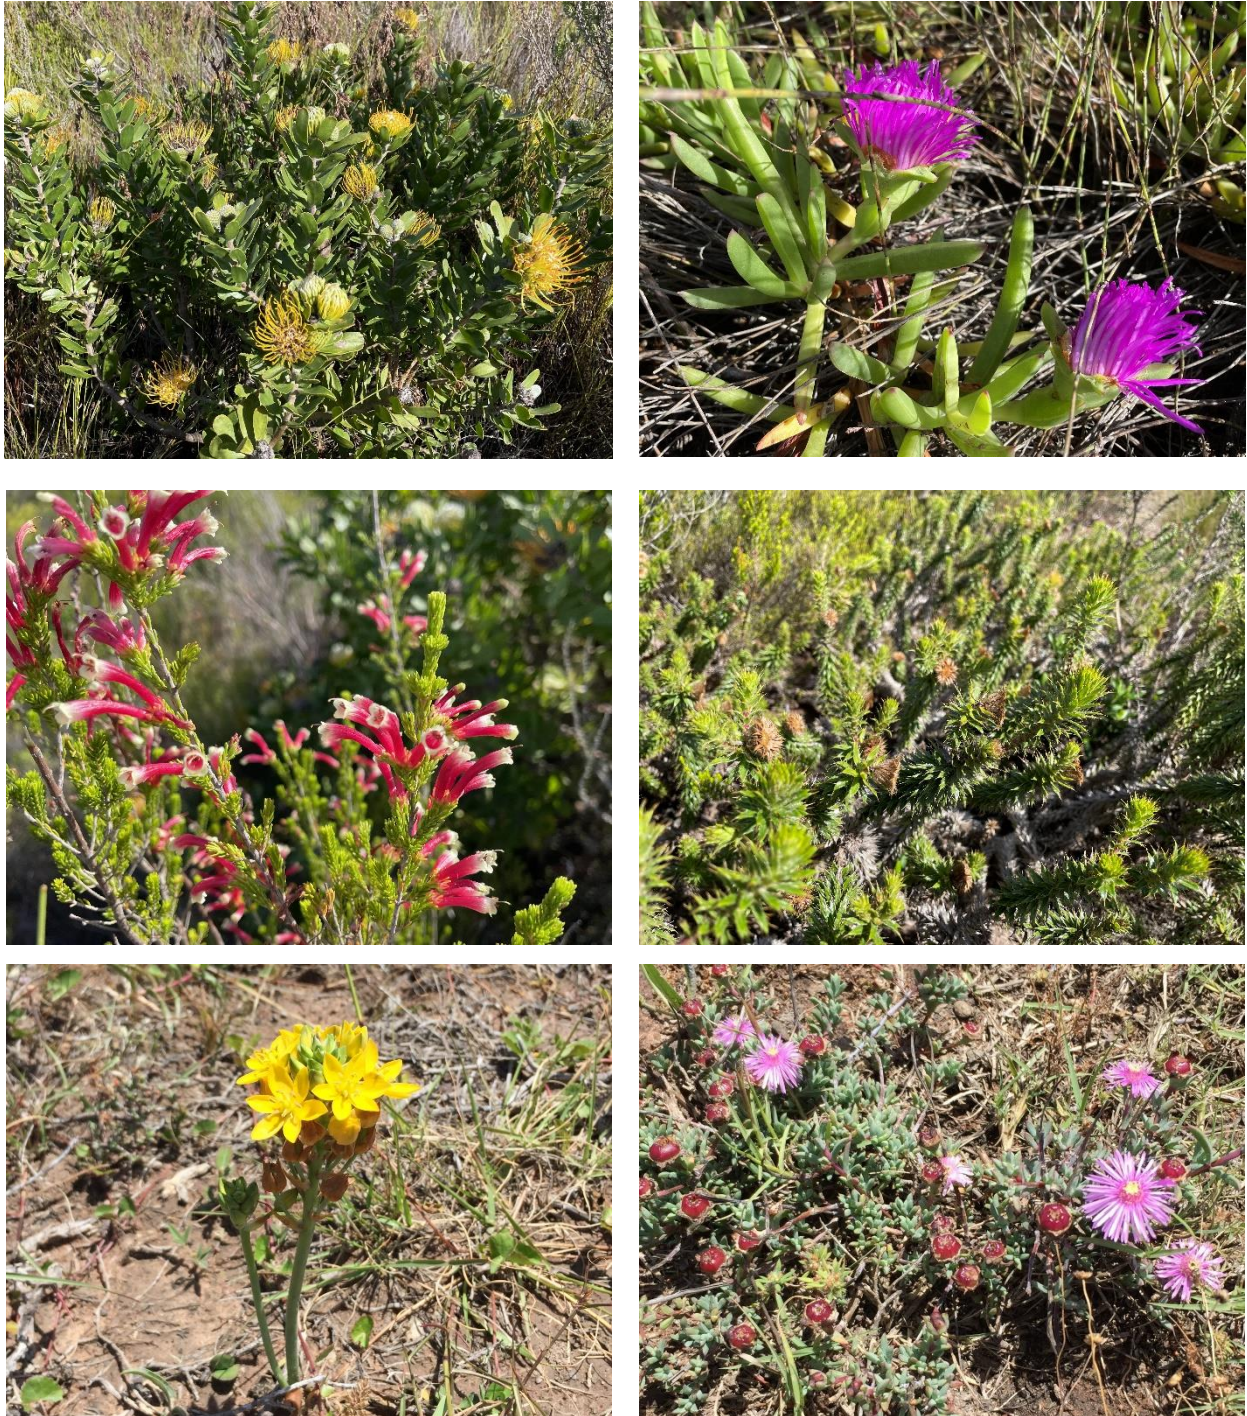
Figure 5-4 shows a few of the indigenous species recorded.

Most of the recorded species are widespread and fairly common in the Mossel Bay area. *Leucospermum praecox* (VU), *Cullumia carlinoides* (NT), *Carpobrotus muiirii* (NT), *Gnidia chrysophylla* (NT), *Hermannia lavandulifolia* (VU) and *Thamnochortus muiirii* (VU) are listed SCC (**Figure 5-5**). Other regional endemics recorded on site include *Protea lanceolata* and *Bobartia robusta*. A few *Pittosporum viridiflorum* trees, a protected tree species in terms of the National Forests Act (Act 84 of 1998), were recorded in the fynbos in close proximity to the proposed road. No milkwoods (*Sideroxylon inerme*), another protected tree species common in the area, were recorded. The removal of these trees requires a permit from the Department of Forestry.

Figure 5-4: A few indigenous species recorded on site, with *Leucospermum praecox* (top left), *Carpobrotus muiirii* (top right), *Erica versicolor* (middle left), *Cullumia carlinoides* (middle right), *Ornithogalum dubium* (bottom left) and *Lampranthus elegans* (bottom right).

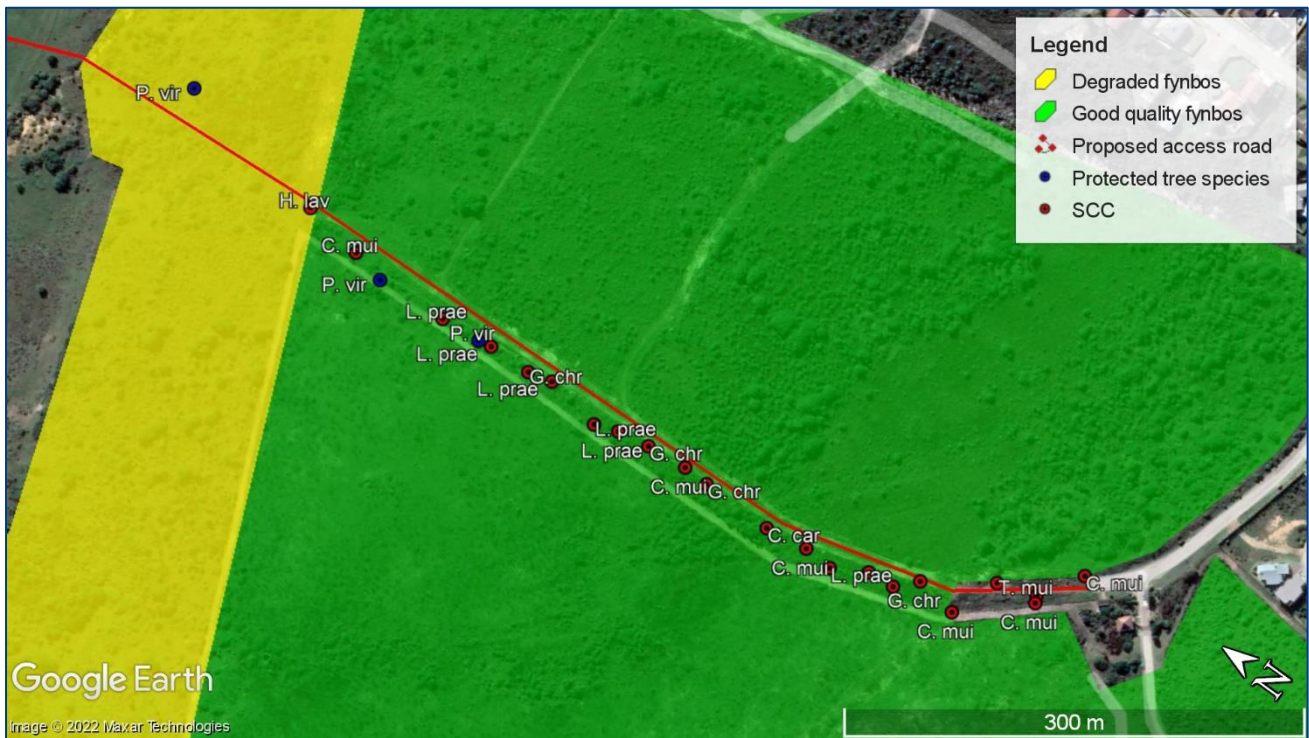
Figure 5-5: Recorded SSC and protected tree species.

- The contractor(s) must be made aware of the presence of SCC and protected tree (*Pittosporum viridiflorum*) species. Removal of the latter requires a permit from the Department of Forestry in terms of the National Forests Act.

- During the staking out of the construction footprint take cognisance of the presence of recorded SCC and protected trees. Try and avoid these as far as practically possible. It is recommended that a botanist be involved during this process.
