Carina Iron Ore Project

Ministerial Statement 852 - 957 Compliance Assessment Report

30 April 2021

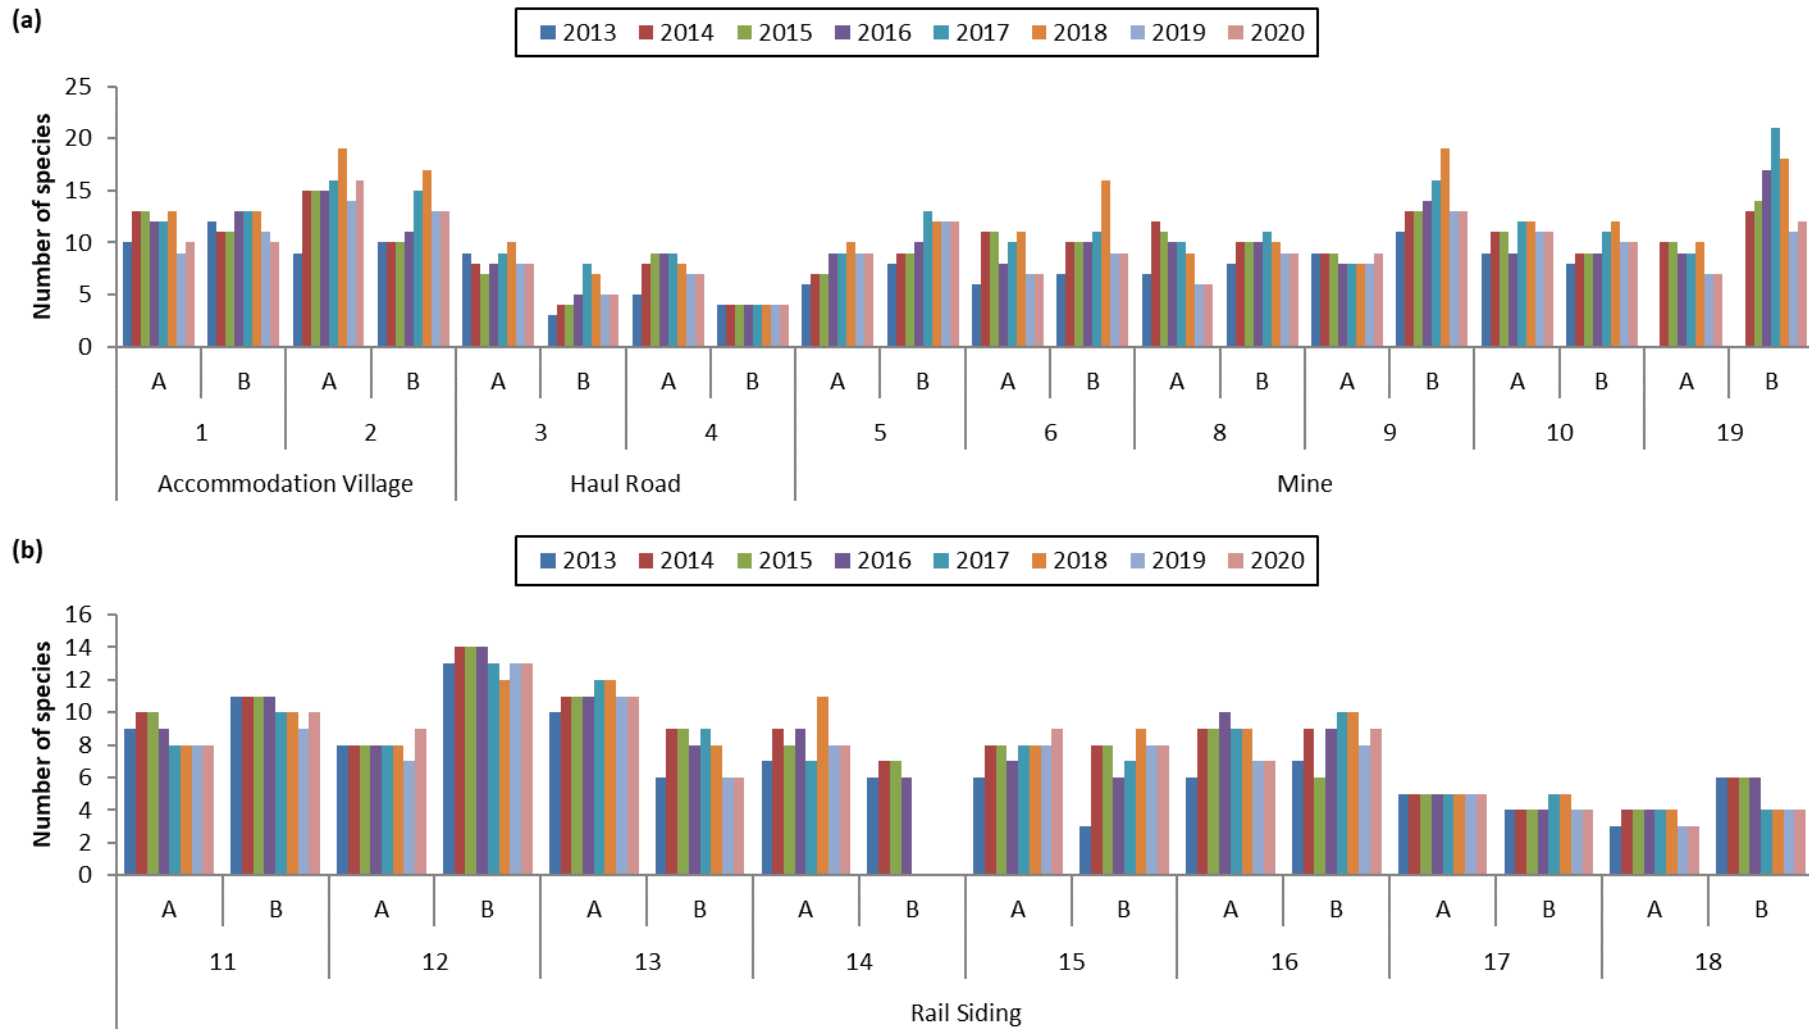
Native species richness in 2020 was not significantly different between analogue and buffer transects ($P = 0.53$; Table 4) and was similar or equal in the majority of transects compared to 2019 (Figure 7). Compared to 2013, species richness in 2020 was significantly higher (Pseudo $F_{1,61} = 5.72$, $P = 0.02$), however, there was no significant difference between analogue and buffer transects (Pseudo $F_{1,61} = 0.34$, $P = 0.58$). Species richness in 2020 within the mine area buffer transects was significantly higher than analogue transects ($P = 0.03$; Table 4), a trend observed since 2016 (Astron Environmental Services 2016, 2017, 2018, 2019). Average species richness at the buffer transects in 2020 was not significantly different to that of 2013 ($t = 0.48$, $P = 0.84$).

Figure 7: Species richness of understory species between 2013 and 2020 at the (a) accommodation village, haul road and mine area, and (b) rail siding area analogue (A) and buffer (B) zones. Numbers indicate the blocks.

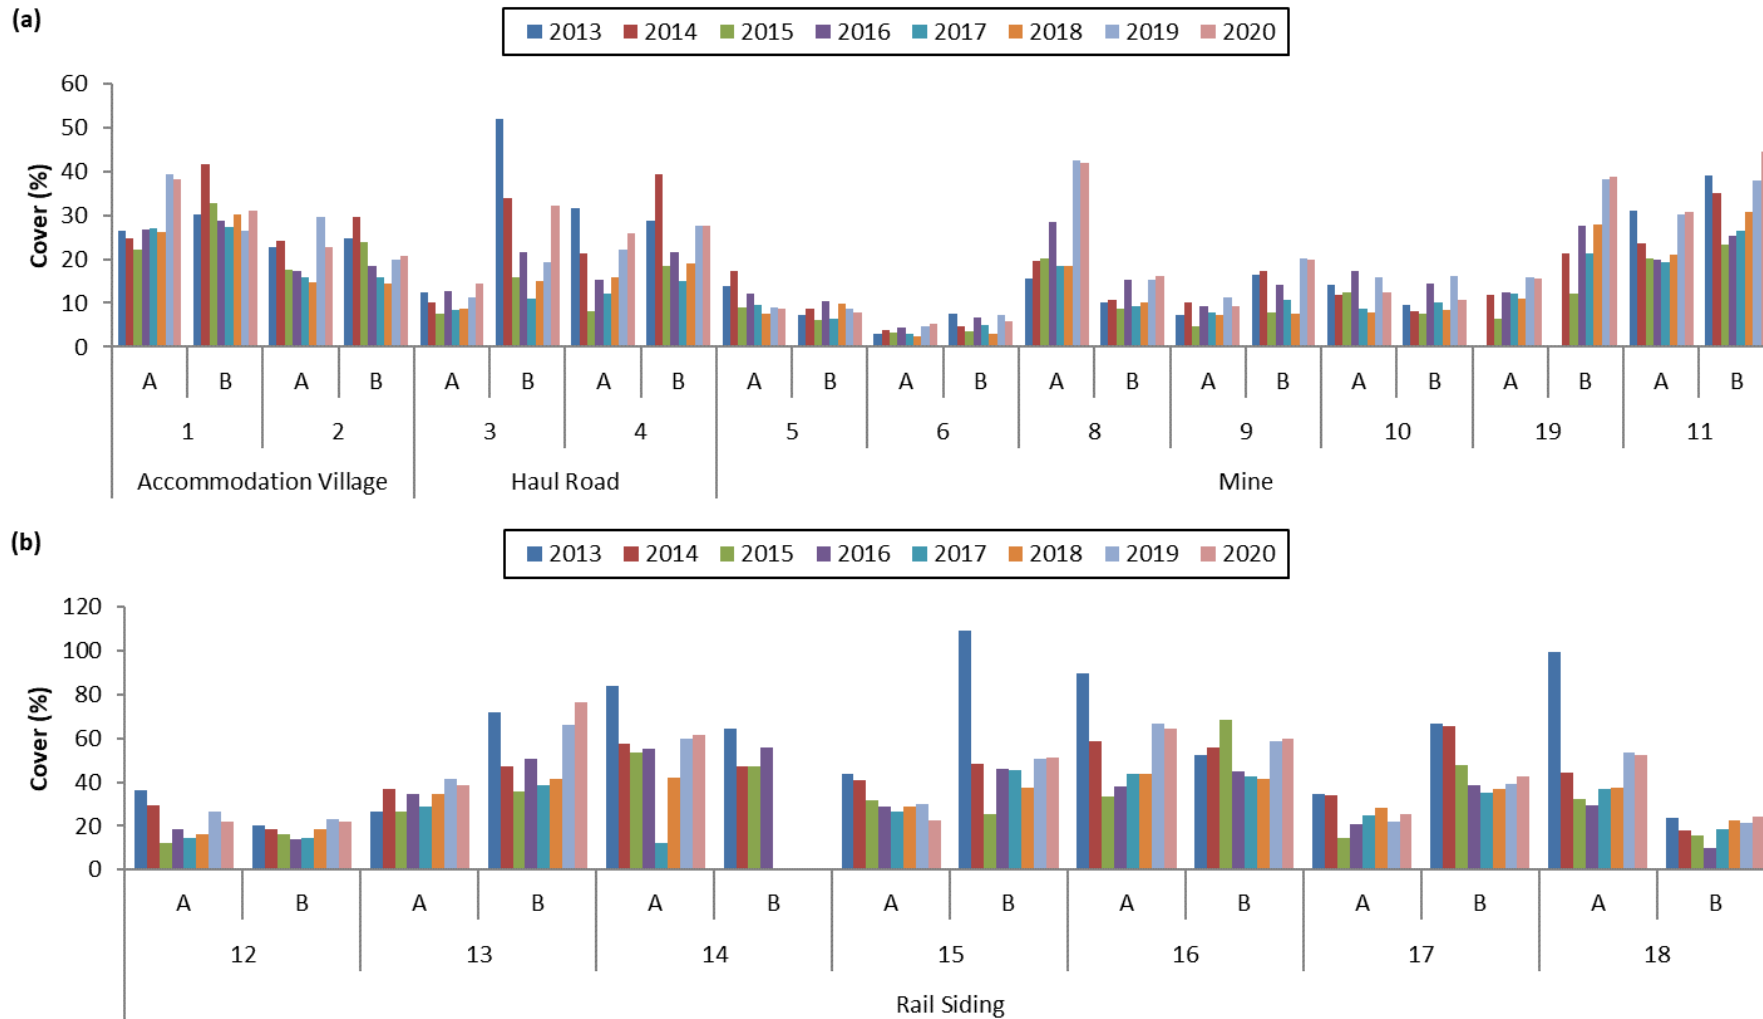
Overall, no statistically significant differences in plant cover were recorded between analogue and buffer transects in 2020 ($P = 0.79$; Table 4) or between 2013 and 2020 (Pseudo $F_{1,61} = 0.43$, $P = 0.51$). In previous years it was noted that there had been a general tendency for lower cover values over time, believed to have been influenced by seasonal conditions associated with changes in survey timing (Astron Environmental Services 2019). However, cover values appear to have stabilised between 2019 and 2020 with similar mean vegetation cover recorded (Figure 8).

Figure 8: Cover (%) of understory species between 2013 and 2020 at the (a) accommodation village, haul road and mine area and (b) rail siding area analogue (A) and buffer (B) zones. Numbers indicate the blocks.

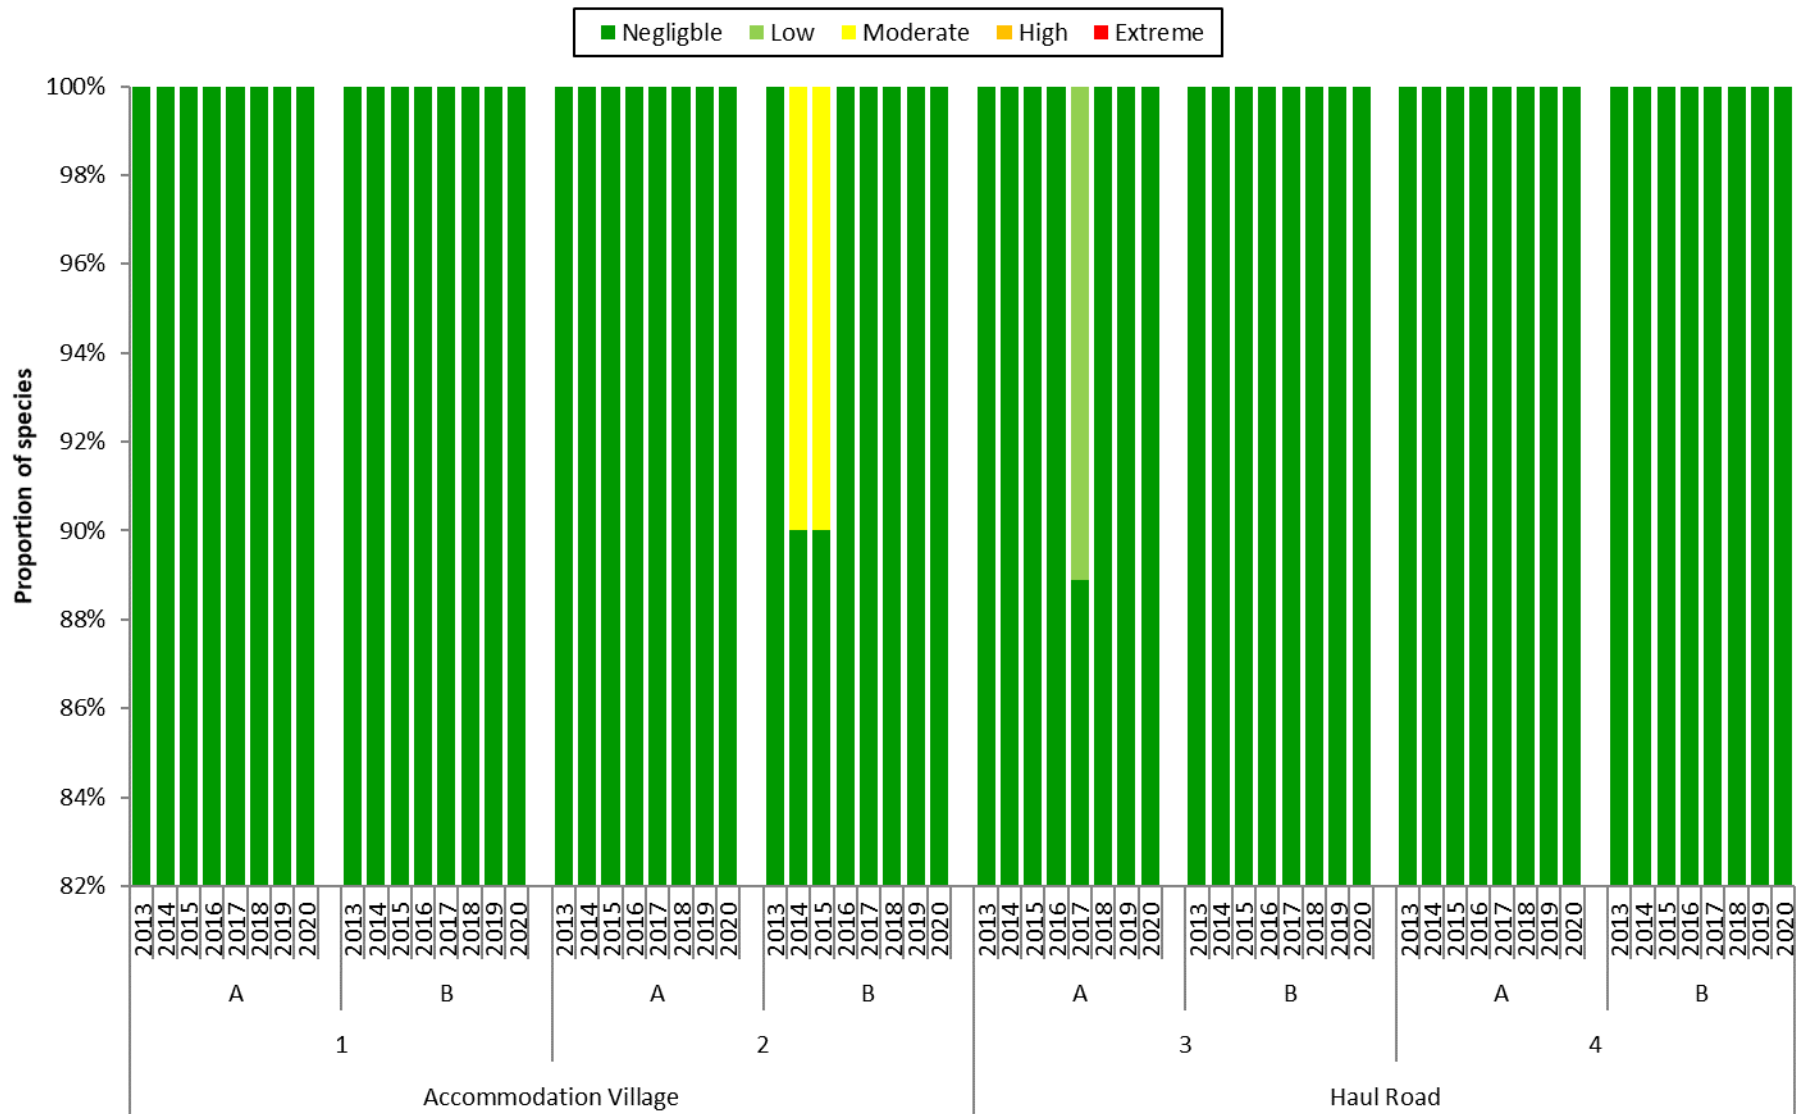
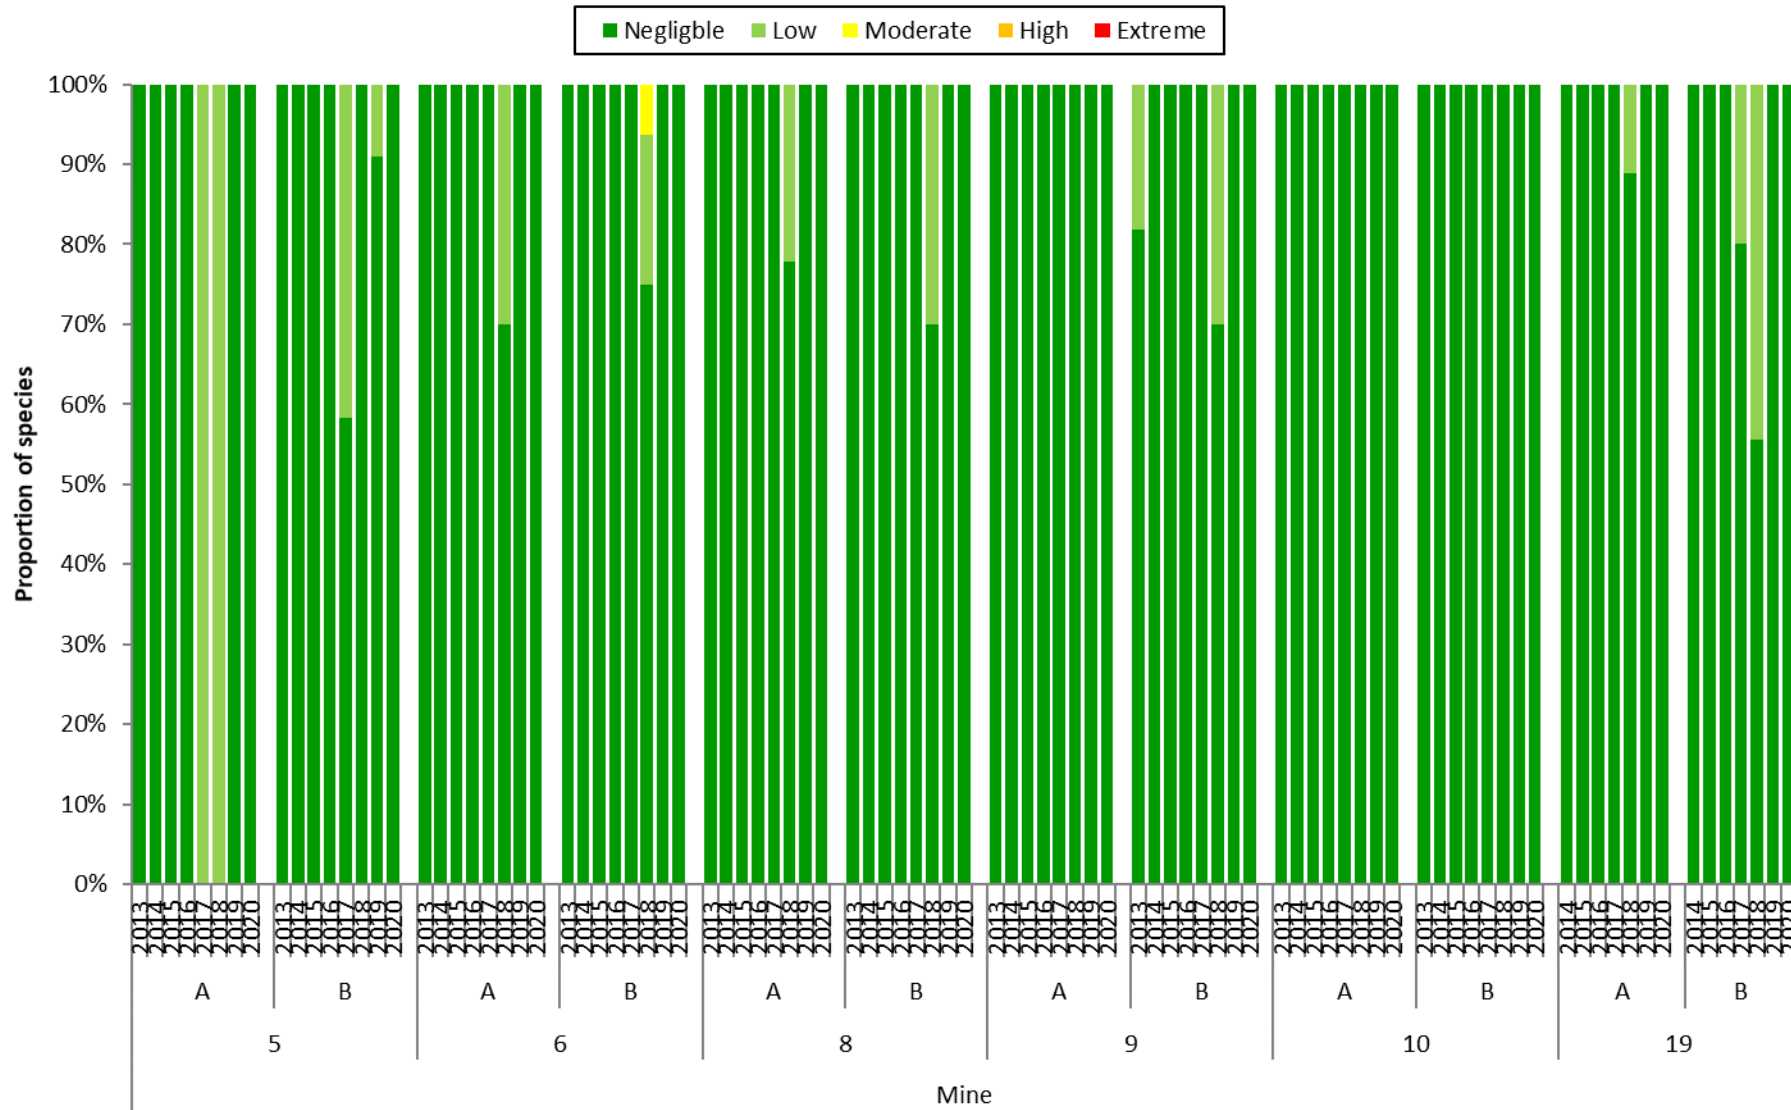
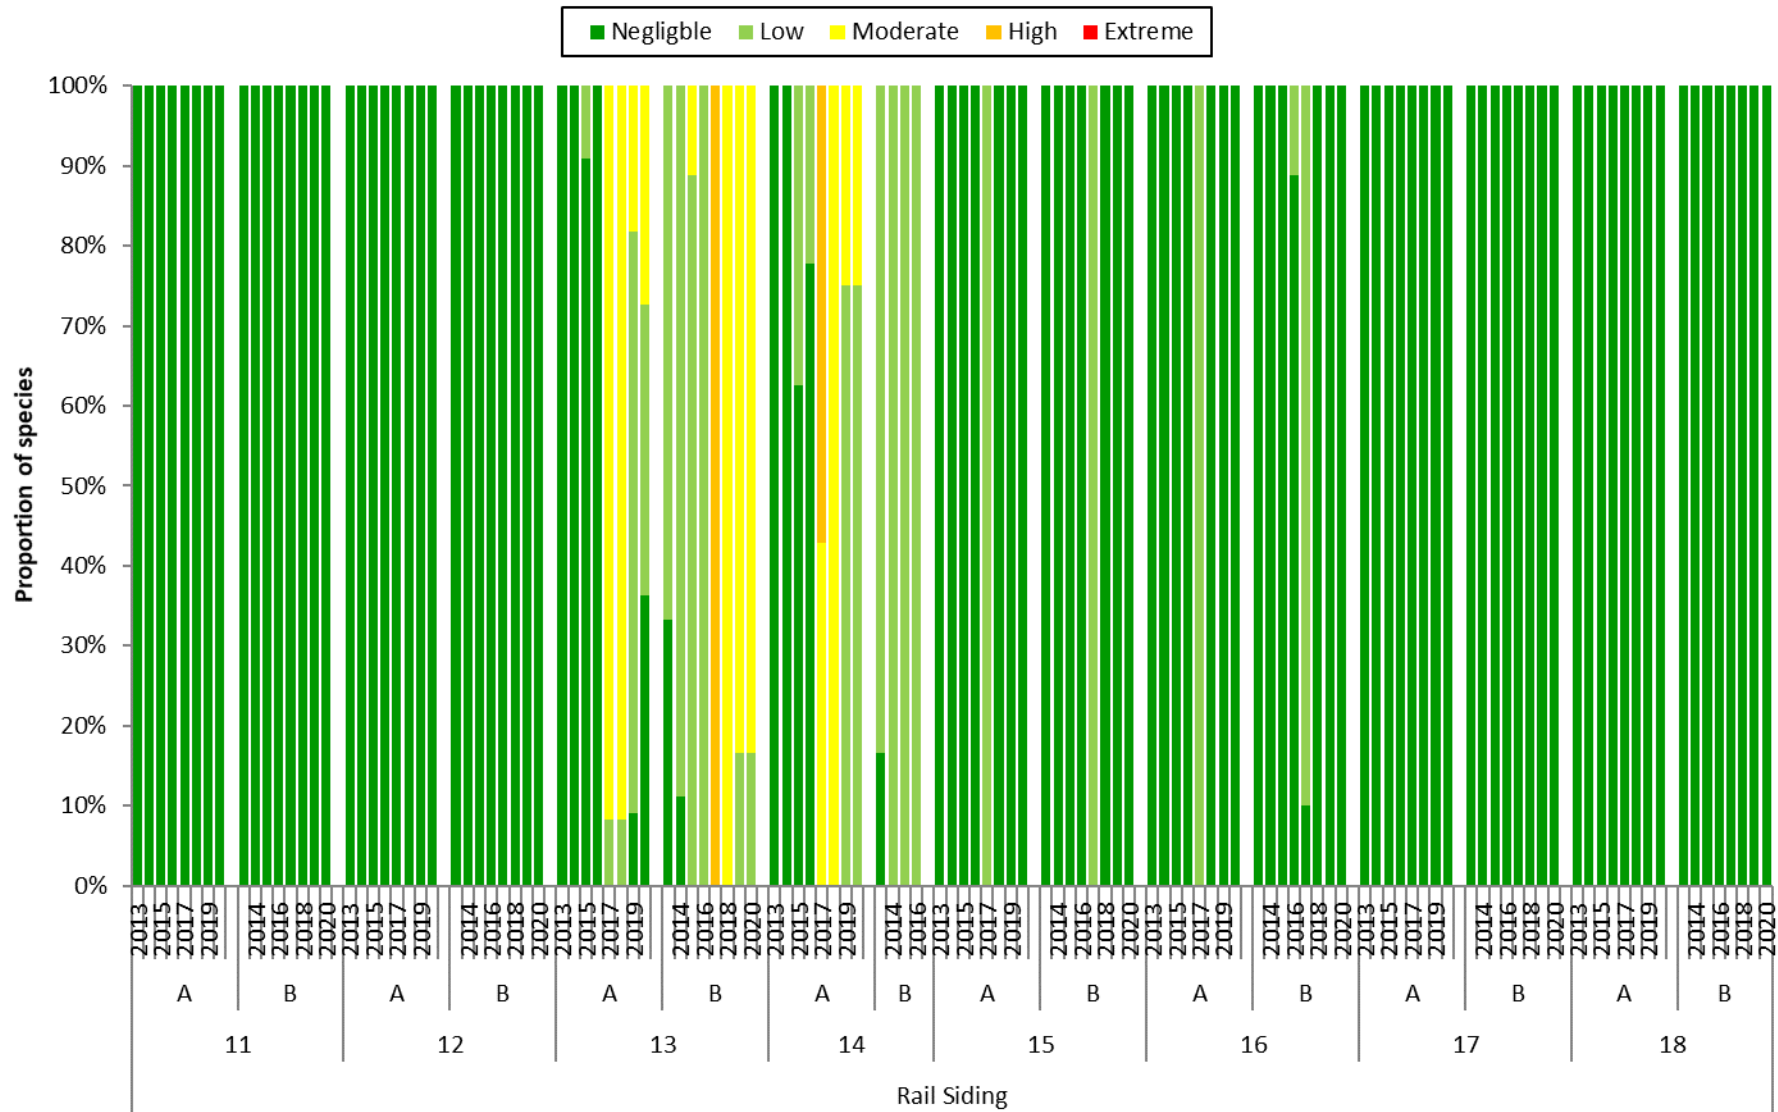
There was no significant difference in dust load between analogue and buffer transects in 2020 (Table 4). There was negligible or low dust cover on understory vegetation at the majority of transects (Figure 9 to Figure 11). Consistent with 2019, moderate dust loads were again recorded on plants at three transects within the rail siding area: RS-13-A (S31), RS-13-B (S31) and RS-14-A (S31). The two rail siding transects are in close proximity to a fire affected area from 2017 and the higher dust loading may be attributed to the open areas caused by the fire. Higher dust loadings at these transects have been observed since 2017, but diminishing over time (Figure 11). The moderate dust loading did not correspond with declines in plant health at any of the three sites (Figure 12 and Figure 14).

Figure 9: Dust load of understory species between 2013 and 2020 at the accommodation village and haul road areas analogue (A) and buffer (B) zones. Numbers indicate the blocks.

Figure 10: Dust load of understorey species between 2013 and 2020 at the mine area analogue (A) and buffer (B) zones. Numbers indicate the blocks.

Figure 11: Dust load of understorey species between 2013 and 2020 at the rail siding area analogue (A) and buffer (B) zones. Numbers indicate the blocks.

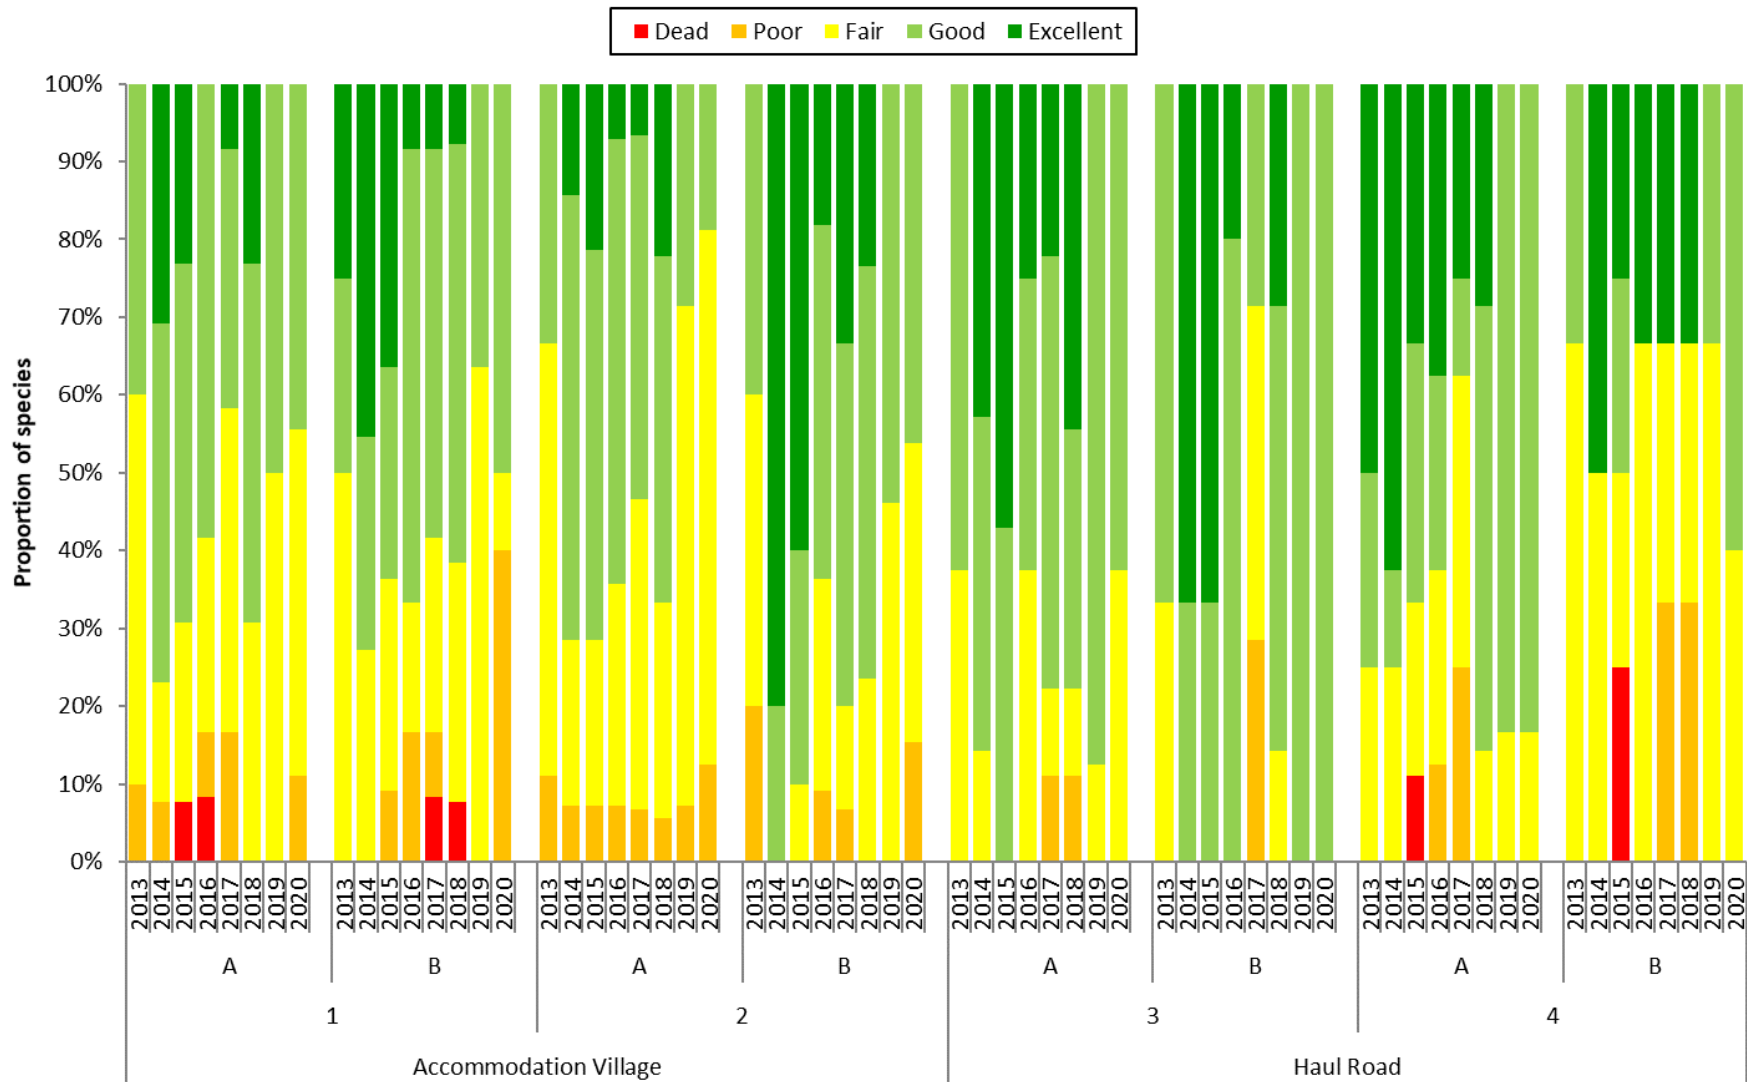
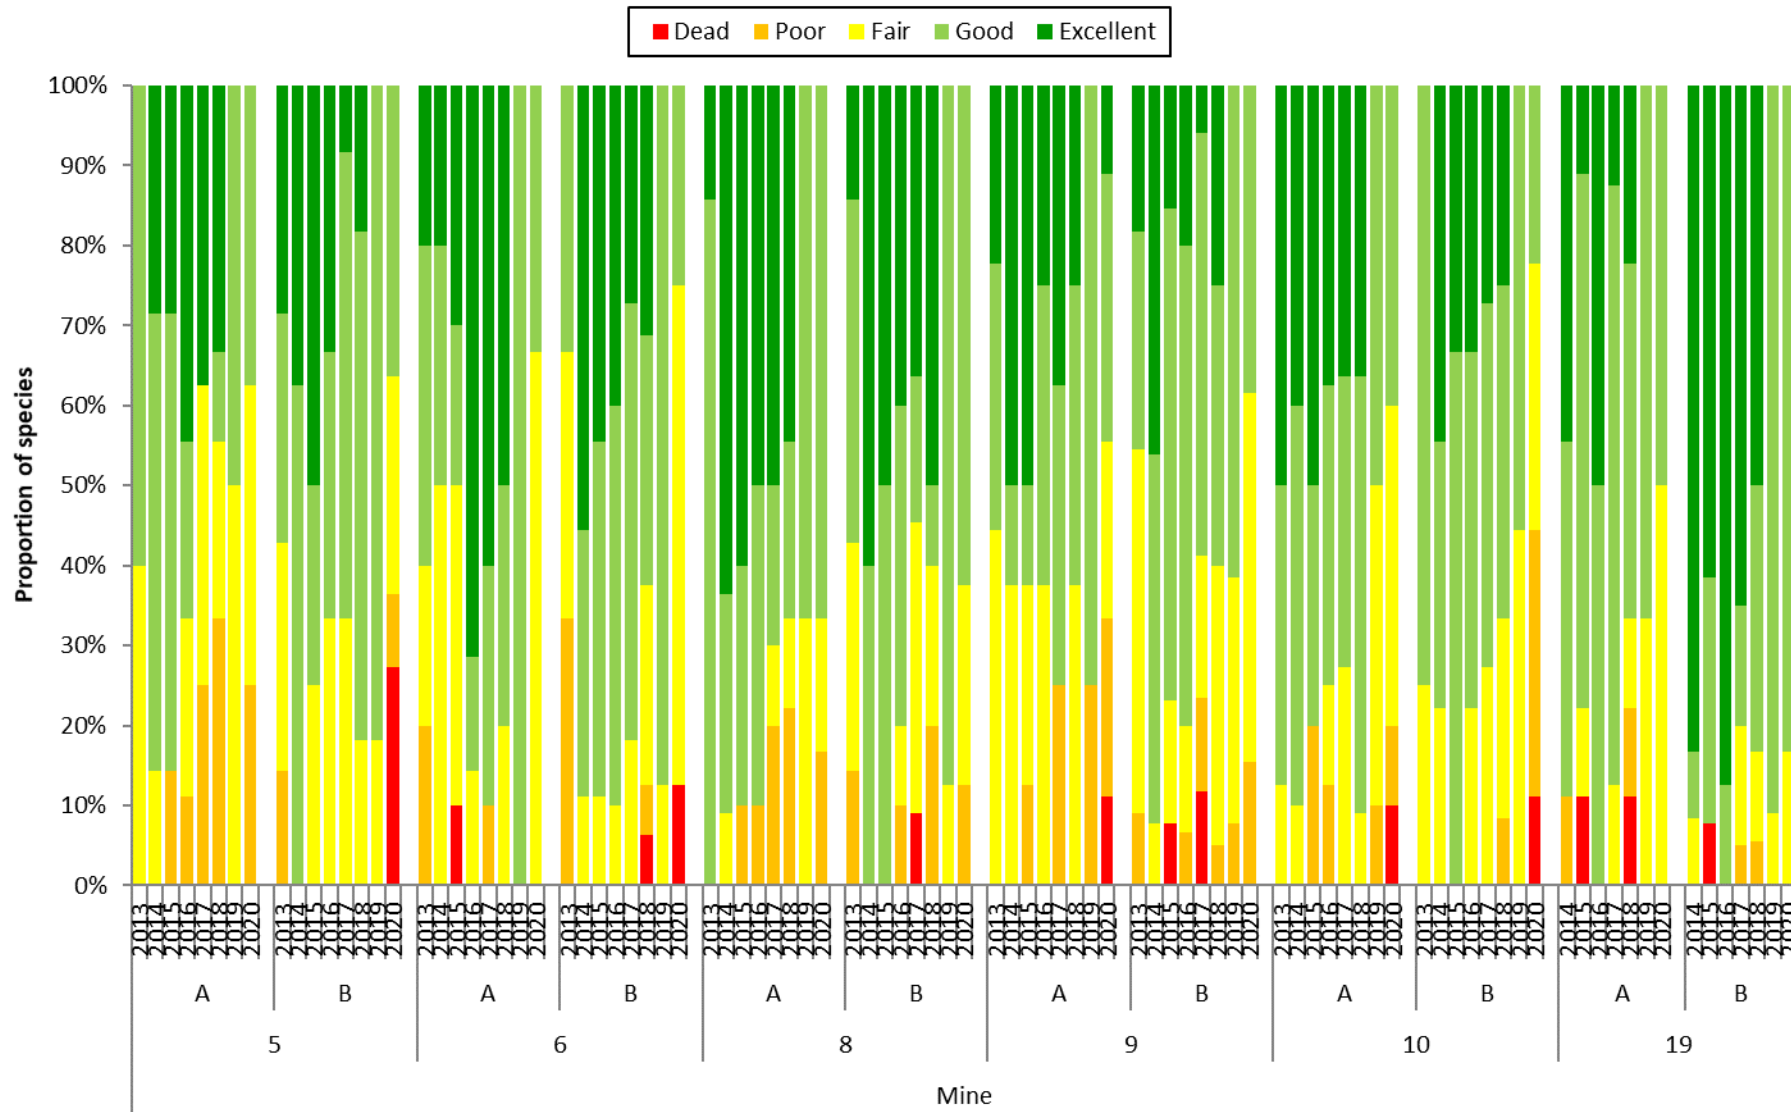
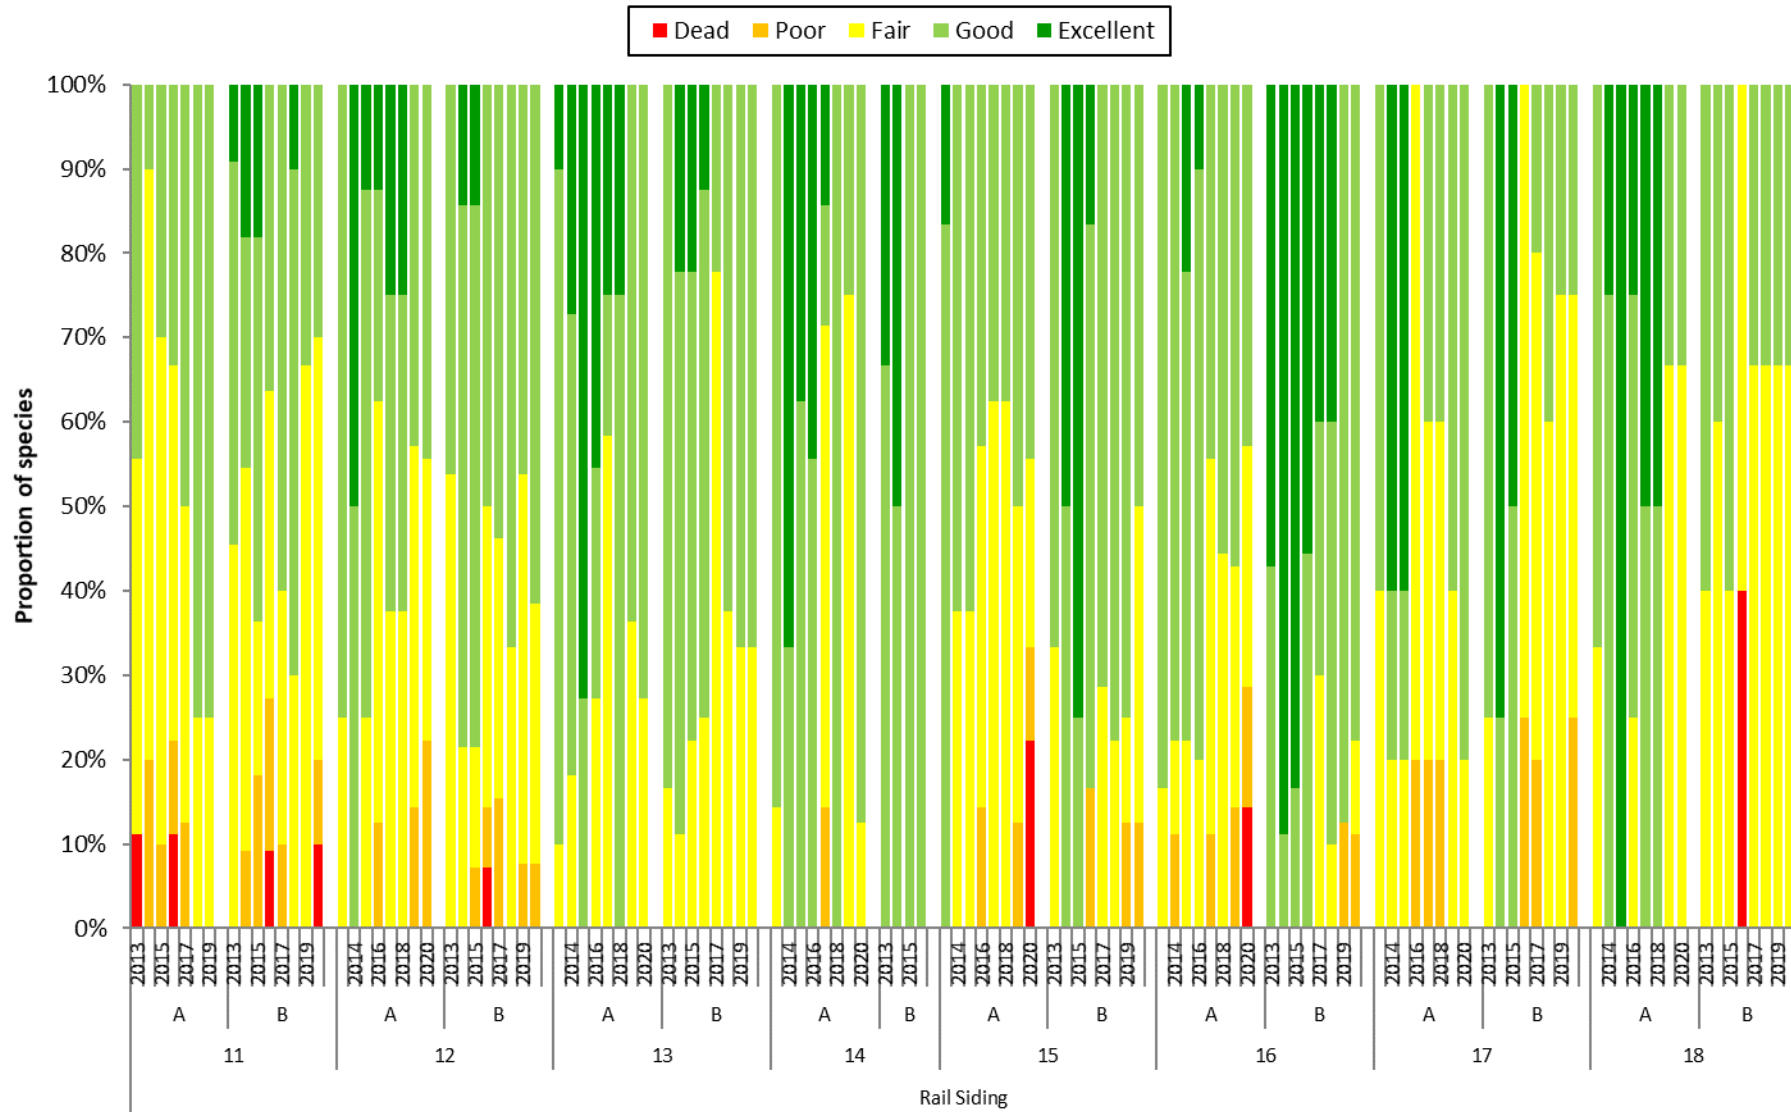
Mean plant health in the buffer transects were not significantly different between 2013 and 2020 ($t = 0.09$, $P = 0.92$; Figure 12 to Figure 14). There was also no significant difference in plant health between analogue and buffer transects in 2020 (Table 4). However in 2020, plants were generally in poorer health than previous years and were mostly recorded in fair and good health at both the buffer and analogue zones (Figure 12 to Figure 14). A larger number of species were observed to be in poor health during the 2020 survey than in 2019. The poorer plant health conditions in 2020 is likely due to long-term impacts from previous poor seasonal conditions (Bureau of Meteorology 2020).

Figure 12: Plant health scores of understorey species between 2013 and 2020 at the accommodation village and haul road areas analogue (A) and buffer (B) zones. Numbers indicate the blocks.

Figure 13: Plant health scores of understorey species between 2013 and 2020 at the mine area analogue (A) and buffer (B) zones. Numbers indicate the blocks.

Figure 14: Plant health scores of understorey species between 2013 and 2020 at the rail siding area analogue (A) and buffer (B) zones. Numbers indicate the blocks.

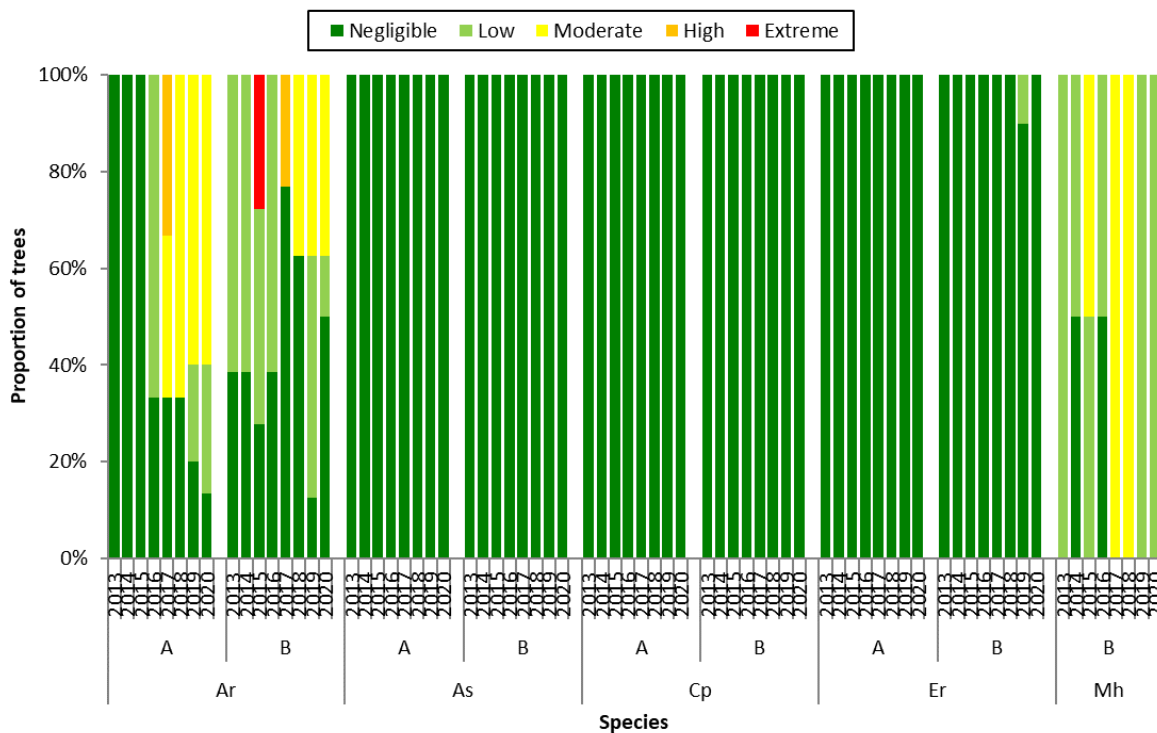
For the marked trees, dust loads for 2020 were negligible, low or moderate and no scores higher than moderate were observed (Figure 15). In 2013, negligible to low dust loads were observed for some *Acacia resinimarginea* trees in analogue and buffer zones, however between 2017 and 2020 surveys, loads have been negligible to moderate for both analogue and buffer zones (Figure 15). Dust loads on *Melaleuca hamata* trees in the buffer zone remained low in 2020 after an increase to moderate loads was recorded between 2017 and 2018 (Figure 15). Overall, tree dust loads in the buffer zone did not differ significantly in 2020 compared to 2013 ($t = 0.02$, $P = 1.00$, Figure 15). Additionally, dust loads did not differ between buffer and analogue zones in 2020 (Pseudo $F_{1,84} = 2.89$, $P = 0.09$).

Figure 15: Dust load of marked trees between 2013 and 2020 at the analogue (A) and buffer (B) zones. Ar = *Acacia resinimarginea*, As = *Allocasuarina spinosissima*, Cp = *Callitris preissii*, Er = *Eucalyptus rigidula*, Mh = *Melaleuca hamata*.

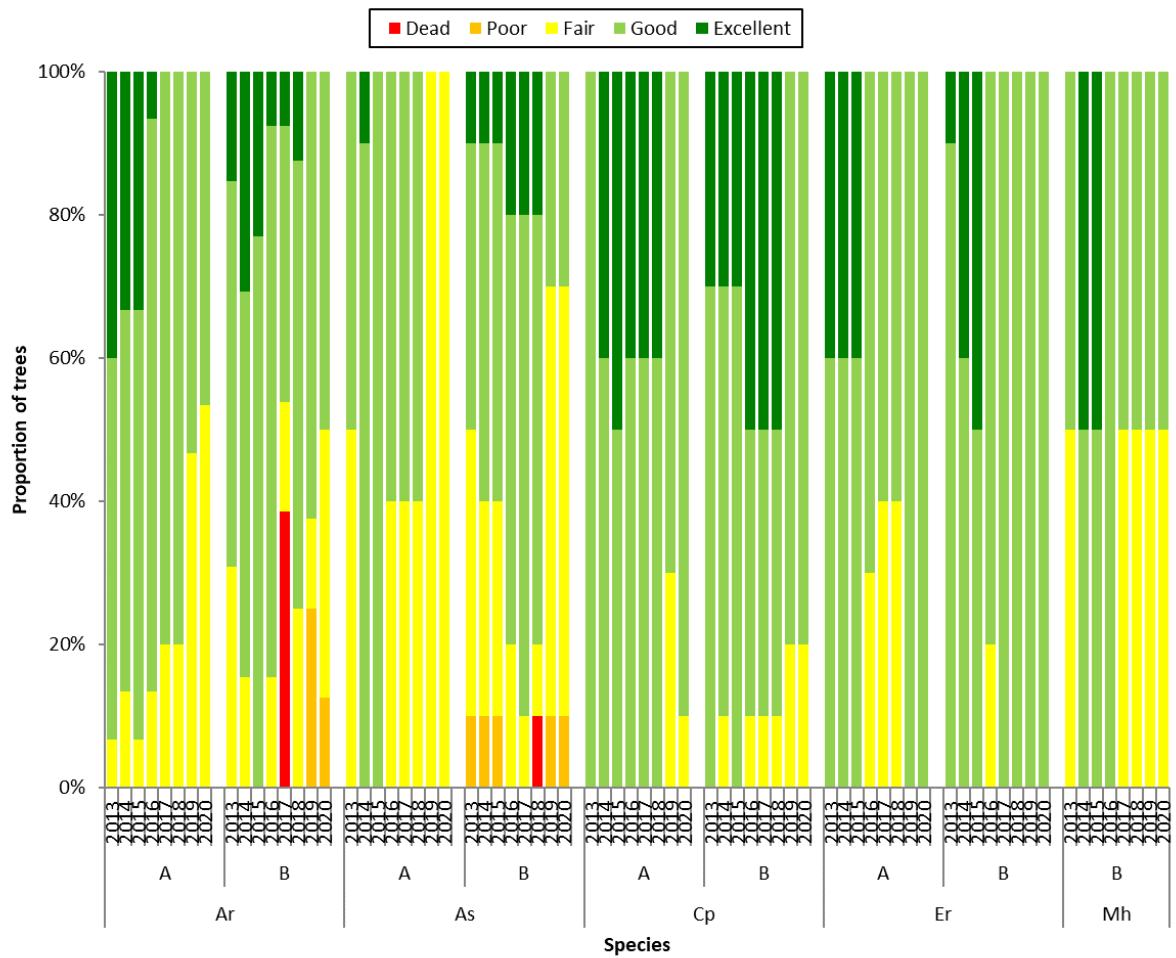
Tree health scores in the buffer zone were significantly lower in 2020 compared to 2013 ($t = 2.26$, $P = 0.03$). However, in 2020 health scores did not differ between buffer and analogue zones ($t = 0.03$, $P = 1.00$). *Acacia resinimarginea* health in the buffer zone has stabilised since the 2017 survey with an increase in the number of trees in fair health rather than poor (Figure 16). However, in analogue zones *A. resinimarginea* health has decreased slightly since 2019.

Figure 16: Health scores of marked trees between 2013 and 2020 at the analogue (A) and buffer (B) zones. Ar = *Acacia resinimarginea*, As = *Allocasuarina spinosissima*, Cp = *Callitris preissii*, Er = *Eucalyptus rigidula*, Mh = *Melaleuca hamata*.

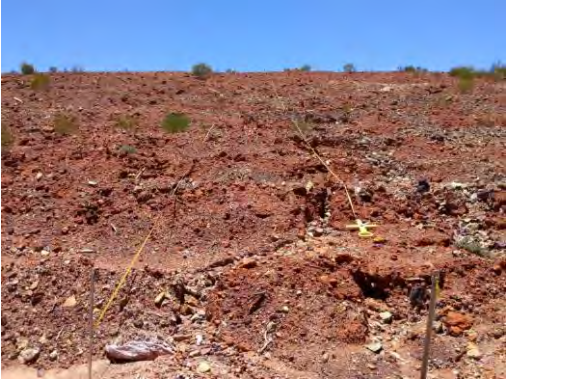
| SR26 | SR27 |

The third year of monitoring at the rehabilitated Carina Extended WRL has recorded active erosion at all sites, with significant erosion features recorded at SR27 and SR28. Despite below average annual rainfall over the past two years, erosion has increased in frequency and severity at the rehabilitation sites, indicating a potentially unstable surface. It is recommended that the UAV survey be repeated in 2021 to identify any areas of concern across the entire WRL that may require remediation. The limited erosion data available from on-ground monitoring indicates that condition 11-1.1 of MS 852 is not being achieved. The UAV survey will allow for a more comprehensive assessment of the stability of the WRL and condition 11-1.1.

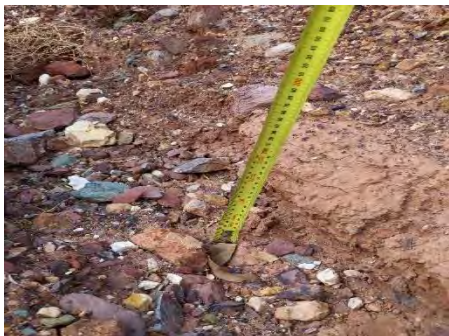
Plate D.1: SR21-Q00-R1 (786711mE, 6626435mN).

Monitoring at the Carina WRL recorded erosion features at all rehabilitation sites. The degree of erosion has remained relatively stable between 2019 and 2020 with no major variation in rill numbers, width and depth. However dry seasonal conditions are limiting the ability to accurately assess condition 11-1.1 of MS 852, with the risk of soil movement highest under heavy rainfall events which were absent in both 2019 and 2020. A repeat of the UAV survey is recommended after heavy rainfall to quantify the change in erosion features over time across the whole of the Carina WRL.
