Progressive Rehabilitation and Closure Plan

Isaac River Coking Coal Project

Coking Coal One Pty Ltd

EA applicant: Bowen Coking Coal Limited | November 2020

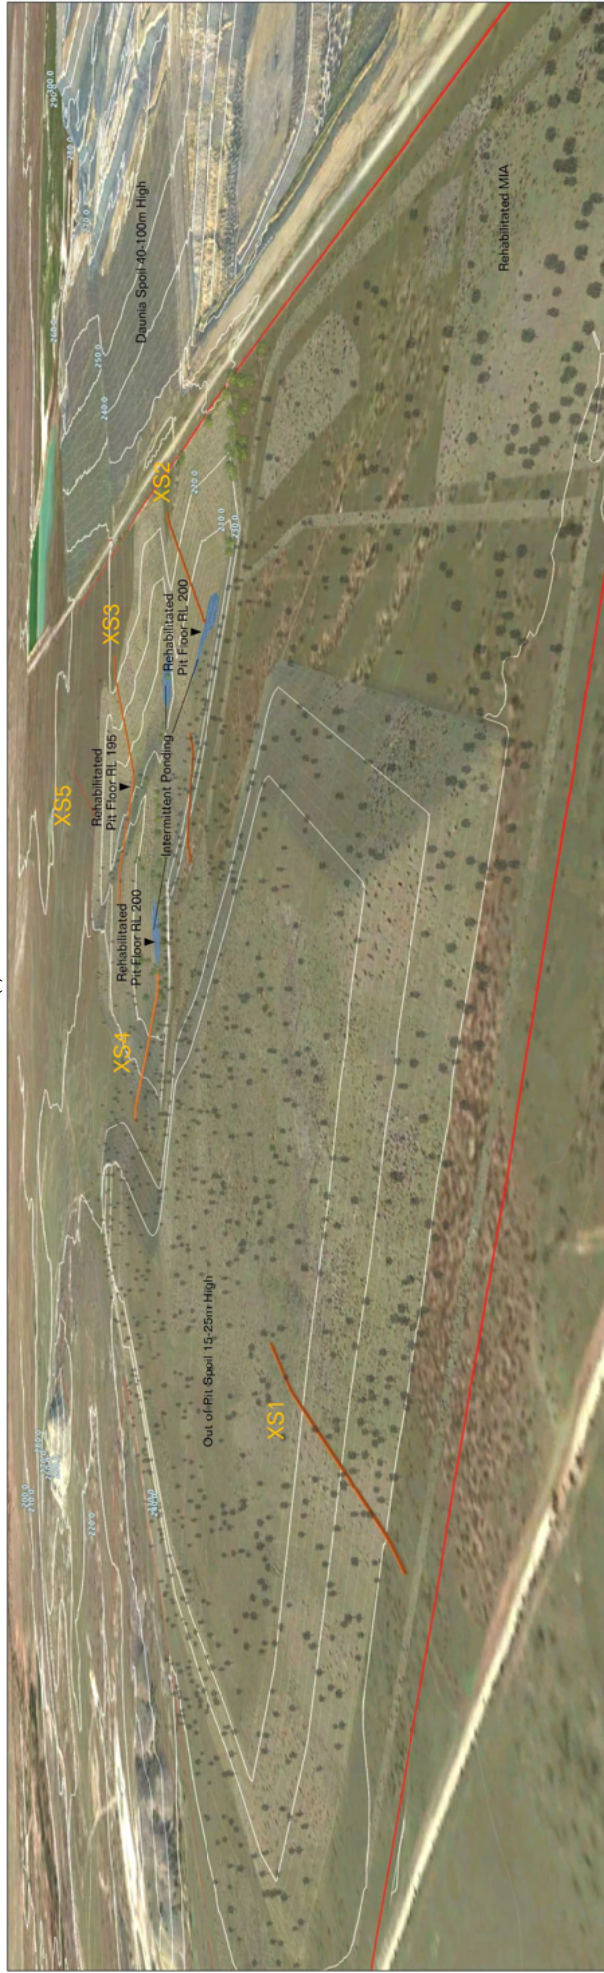
Figure 14 Final landform visualisation (a) Project looking north-west (b) Project looking south

A three-dimensional (3D) design plan of the final landform is given in Figure 14. The intent of the final landform design is to create a gentle sloping landform suitable for pasture grazing which blends into the surrounding landscape. All embankments / slopes will be battered to 15% or less (see Figure 15 and Figure 17 in Appendix A). The *Guidelines for Agricultural Land Evaluation in Queensland* (DSITI & DNRM 2015) apply limitations to some land where the use of machinery is impeded or where access by grazing animals may be constrained (ie usually steep slopes). Slopes greater than 25% are typically considered as unsafe for general machinery use and are therefore regarded as unsuitable. While the DNRM guideline does not define a 'steep' slope, *Meat and Livestock Australia* defines sloping lands of 10-25% as being suitable for grazing (MLA 2019). A maximum slope of 15% is therefore not considered steep and should not provide any impediment to livestock movement. Given all sides of OCI will be at a maximum slope of 15% or less, access and egress to all areas of the void will be possible for grazing animals.
