Wetland Delineation and Impacts Assessment Report for the Proposed Kusile 60-year Ash Dam

Reference: 913/2012

PROJECT: **DRAFT: Wetland Delineation and Impact Assessment
Report for the Proposed Kusile 60-year Ash Dam**

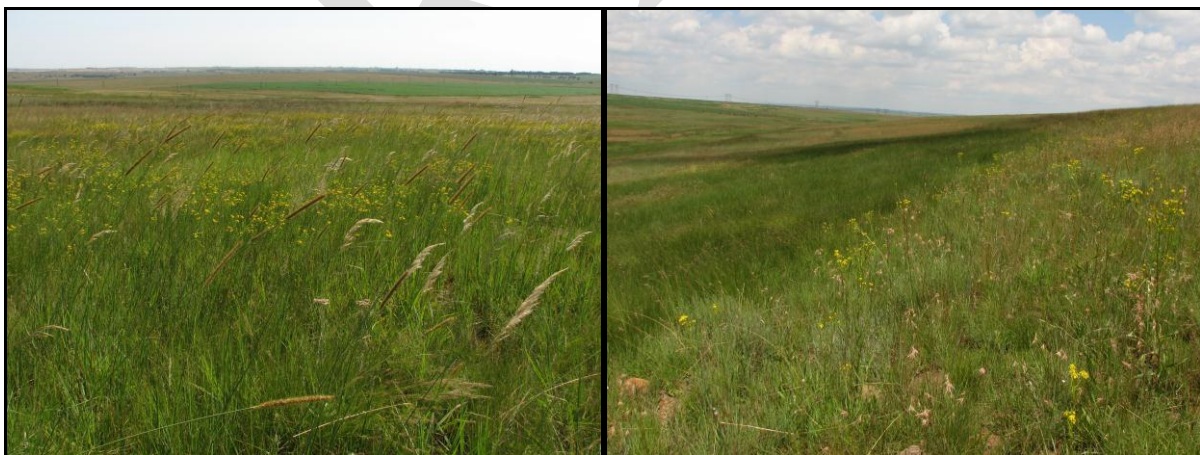
Figure 9. Photos of the wetlands observed within Site A: previously cultivated wetland left and largely natural wetland right.

The seepage wetlands within solution A have been extensively impacted by cultivation, specifically the wetlands within the western and southern sections of the site. Although many of these wetlands are no longer under cultivation, they are characterised by secondary vegetation with a high occurrence of weeds and ruderal species (Figure 9, left photo).

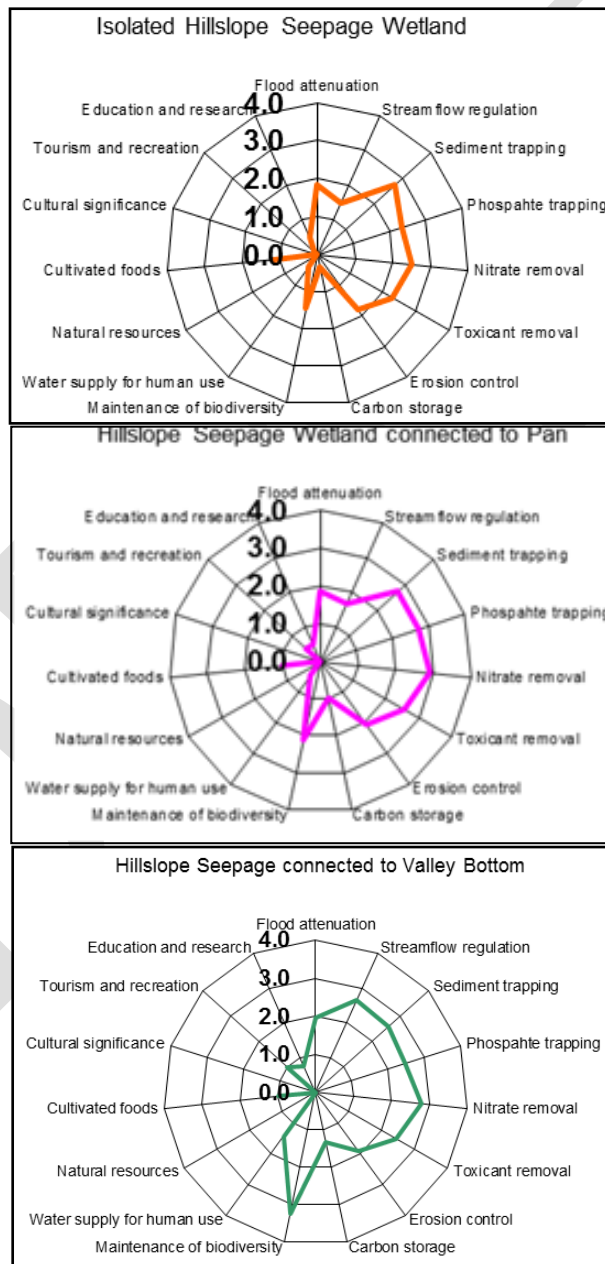
Figure 17. Radial plots showing the results of the WET-EcoServices assessment.
